Environmental Working Group

Monthly Report

April 2013

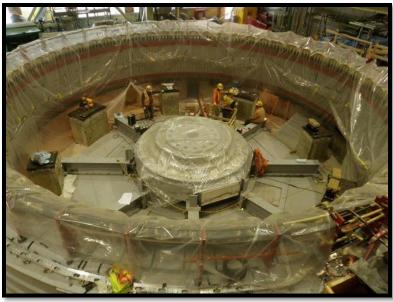
- CanAm continues to install flashing on the north wall of the lower roof.
- Andritz workers continue to install turbine and generator components. Components installed this month include the generator shaft, the inner head cover, wicket gate dowel pins, operating ring, thrust bearing and thrust bearing support cone, lower bracket, rotor frame and rotor rim (Figure 1).

Figure 1: Little Long assembling the lower brackets

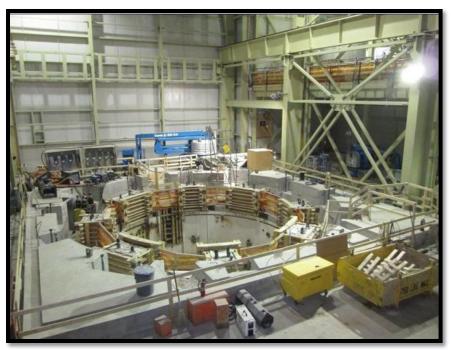
- CanAm has installed the polyurethane foam insulation and has started installing the exterior cladding on the walls of the Unit 3 powerhouse and Mezzanine.
- Andritz completed the installation of the draft tube liner components in Unit 3 (Figure 2).
- KAP and Harris Rebar have nearly completed the preparations (rebar, forms, etc) for draft tube liner secondary concrete.
- KAP has started preparations to water up the lagoon area. Current primary activities on this are clean up of the construction area and the leveling of a pad to drill pressure relief holes.
- AFI continues remedial work on the intake gates. They completed aligning the intake sealing faces and are currently welding the stainless steel overlay to the existing lintel.

Figure 2: Harmon inside the powerhouse

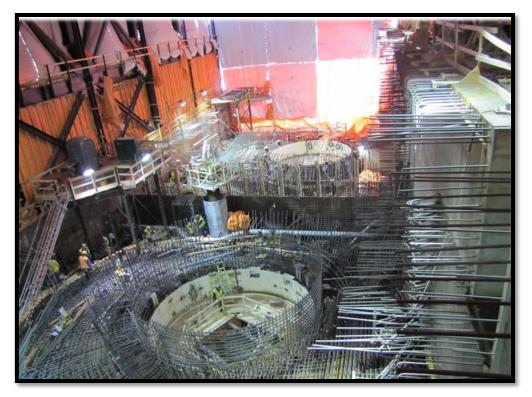
- Alstom continues to prepare Turbine/Generator components in the West Service Bay (WSB).
 They have completed the following tasks:
 - All four presses of the Unit 1 stator were placed (Figure 3). The core loop test is scheduled for early May. Stator winding is scheduled to begin once the core loop test is complete. Unit 1 rotor assembly has started;

- o At Unit 2, the concrete pour under the stay ring was completed (Figure 3); and
 - At Unit 3, formwork and rebar installation for the concrete pour under the stay ring are complete.

Figure 3: Smoky Falls Unit 1 and 2 Scroll Case

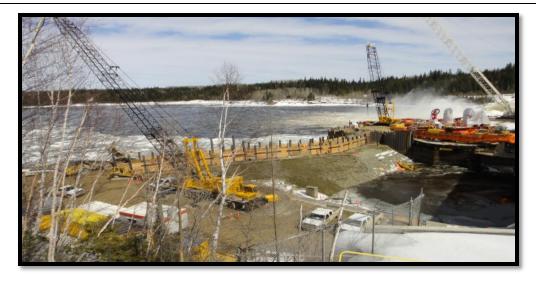
- The Stage 2 vertical extension for spring flooding (lagging wall) portion of the earth berm was completed (Figure 4). Dewatering the work area was completed April 25th.

Figure 4: Kipling Completed Lagging Wall (with H-piles and sheet piles)

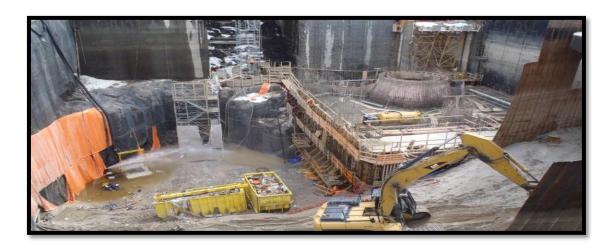
- Fill from Arc Cell 2-3 was placed under the concrete ring to create a level pad on which to lower it.
- The concrete ring from the failed Cell 3 was safely lowered to the ground April 30th. Demolition of the ring has started.

- Previously submerged forms have been inspected for damage. No significant issues were identified.
- Clean-up of the work area is under way with concrete pours scheduled to resume in early May (Figure 5).

Figure 5: Kipling debris clean-up within dewatered lagoon

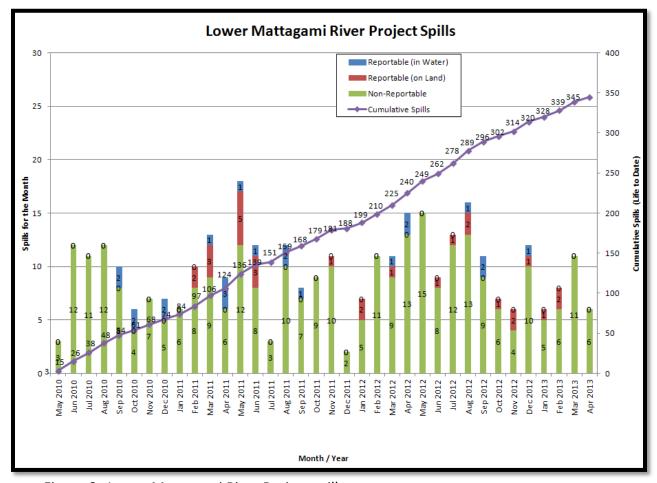
SPILL	_S							
No. c	of Spills:	6; Spill	6; Spill Reports 340-345 (see Figure 6 for LMRP spills breakdown).					
Class	ification of	Projec	Project Classification					
Spills	s:	Minor	Minor – 5 Moderate – 1 Major –0 To Water - 0					
		MOE C	MOE Classification					
		Non-re	Ion-reportable - 6					
		Report	Reportable to MOE

Figure 6: Lower Mattagami River Project spills
