# **Environmental Working Group**

**Monthly Report**

June 2013

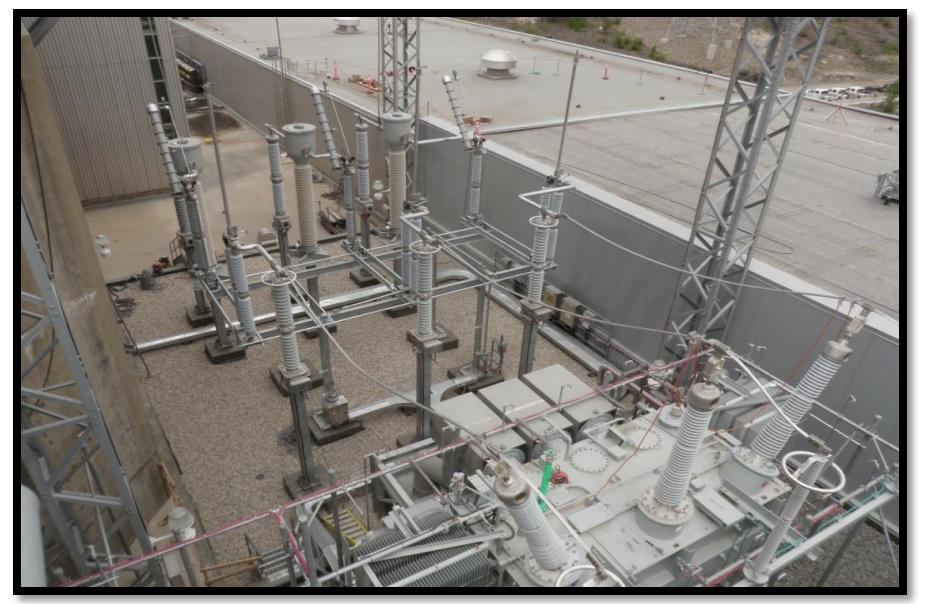
Figure 1: Little Long – Unit 3 Switchyard Completed

- Electricians continue to install panels, cable trays and cables in various areas in the powerhouse and the switchyard (Figure 1).
- Testing of components is ramping up with a number of tests completed in the month, including: transformer electrical tests, operation of switchyard disconnect switch (from the unit control panels), simulated transformer failures to test protection systems, wet testing of the intake gate, HVAC system pre-tests, pre-operational testing of 600V, 208V and control cables for the fire protection and tailrace hoist systems, pre-operational testing of the transformer deluge system, load verification on a number of circuits, and pressure testing on the lines between the governor and the servomotors.

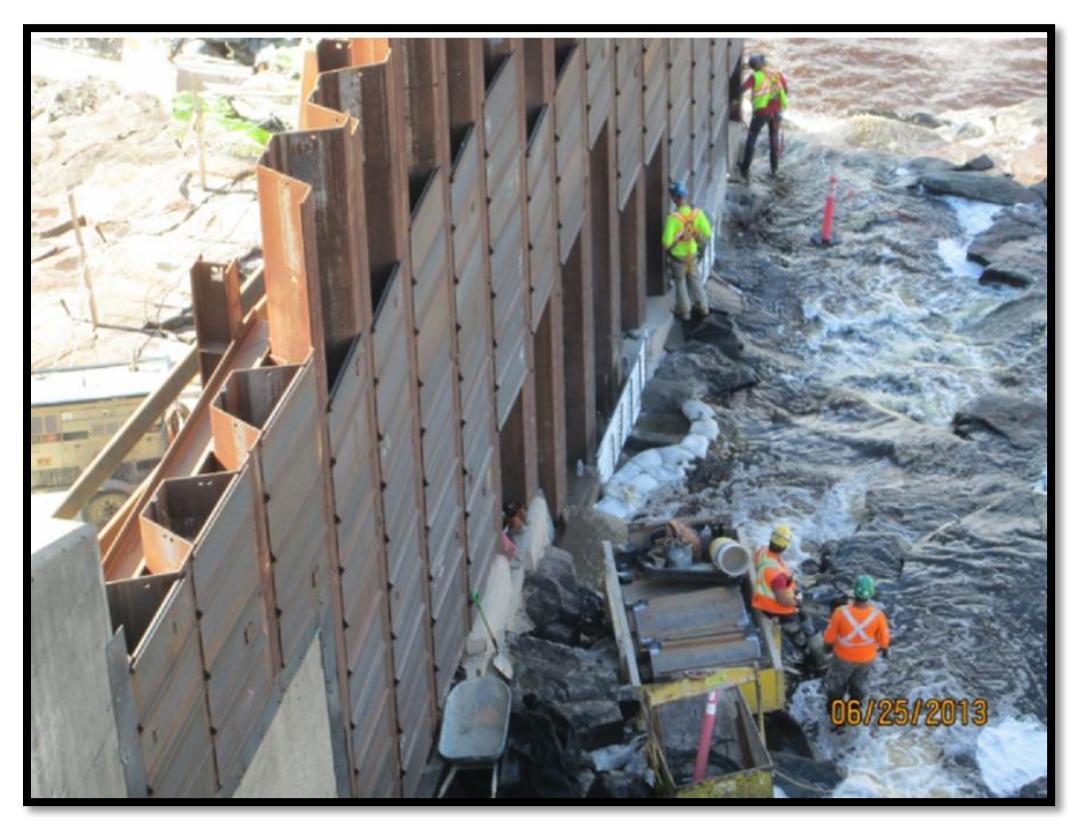
Figure 5: Work on Kipling Deflector Wall

- Excessive leakage was identified through the spillway deflector wall, which caused a minor delay in construction. River flow was temporarily diverted through the Adam Creek Spillway, allowing KAP to identify and correct the deficiency. A concrete plug needed to be re-poured and small plates needed to be re-welded to the deflector wall (Figure 5).

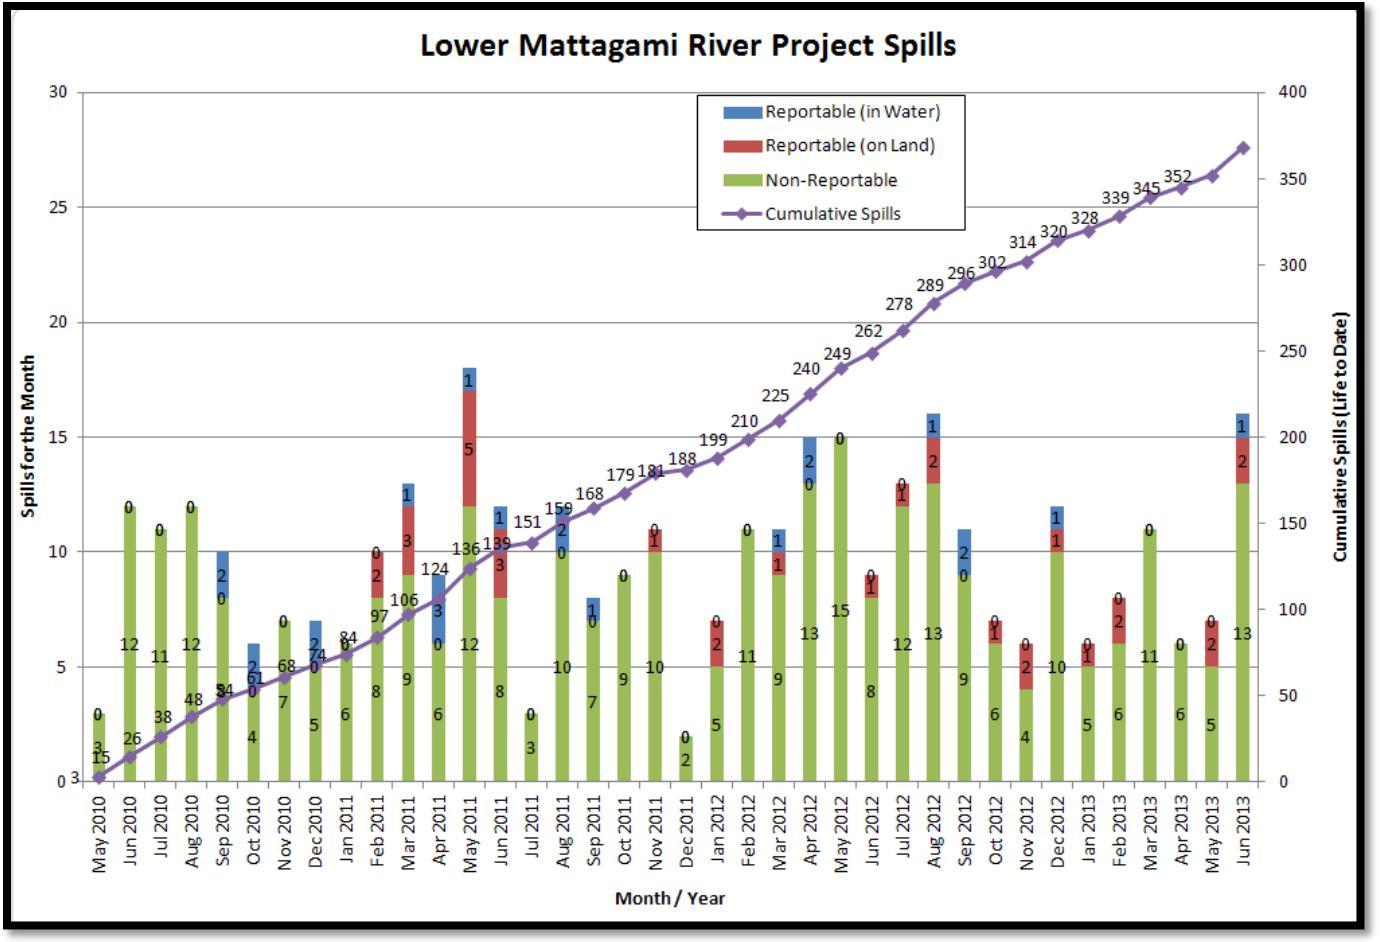
Figure 6: Lower Mattagami River Project spills

#### SPILLS No. of Spills: 16; Spill Reports 355-370 (see Figure 6 for LMRP spills breakdown). Classification of **KAP Project Classification** Spills: Minor – 12 Moderate – 3 Major –1 To Water - 0 **MOE Classification** Non-reportable - 13 Reportable to MOE \_ Class C – 3 Class B – 0 \_ Class A – 0 **Reportable Spills** Quantity No. Spill Site Reason for being Reportable /Product Spilled 1 200 L/ Smoky Falls – On-land reportable spill. Upon further inspection of the alum Sediment Pond Aluminum tote at the Smoky Falls sediment pond, it was noticed that the Sulphate fitting on the tote (shut-off valve) had completely eroded, which (Alum) filled up the secondary containment under it. The secondary containment had also eroded, which caused the alum to leak onto the ground. The fitting on the tote was replaced with a different one to prevent the alum from eroding through the steel, and all fittings on alum and citric acid totes will be replaced on site. The environmental department will look at ordering secondary containment that will not erode with these types of products. 2 20 L/ Raw On-land reportable spill. The wash car had been used Harmon – Existing Sewage throughout the day, and had overfilled the tank, causing raw Powerhouse sewage to leak out of the tank, onto the ground. The workers were reminded to call the site services department to empty out pad the washcars when they were full in order to prevent these types of spills. 3 10 L/Engine Harmon In-water reportable spill. A truck that pulled over to the side of Oil Upper laydown the road tipped onto its side. Engine oil was released from the breather hose. The oil went on the ground and the water from yard the truck washed it into the drainage ditch and culvert leading to the Mattagami River. **KAP Project Classification** MOE Classification (see Reportable and Non-reportable Spills Minor: $\leq 10L$ definition below) Moderate: Between 10L and 100L Non-reportable: < 100L Major: ≥100L Reportable to MOE To Water: Any amount is reportable to Class C - Less Serious ٠ the MOE Class B - Serious (See Figure 7: KAP Spills Response Class A – Very Serious Flowchart) Sediment Pond Exceedance of Effluent Objective
