## **Environmental Working Group**

### **Monthly Report**

**March 2014**

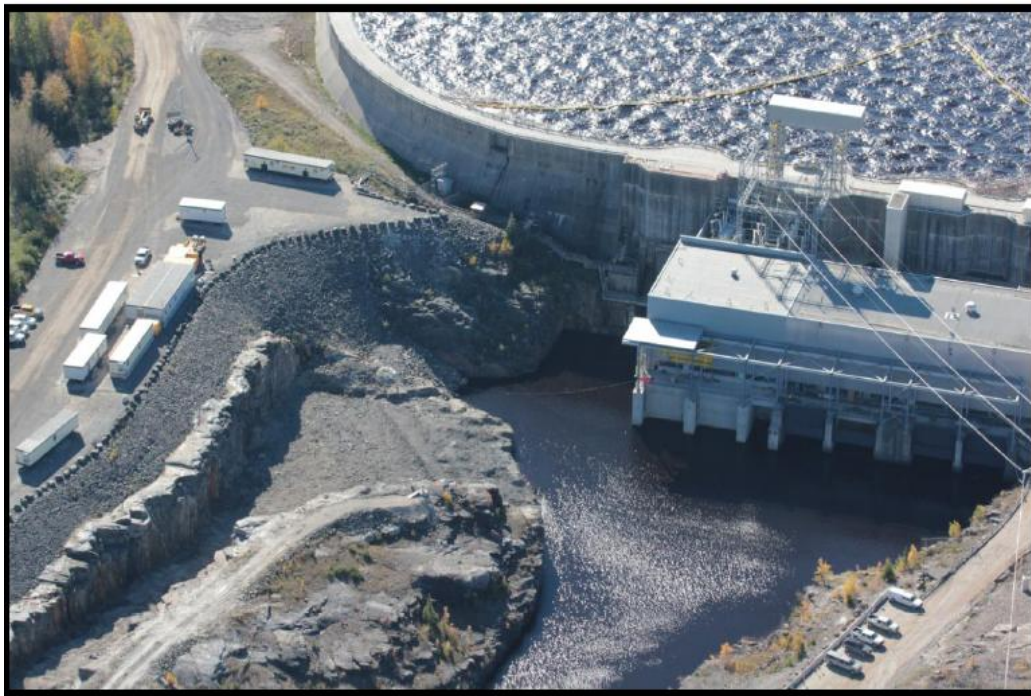
Figure 1: Little Long Unit 3

- The focus of work this month was on deficiency (i.e. punch list) remediation and completion of Transfer of Control (TOC) documentation.
- KAP issued a notice of substantial completion to OPG dated March 18. The OPG Project team is reviewing the notice and preparing a response for KAP.
- Little Long Unit was 3 (Figure 1) was declared in service on January 19, 2014.

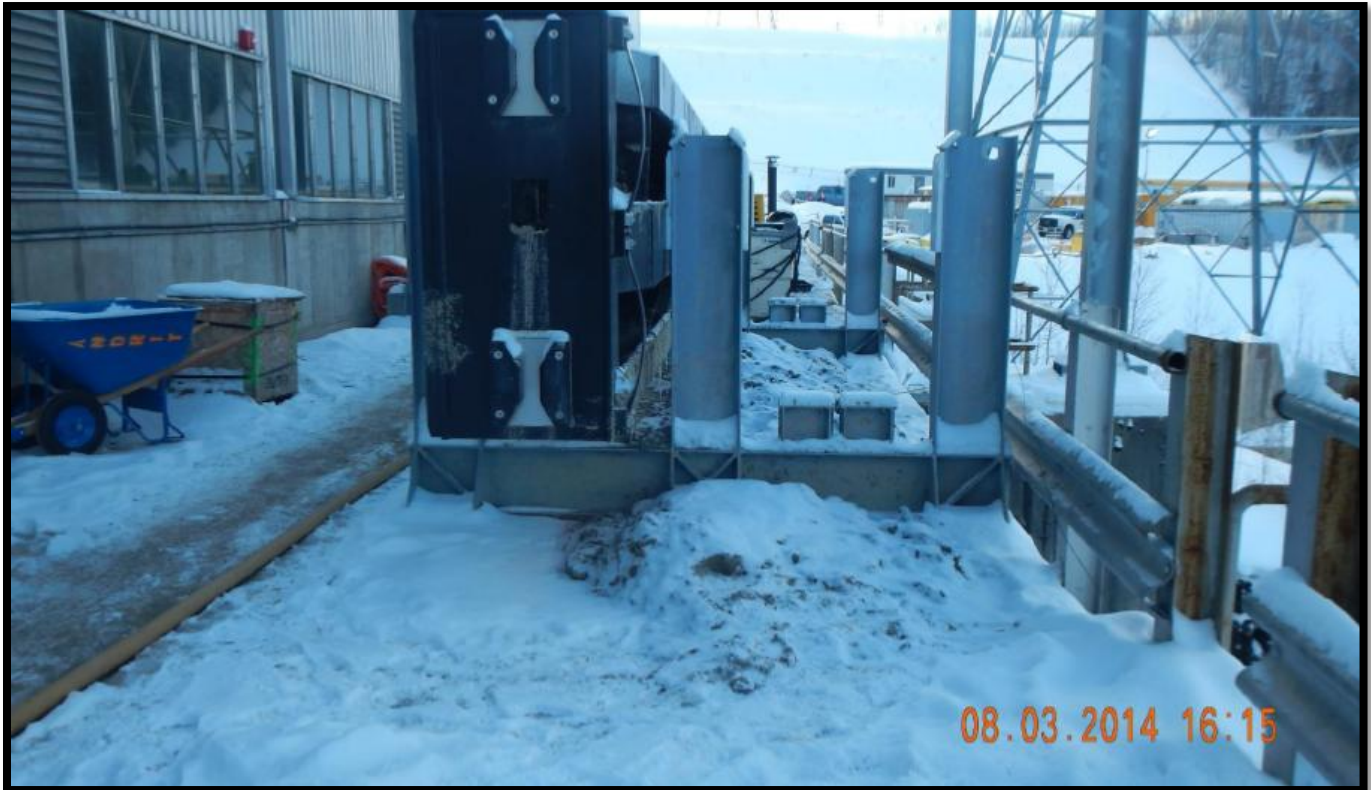
Figure 2: Harmon stop log and accumulated sediment

- With Turbine and Generator construction declared complete at the end of last month, the focus has switched to pre-operational testing and commissioning.
- The Unit was watered up mid-march and water seepage was identified, similar to what was observed at Little Long. The DB Contractor is applying the same remedial measures that were successful at Little Long (epoxy grout injection in the concrete).
- Wicket gate leakage checks, first rotation of the unit, a balancing run and a heat run were completed successfully.
- There was a delay in starting the turbine as there was difficulty removing the last stop log because it was stuck in the cofferdam sand that was pushed in front of G3 (Figure 2).
- An overspeed test was successfully completed and the post-test inspection of the discharge ring revealed no contact was made between the runner and the discharge ring.

- MCFN member of the EWG was on-site and found out that there was a delay in starting the turbine as they had difficulty removing the last stop log as it was frozen at the bottom due to a sediment build-up (approximately 1 m<sup>3</sup>). EWG members were concerned that the sediment build-up represented an in-water spill.

Action Required: KAP explained that the sediment build-up (Figure 2) was a result of sediments collecting at the bottom of the stop logs when the cofferdam area was watered up. KAP contacted the Ministry of the Environment to discuss the situation and determine that this did not represent an in-water spill.

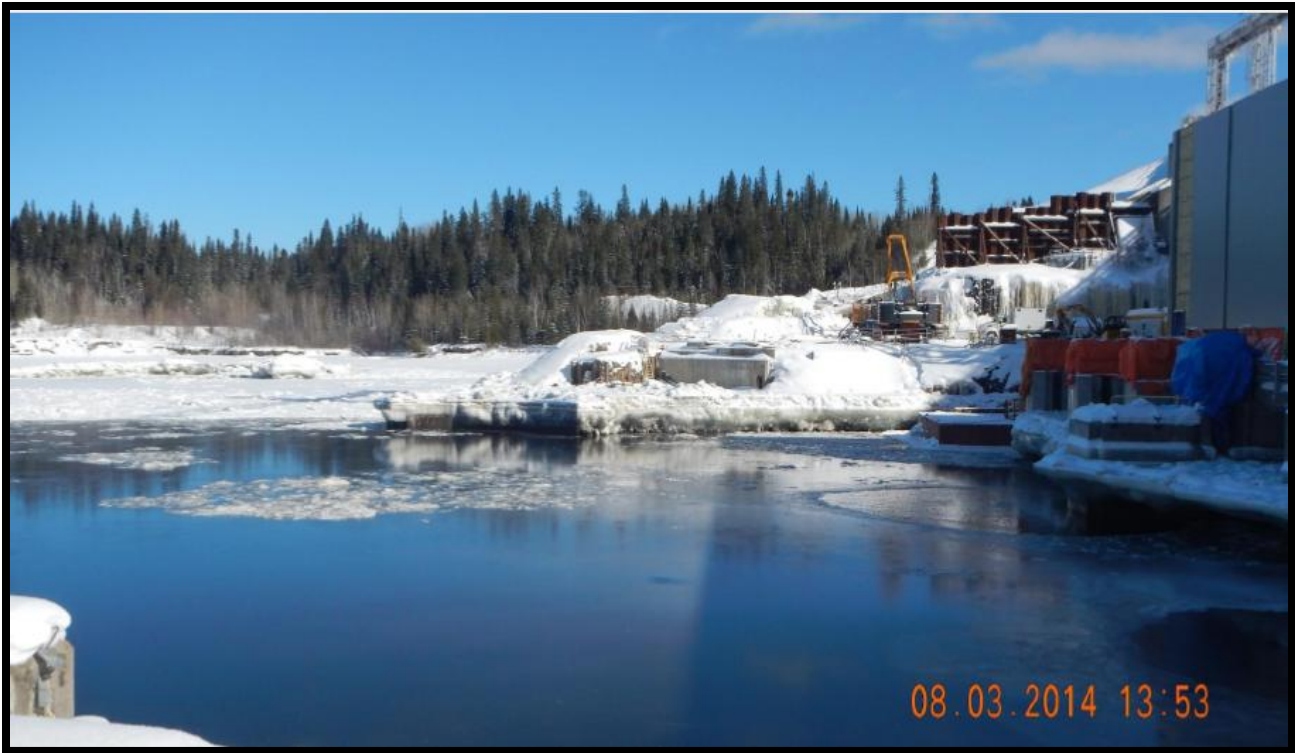
Figure 3: Kipling cofferdam removal

- Stator piling was completed this month. The core loop test was completed successfully, allowing stator winding activities to start.
- Cofferdam removal is complete and the DB Contractor has demobilized equipment used for cofferdam removal (Figure 3).

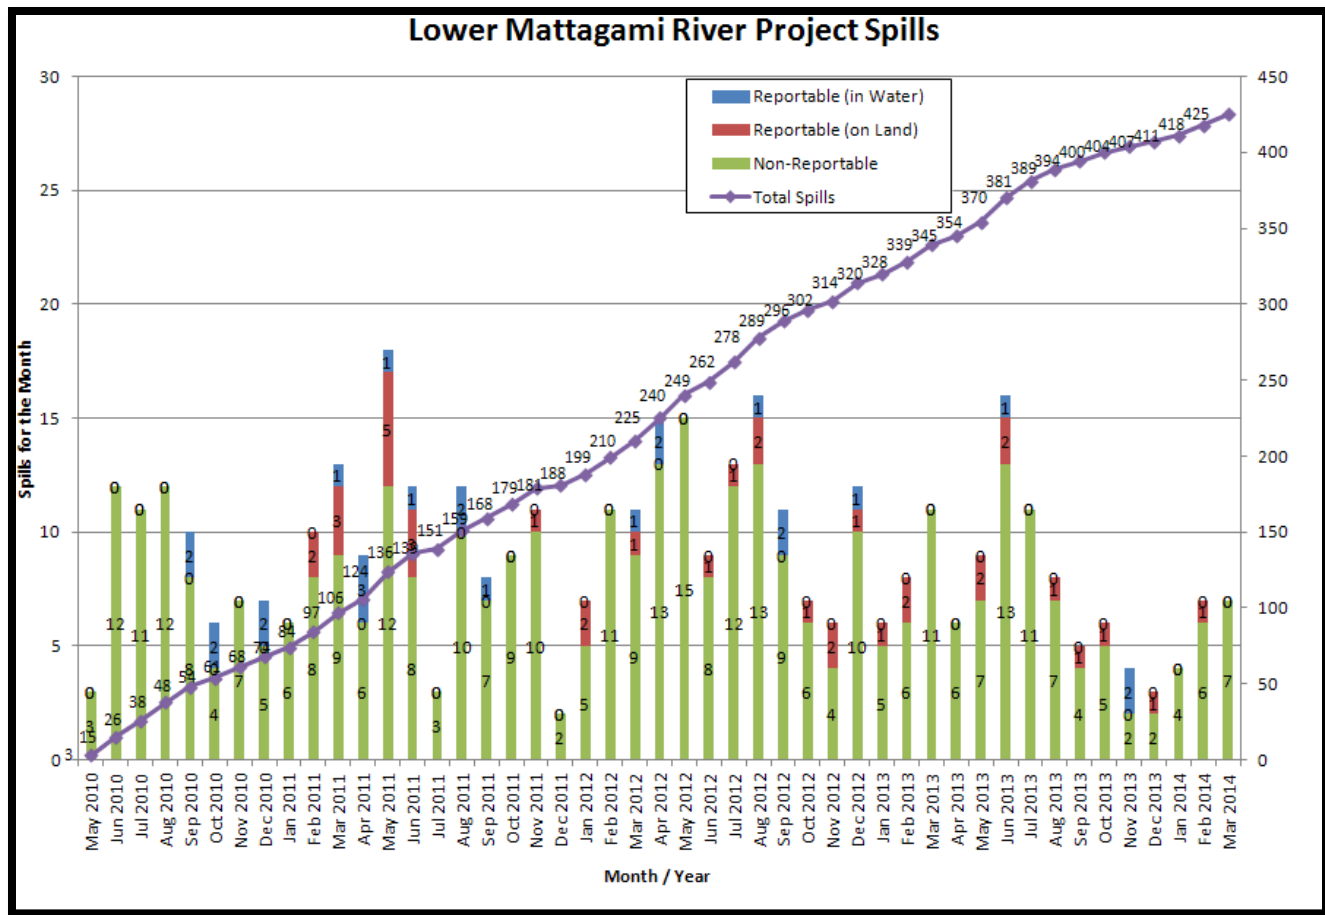
Figure 6: Lower Mattagami River Project spills

SPILLS			
No. of Spills:		7; Spill Reports 419-425 (see Figure 6 for LMRP spills breakdown).	
Classification of Spills:		<u>KAP Project Classification</u> Minor – 7 Moderate – 0 Major –0 To Water - 0 <u>MOE Classification</u> Non-reportable - 7 Reportable to MOE <div><div>- Class C – 0</div><div>- Class B – 0</div><div>- Class A – 0</div></div>	
Reportable Spills			
No.	Quantity /Product Spilled	Spill Site	Reason for being Reportable
n/a			
KAP Project Classification Minor: ≤ 10L Moderate: Between 10L and 100L Major: ≥100L To Water: Any amount is reportable to the MOE (See Figure 7: KAP Spills Response Flowchart)			MOE Classification (see Reportable and Non-reportable Spills definition below) Non-reportable: < 100L Reportable to MOE <ul style="list-style-type: none"><li>• Class C - Less Serious</li><li>• Class B – Serious</li><li>• Class A – Very Serious</li></ul>
Sediment Pond Exceedance of Effluent Objective
