Environmental Working Group

Monthly Report

August 2012

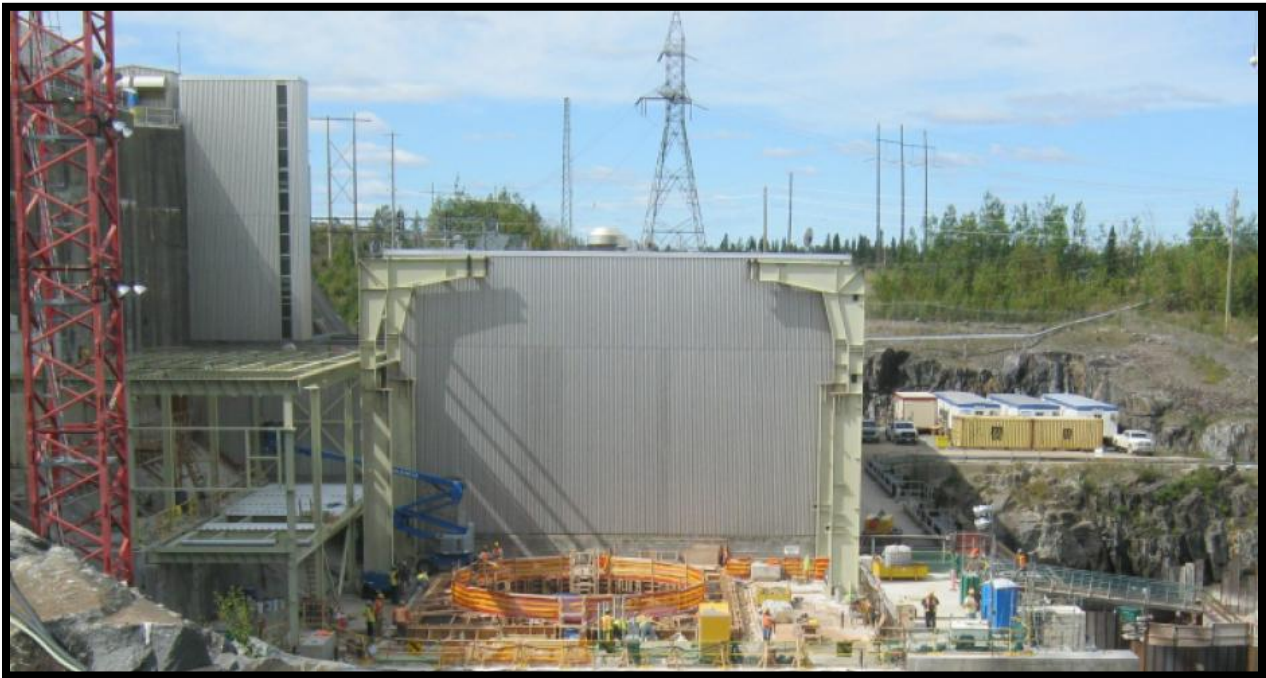
Figure 1: Little Long – Superstructure Progress

- Concrete work is progressing well and nearing completion, with 596 m³ of concrete poured, bringing the total poured to date to 13,138 m³ of 13,886 m³ total, against a plan of 12,978 m³.
- Concrete work (forms, rebar, pours) for the mezzanines continues.
- Work on transmission towers (formwork and rebar for foundation pours) is ongoing.
- A steel beam ramp was installed between cofferdam Cell 1 and the mobilization pad to create crane access, and a crane pad was prepared at the cofferdam for the crane to be used for the superstructure erection, sectional gate hoist structure erection, and the cofferdam removal.
- The superstructure erection is under way and progressing (Figure 1).
- Three stator frames have been received at the site.
- Machining of the stay ring bottom flange is complete.
- The existing east powerhouse wall external cladding removal has started.

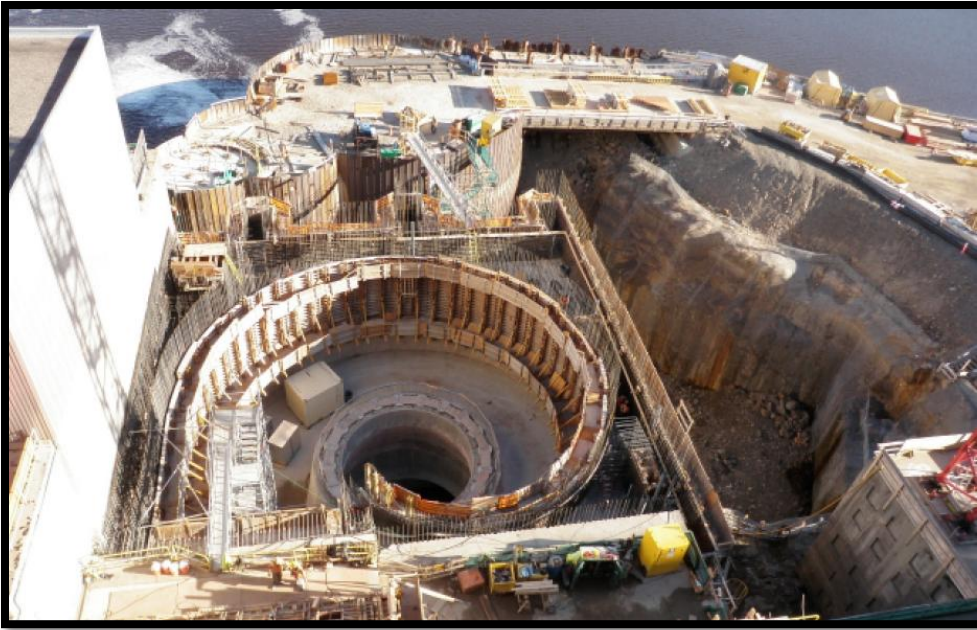
Figure 2: Harmon Site Overview

- 1,493 m³ of concrete was poured this month, bringing the total poured to date to 8,423 m³ of 12,251 m³ total, against a plan of 6,869 m³.
- The concrete work this month was focused on the intake soffit and the scroll case outer walls.
- The stay ring jack bearing plate installation was completed and stay ring sections have been delivered to the site.
- Removal of the tailrace soffit shoring modules continues to advance.
- The three pit liner sections were delivered to the site this month. KAP has dry fit them and is preparing to begin welding them.
- Installation of the bottom stay ring anchors is under way (Figure 2).

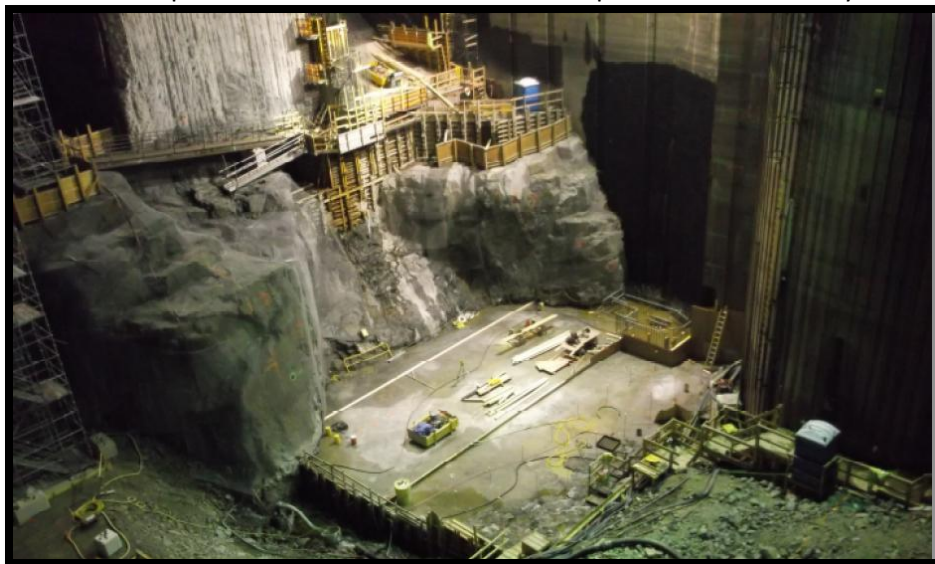
Figure 3: Kipling mud slab pour

- 283 m³ of structural concrete was poured this month, bringing the total poured to date to 283 m³ of 11,169 m³ total, against a baseline plan of 5,220 m³.
- Bullnose rock stabilization efforts are under way and wire mesh was installed over the east rock face of the excavation area.
- Excavation work in the powerhouse area was completed.
- A minor leak detected during dewatering at the interface of cofferdam Cell 3 and the pier tie-in was repaired using a chemical grout.
- Concrete work in the intake has progressed, with the base completed and progress being made on the East and West intake walls.
- The RSW geologist cleared KAP to begin pouring concrete after inspecting the powerhouse area. Two large powerhouse mud slabs and the sump shaft mud slab were poured (Figure 3).
- The transformer pad with oil containment walls was poured at the switchyard.

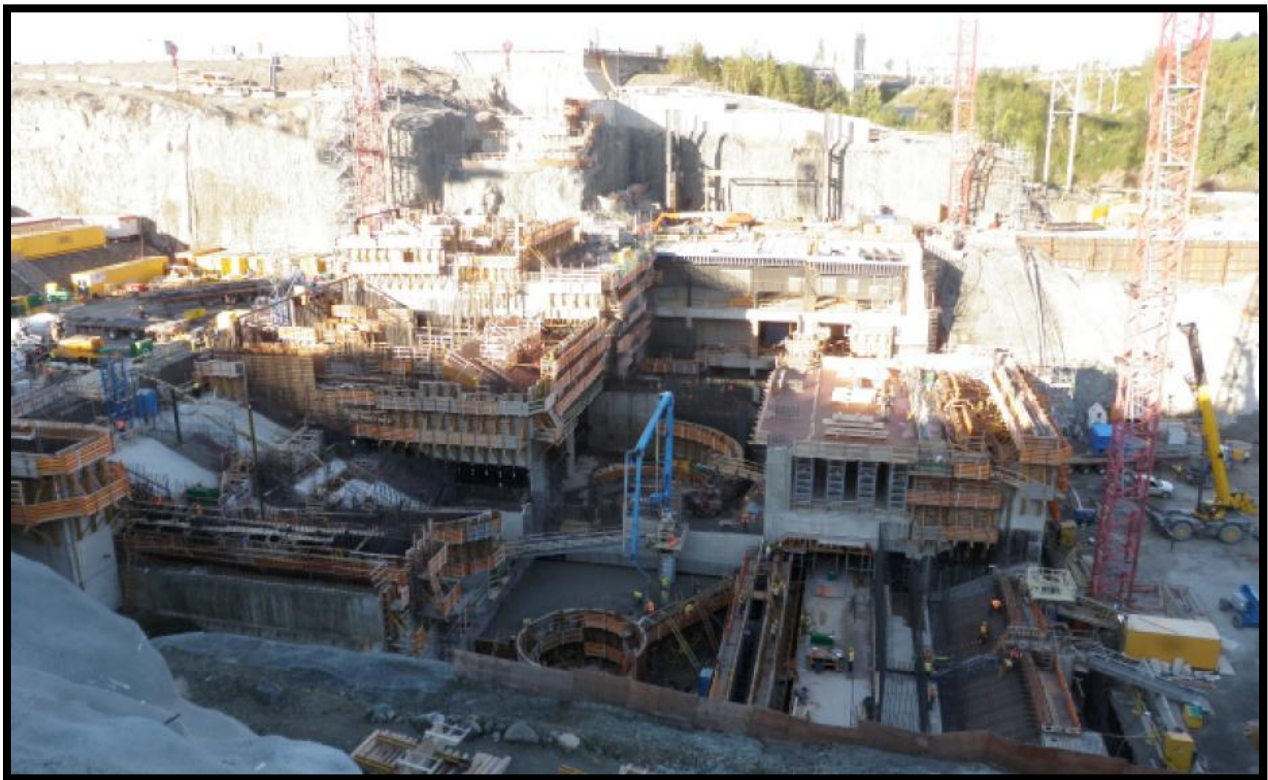
Figure 4: Smoky Falls Site Overview

- 9,599 m³ of concrete was poured this month in the service bay, powerhouse, and intake areas, bringing the total poured to date to 58,823 m³ of 155,084 m³ total, against a plan of 62,777 m³ (Figure 4).

- At the end of the month, twenty two (22) concrete pours are in various stages of work (formwork started and/or rebar being installed) and progressing in the intake, powerhouse, East gravity dam, and at the permanent bridge.

- The steel superstructure erection is under way and progressing.
- Work has started on Sluiceway Gate 5 by AFI. The hoist structure is in position at Gate 5 and stop log installation will begin in early September.

- Wet Tailrace Channel: The drilling subcontractor continued the drilling of blast holes through the marine pad for the excavation of the downstream end of the wet tailrace channel. Phase 2 blast 1 was completed on August 15th and the blasted rock was hauled to the crushing plant. Phase 2 blast 2 is scheduled for September 1st.

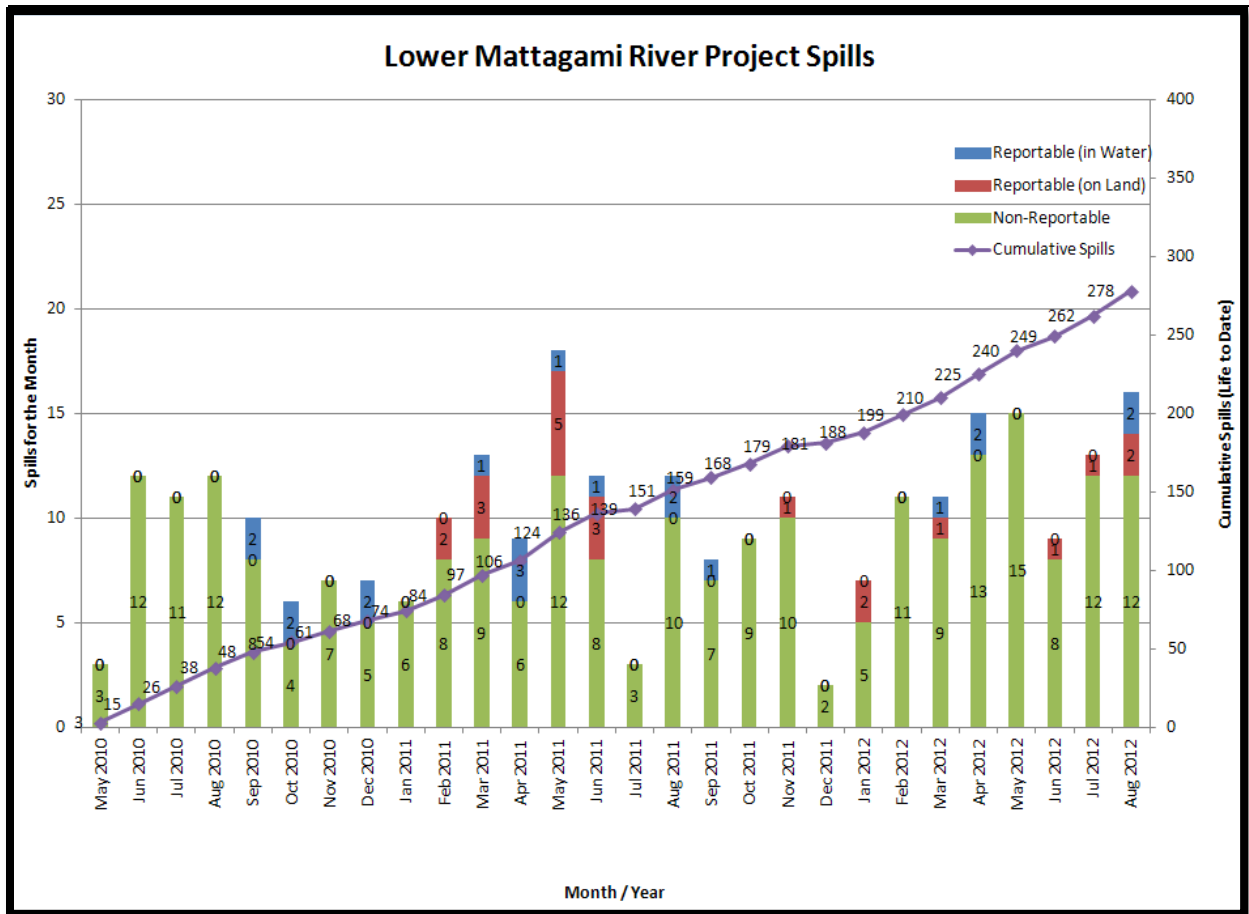
Figure 6: Lower Mattagami River Project spills

SPILLS			
No. of Spills:		16; Spill Reports 263-278 (see Figure 6 for LMRP spills breakdown).	
Classification of Spills:		<u>Project Classification</u> Minor – 13 Moderate – 1 Major –2 To Water - 0 <u>MOE Classification</u> Non-reportable - 12 Reportable to MOE <ul style="list-style-type: none">- Class C – 4- Class B – 0- Class A – 0	
Reportable Spills			
No.	Quantity /Product Spilled	Spill Site	Reason for being Reportable
1	Oil, grease/Unknown	Kipling Cofferdam	Reported by KAP to MOE Spill Action Centre, but later determined that the spill was did not meet the definition of a spill under the EPA “from or out of ... container, abnormal in quality and quantity”. Also does not apply to s.30 of OWRA, as the discharge did not reach ‘waters’, per the report.
2	Sediment/Unknown	Smoky Falls - Tailrace	A thunderstorm with hail and heavy rain caused the road and ditches prior to the temporary bridge to be washed out . The water then in turn made its way to the Smoky Falls switchyard, as well as Structure 2, which then seeped out of the area, through the bush, into the tailrace. The ditches as well as the sediment and erosion control methods in this area were looked at and improved in order to better contain the water should a storm of this magnitude occur again.
