Environmental Working Group

Monthly Report

January 2012

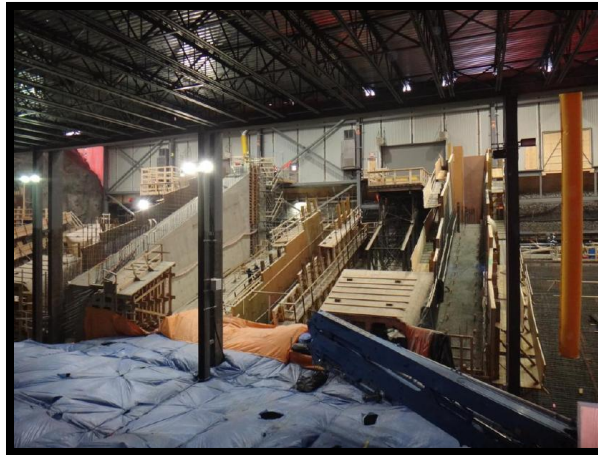
Figure 1: Smoky Falls Concrete Work Inside the Winter Shelter

- Over the Christmas period, the heaters were kept on to maintain a constant temperature inside the shelter.
- Concrete pours in the service bay, powerhouse, and intake areas resumed, with a total of 1,831 m³ of concrete poured in January (January 3rd to February 3rd).
- There are sixteen pours in total with work under way (rebar and form work) at the end of the month.
- Work continues under localized hoarding on the reconstruction of the Smoky Falls Unit 2 / Unit 3 bullnose. Installation of form work and rebar installations are progressing.
- Inside the winter shelter, foundations for all of the four concrete placing booms are complete, except for one (the grout is curing on the last foundation). All but one of the placing booms are installed and in-service (Figure 1).

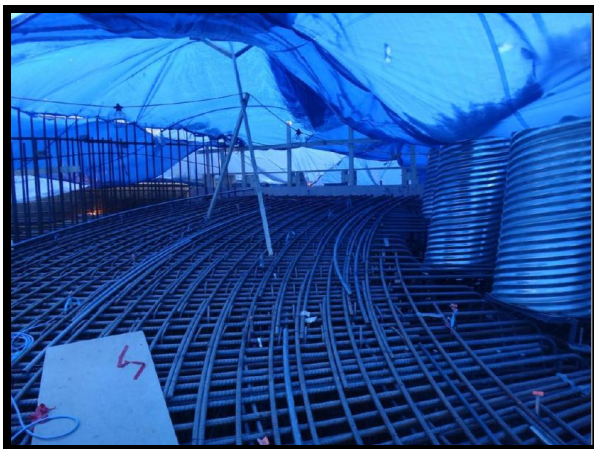
Figure 2: Corrugated metal pipes and rebar inside Little Long Hoarding

- Steel frames and corrugated metal pipes used for anchor box-outs have been installed for the base of the stay ring (Figure 2).
- Concrete work is progressing well, with 531 m³ of concrete poured in the powerhouse area (Figure 3). Work continues to advance at an accelerated pace despite occasional extremely cold weather. KAP is reporting that Little Long is now 351 m³ of concrete ahead of plan as of January 25th.

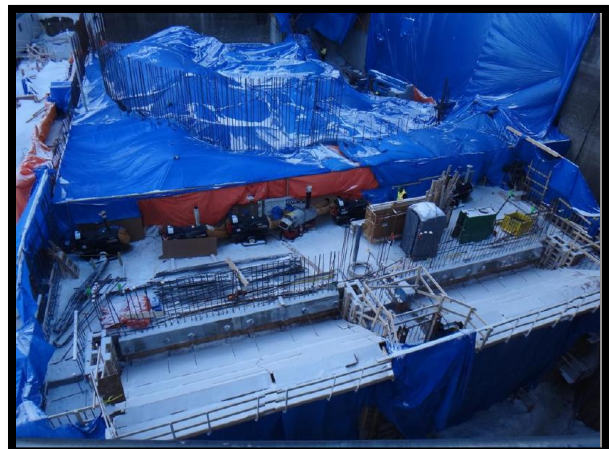
Figure 3: Little Long Powerhouse Area Overview as seen From the Cofferdam

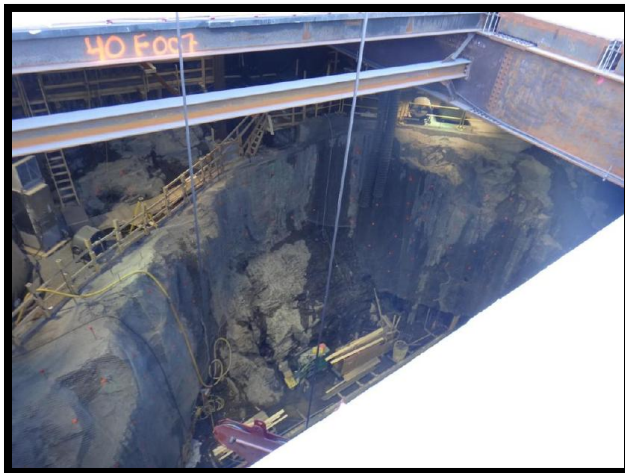
Figure 4: Harmon Powerhouse Work Area seen from the top of the Winter Shelter

- Upon their return from the Christmas break, KAP made adjustments to the winter shelter tarps and installed additional heating equipment inside the shelter (Figure 4).
- Ice removal under the winter shelter was required and completed.
- Preparations for the concrete pour for the base of the draft tube (658 m³) have been advancing well, and the pour is currently planned for two days ahead of the baseline schedule.
- 51 m³ of concrete was poured in the intake in January.

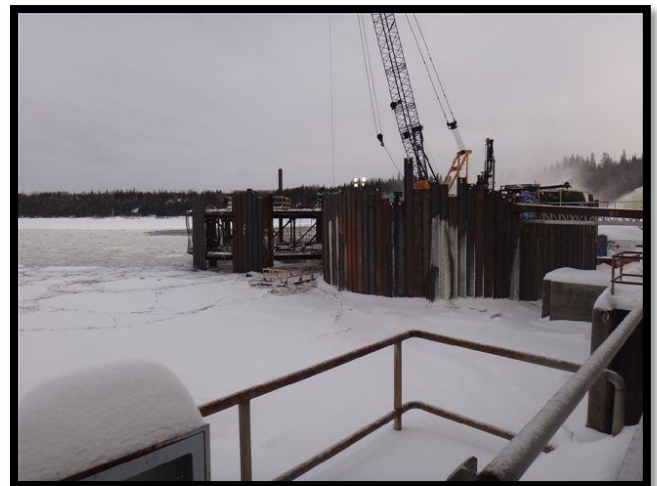
Figure 5: Kipling – Installing Cell #2 Sheet Piles

- The bubbler system in put place over the Christmas break was successful in minimizing the ice build-up in the cofferdam area.
- KECO (designer) worked through the Christmas break to determine the best re-designed configuration for post-tensioned anchors and the best way to seal Cell #2.
- Cofferdam Cell #2's position was slightly altered due to a spud pile bearing on uneven bedrock. Cell #2's spud piles have been installed and sheet pile installation is under way (Figure 5).
- Additional bracing has been added to Cell #2 (to Cells #1 and #3) in lieu of an anchor on the north spud pile, which is located in the fault zone.

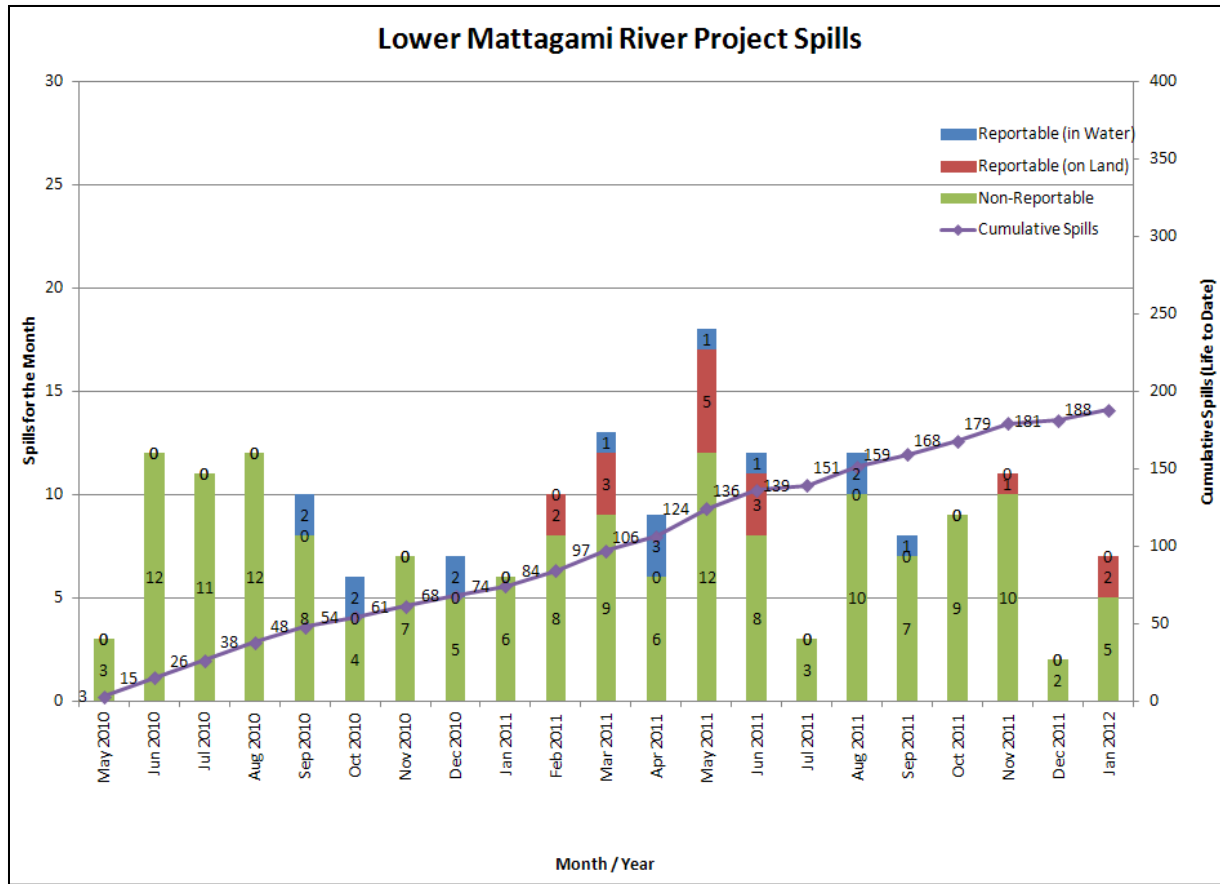
SPILLS			
No. of Spills:		7; Spill Reports 182-188 (see Figure 6 for LMRP spills breakdown).	
Classification of Spills:		<u>Project Classification</u> Minor – 3 Moderate – 3 Major – 1 To Water - 0 <u>MOE Classification</u> Non-reportable - 5 Reportable to MOE <div>- Class C – 2 - Class B – 0 - Class A – 0</div>	
<u>Reportable Spills</u>			
No.	Quantity /Product Spilled	Spill Site	Reason for being Reportable
1	535 L/ Glycol (exact amount of material spilled cannot be determined as the volume of glycol in the ground heater before the spill was not known. The tank and hose capacity of the heater is approximately 535 L and this would be the maximum amount of glycol released. This volume was reported to the MOE Spills Action Center.	Harmon - Dewatered Area	Reportable (on-land due to quantity)
2	12 L/ Engine Oil	Adam Creek Parking Lot	Reportable (on-land from a non-motor-vehicle)
Project Classification (KAP) Minor: ≤ 10L Moderate: Between 10L and 100L Major: ≥100L To Water: Any amount is reportable to the MOE (See Figure 7: KAP Spills Response Flowchart)			MOE Classification Non-reportable: < 100L Reportable to MOE <div>• Class C - Less Serious • Class B – Serious • Class A – Very Serious</div>

Figure 6: Lower Mattagami River Project spills

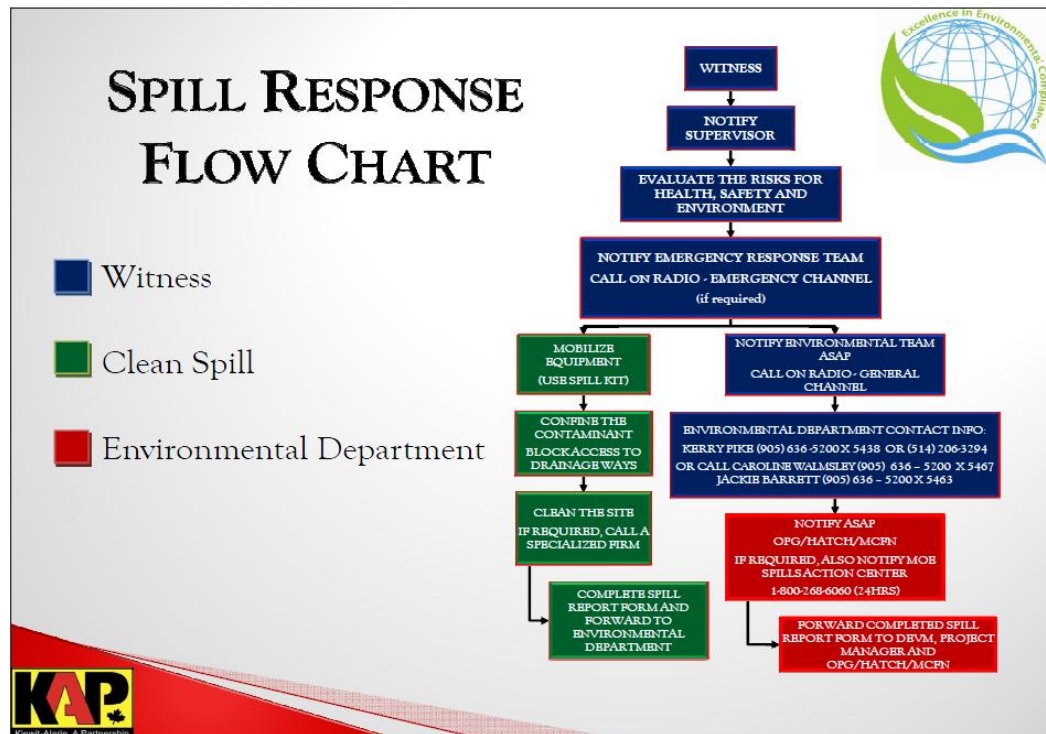
Figure 7: KAP Spills Response Flowchart
