# **Environmental Working Group**

# **Monthly Report**

**June 2012**

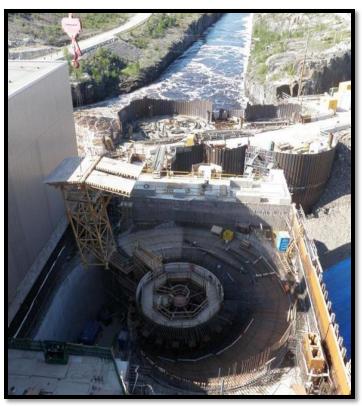
Figure 1: Little Long removal of intake shoring

- Work on the Little Long switchyard has started with excavation, grading, concrete form work and rebar in progress.
- The shoring towers in the intake have been removed, and the scroll case soffit shoring tower erection is nearing completion (Figure 1).

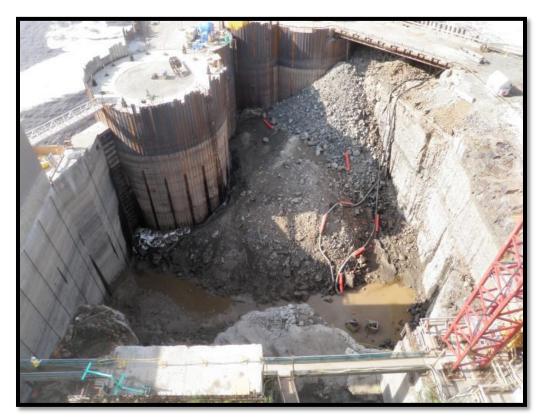
Figure 3: Kipling dewatering completed on June 25

- Drill and grout of cofferdam Cell #2 and the shore tie-in was completed.
- Cofferdam dewatering started on June 9th, and was successfully completed on June 25<sup>th</sup> (Figure 3). Some leakage was identified at Cell #3, but was stopped with a mixture of gravel, hydro-lite, and bentonite pellets placed on the river side of the cofferdam.
- The Unit 3 intake block wall removal complete.
- Drill and blast operations have started in the intake area, and excavation is under way in the powerhouse area.

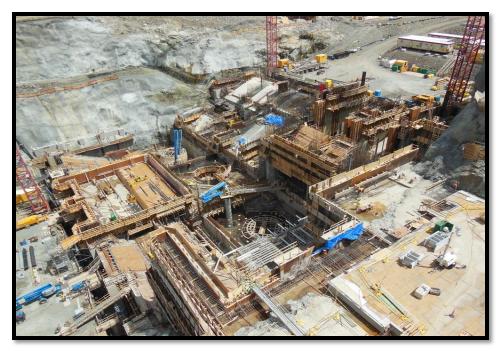
Figure 4: Smoky Falls Site Overview from West Tower Crane

- 6,574 m3 of (neat line) concrete was poured this month in the service bay, powerhouse, and intake areas, bringing the total poured to date to 37,416 m3 compared with a total volume planned of 135,913 m3.
- Twenty four other concrete pours are in various stages of work (form work started and/or rebar being installed) and progressing in the intake, powerhouse, and East gravity dam areas.
- Drilling for the galvanized rock anchors for the permanent bridge is complete and anchor installation is under way.
- West gravity dam: a blasting proposal was received from SLI for the removal of the embedded wood on the downstream face of the existing dam. Test blasts are being planned.
- Several concrete pours were completed for the East Gravity Dam (Figure 4).
- Work in the switchyard (concrete form work, rebar, pours, and backfilling) continues to progress.

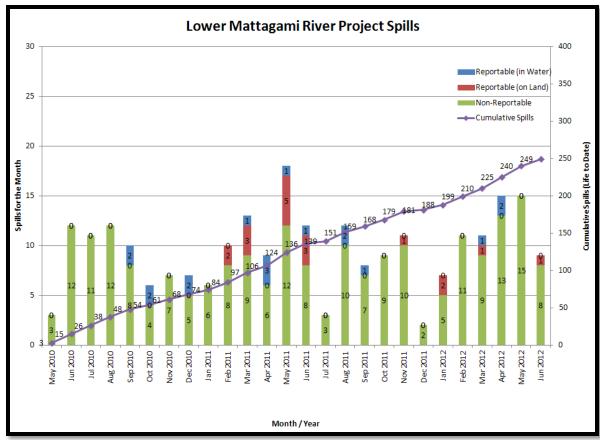
Figure 6: Lower Mattagami River Project spills

No. of Spills:  15; Spill Reports 226-240 (see Figure 6 for LMRP spills breakdown).  Classification of Spills:  Project Classification Minor - 7 Moderate - 1 Major - 1 To Water - 0  MOE Classification Non-reportable - 8 Reportable to MOE  - Class C - 1 - Class B - 0 - Class A - 0  Reportable Spills  No. Quantity /Product Spilled Spill Site Reason for being Reportable Genetron R-22 (Freon) Smoky Falls - Batch plant Reported by KAP to MOE Spill Action Centre, but later determined that the spill was captured under EPA Reg. 675/09 exemption for refridgerants, as the amount released was less	Wionthly Summary – June 2012										
breakdown).  Classification of Spills:  Project Classification Minor − 7 Moderate − 1 Major − 1 To Water − 0  MOE Classification Non-reportable − 8 Reportable to MOE  - Class B − 0 - Class B − 0 - Class A − 0  Reportable Spills  No. Quantity /Product Spilled Spill Site Reason for being Reportable Genetron R-22 (Freon) Smoky Falls − Batch plant Reported by KAP to MOE Spill Action Centre, but later determined that the spill was captured under EPA Reg. 675/09 exemption for refridgerants, as the amount released was less than 100 kg (1200 litres of R22 is equal to 4.392 kg).  Project Classification (KAP) Minor: ≤ 10L Moderate: Between 10L and 100L Major: ≥100L Moderate: Between 10L and 100L Major: ≥100L See Figure 7: KAP Spills Response Flowchart)  Sediment Pond Exceedance of Effluent Objective  No. of Exceedance days recorded  The increase in turbidity and pH levels were due to the dewatering activities at the Kipling cofferdam. KAP added Alum and citric acid to the pond as a corrective measure, in addition	SPILLS

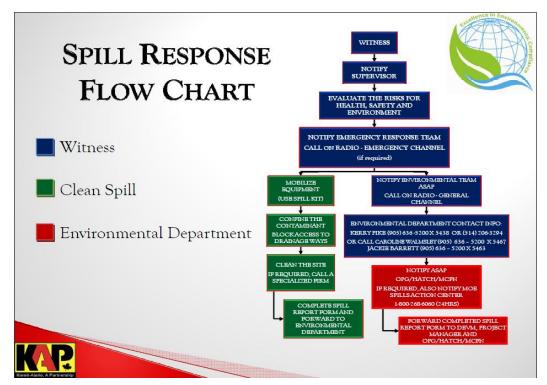
Figure 7: KAP Spills Response Flowchart

exemption for refridgerants, as the amount released was less than 100 kg (1200 litres of R22 is equal to 4.392 kg).  Project Classification (KAP)  Minor: ≤ 10L  Moderate: Between 10L and 100L  Major: ≥100L  To Water: Any amount is reportable to the MOE (See Figure 7: KAP Spills Response Flowchart)  Sediment Pond Exceedance of Effluent Objective  No. of   Location   Mitigation Measures used    Exceedance days recorded  The increase in turbidity and pH levels were due to the dewatering activities at the Kipling cofferdam. KAP added Alum and citric acid to the pond as a corrective measure, in addition											
than 100 kg (1200 litres of R22 is equal to 4.392 kg).  Project Classification (KAP)  Minor: ≤ 10L  Moderate: Between 10L and 100L  Major: ≥100L  To Water: Any amount is reportable to the MOE (See Figure 7: KAP Spills Response Flowchart)  Sediment Pond Exceedance of Effluent Objective  No. of  Exceedance days recorded  The increase in turbidity and pH levels were due to the dewatering activities at the Kipling cofferdam. KAP added Alum and citric acid to the pond as a corrective measure, in addition	1				1

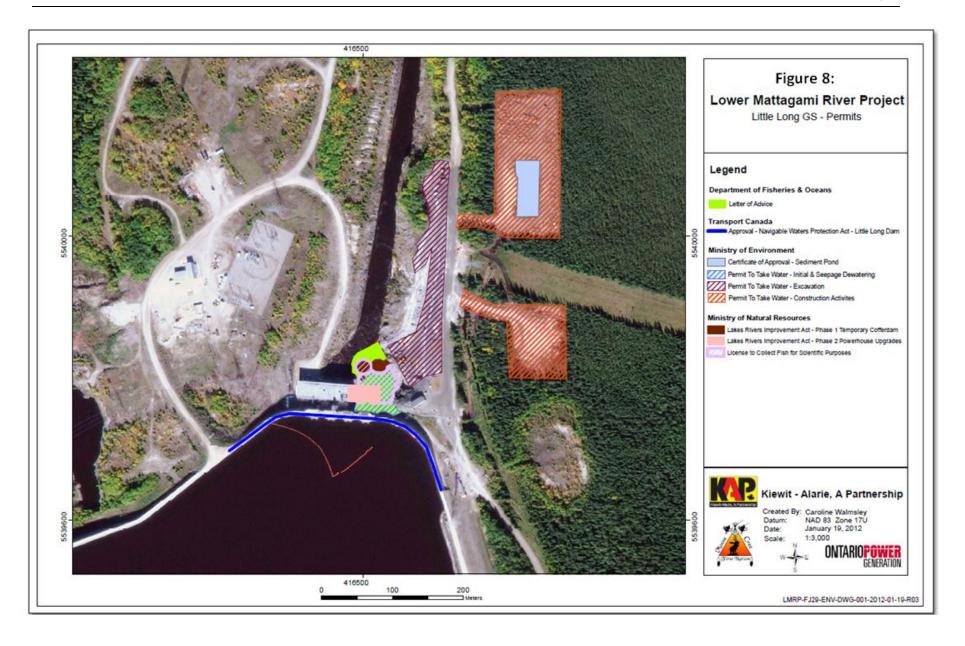
PERMIT AND APPROVAL REVIEW								
No. Reviewed:	0	List:						
No. Sent to KAP:	0	List:						
Reports Review								
No. Reviewed for KAP	0	List:						
No. Sent to KAP	0	List:						
No. Reviewed for MECC	5	List:	<ul> <li>On-going:</li> <li>Cost Benefit Analysis of Mitigating and Reducing Spill in Adam Creek.</li> <li>Mercury in Fish Flesh Summary Report.</li> <li>Fish Habitat Assessment Report</li> <li>Terrestrial Habitat Restoration Downstream of Kipling GS</li> </ul>					
No. Review Completed	3	List:	<ul><li>Operation Overview Report.</li><li>Waste Management Plan</li><li>Noise Control Plan</li></ul>					
REQUESTS FOR INFORMATION (RFIs)								
No. Reviewed:	0	List:	n/a					
No. Sent to KAP:	0	List:	n/a					
See figures 8 to 13 below for site location of the permits that have been or are pending approval.
