Environmental Working Group

Monthly Report

March 2012

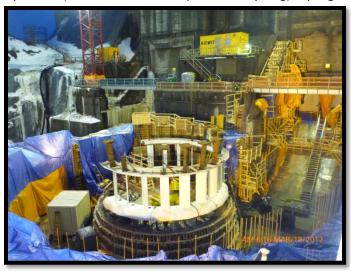
Figure 1: Formwork and stay ring at install at Little Long
Powerhouse

- Concrete work is progressing well, with 1,438 m3 of concrete poured in the powerhouse and intake areas. Work continues to advance at an accelerated pace despite occasional cold weather.
- Rebar and form work continues to progress at a good pace.
- The Unit 3 stay ring was installed.
- Electrical systems (light, heat and alarms) were removed from the east wall of the existing powerhouse.
- Work on the pit liner (to be installed on top of the stay ring) is progressing (Figure 1).

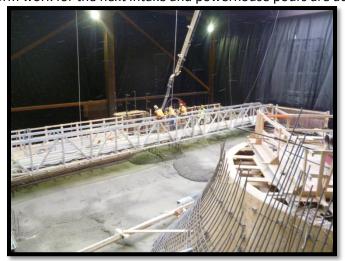
Figure 2: Pouring at Harmon

- Prefabricated curved forms for the draft tube are now assembled.
- 1,257 m3 of concrete was poured this month, 148 m3 in the intake and 1,109 m3 in the powerhouse (Figure 2).
- Rebar and form work for the next intake and powerhouse pours are advancing.

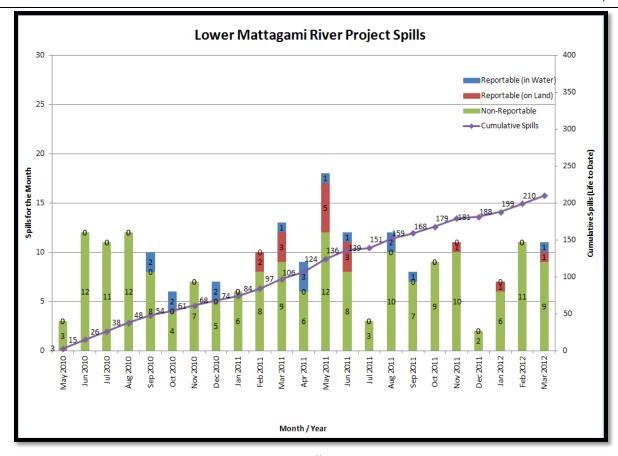
Figure 6: Lower Mattagami River Project spills

SPILL	.S	10111	any Summary Water 2							
	No. of Spills: 11; Spill Reports 200-210 (see Figure 6 for LMRP spills									
110. 0	n Spins.		breakdown).	· · · · · · · · · · · · · · · · · · ·						
Class	ification of	Snills	Project Classification							
Classification of Spills:			Minor – 9 Moderate – 0 Major – 1 To Water - 1							
Willion - 5 Woderate - 6 Wajor - 1 10 Water - 1										
	MOE Classification									
			Non-reportable - 9							
			Reportable to MOE

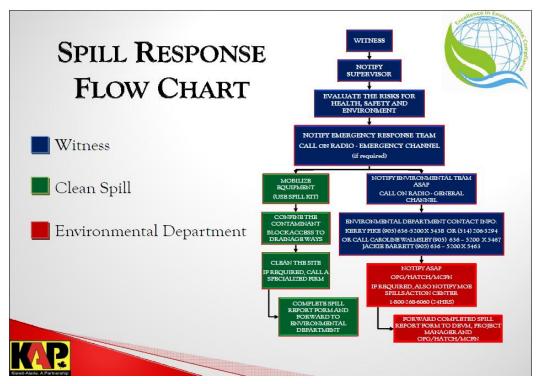
Figure 7: KAP Spills Response Flowchart

To Water: Any amount is reportable to the MOE (See Figure 7: KAP Spills Response Flowchart)				 Class B – Serious 						
(See	rigure 7: K	Ar Spills Kespons	Class A – Very Serious							
Sediment Pond Exceedance of Effluent Objective (>15mg/L)										
ſ	easures used									
	eedance									
days	recorded									
With the warmer temperatures there is an increas										
	3		the pond and the bubblers are working against the settling							
(Ma	rch 9-11)	Smoky Falls	effect. To correct this, the bubble	. •						
dur				during the night when temperatures drop and are shut off						
			during the day.

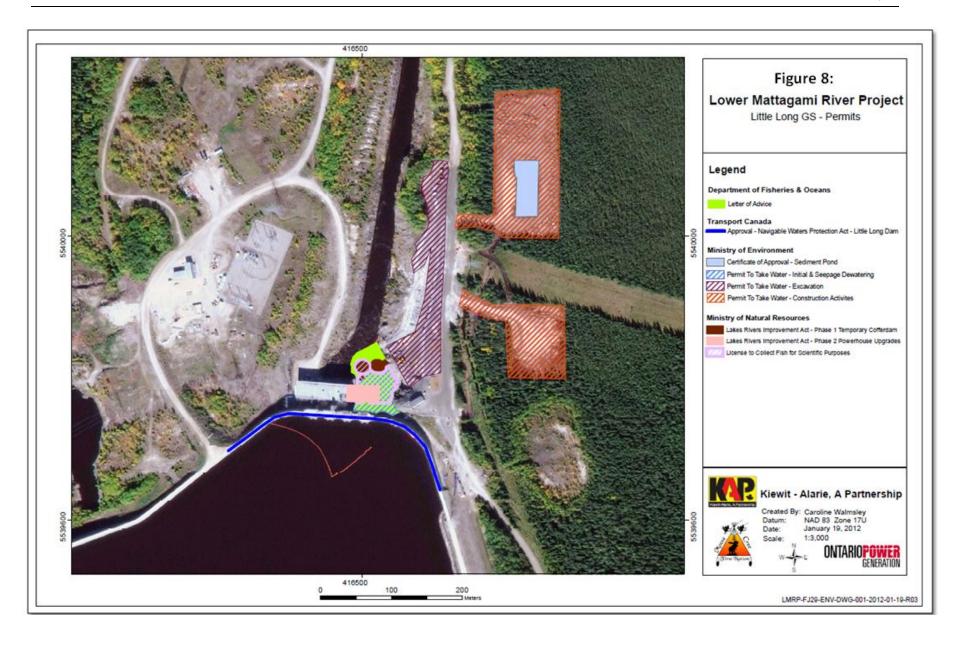
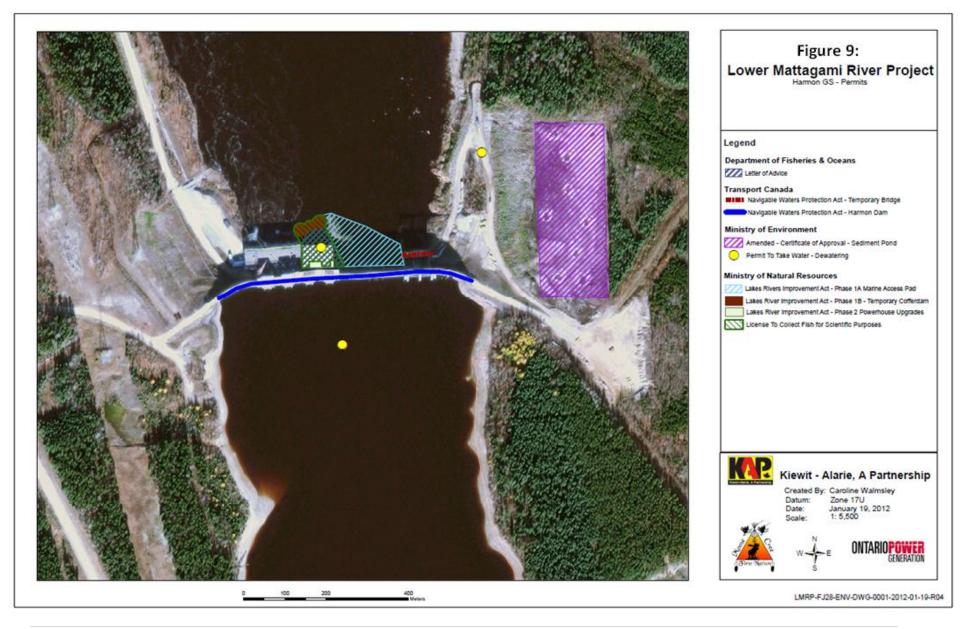
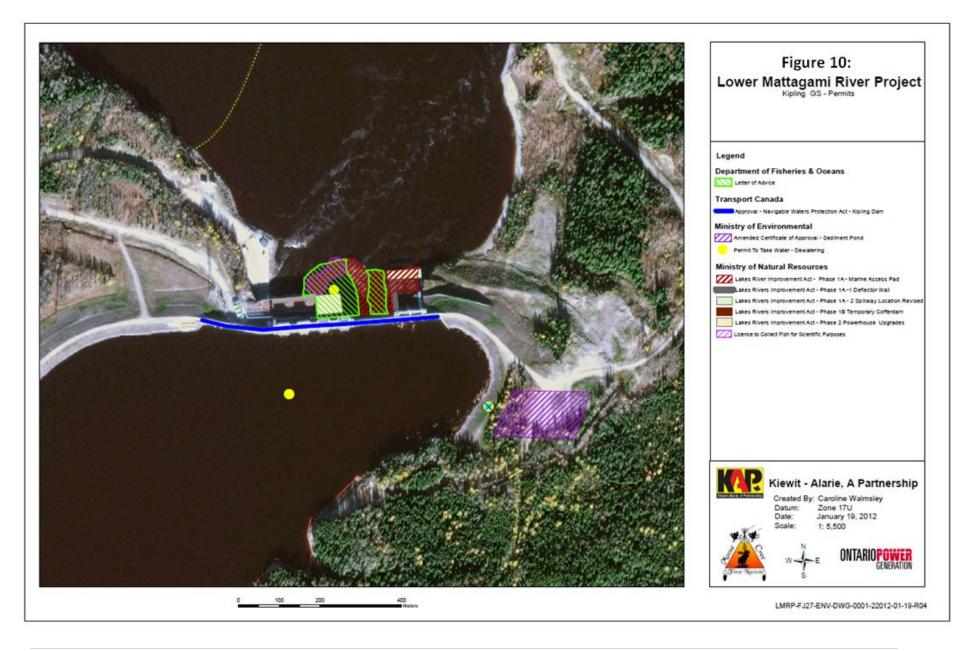
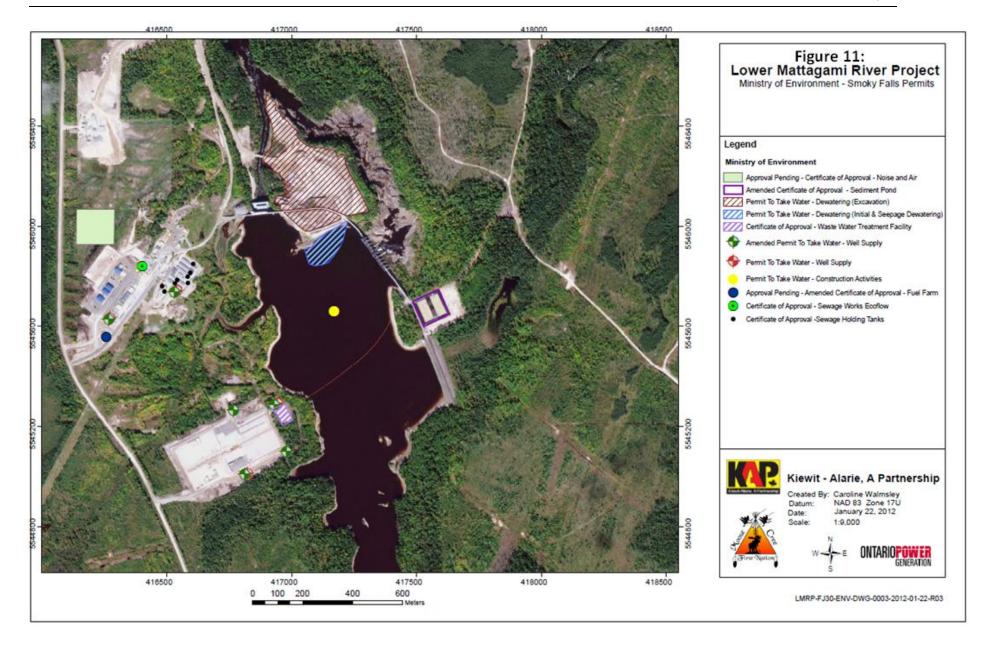
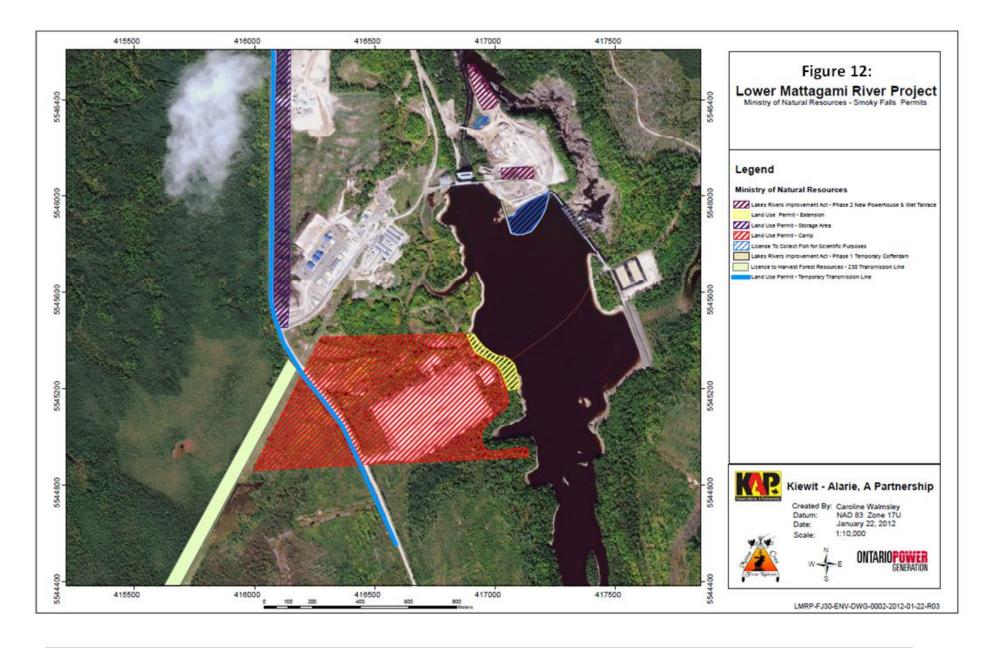
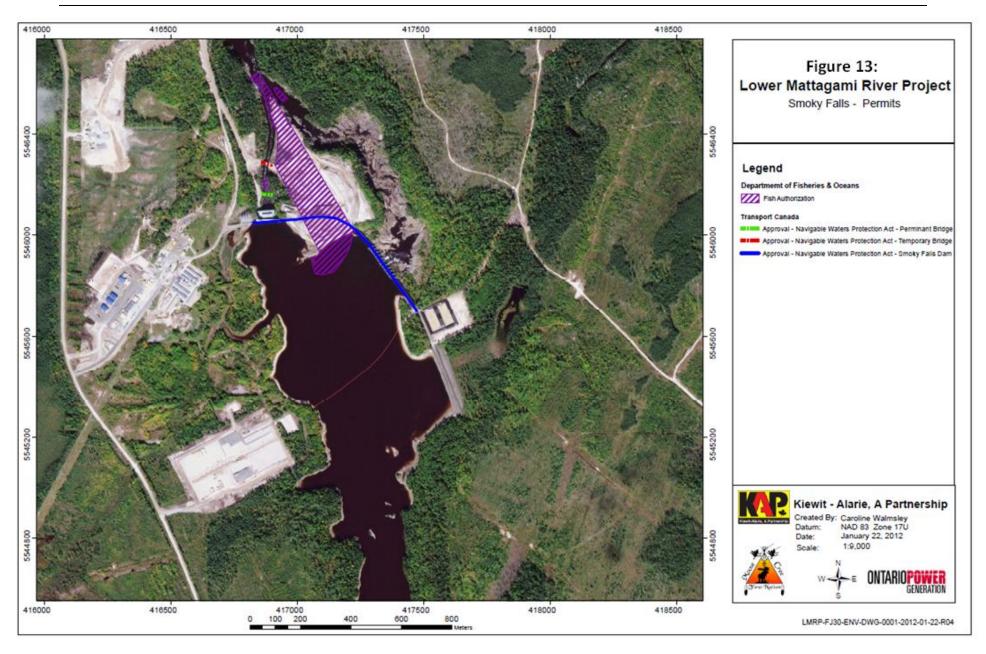
PERMIT AND APPI	ROVAL REVIEW	V						
No. Reviewed:	0	List:						
No. Sent to KAP:	0	List:						
Reports Review								
No. Reviewed for KAP	0	List:						
No. Sent to KAP	0	List:						
No. Reviewed for MECC	3	List:	 On-going: Cost Benefit Analysis of Mitigating and Reducing Spill in Adam Creek. Mercury in Fish Flesh Summary Report. Fish Habitat Assessment Report 					
No. Review Completed	1	List:	Operation Overview Report.					
REQUESTS FOR INFORMATION (RFIs)								
No. Reviewed:	0	List:	n/a					
No. Sent to KAP:	0	List:	n/a					
See figures 8 to 13	below for site	location of the	e permits that have been or are pending approval.
