Environmental Working Group

Monthly Report

May 2012

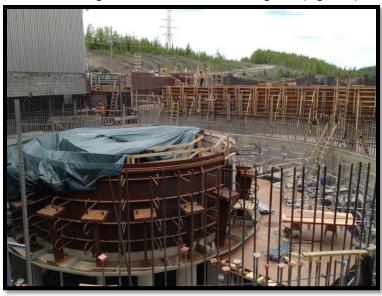
Figure 1: Little Long Pit liner, scroll case shoring and stay ring

- Concrete work is progressing well, with 1,135 m³ of concrete poured in the powerhouse and intake areas this month, bringing the total poured to date to 9,908 m³.
- Rebar and form work continues to progress at a good pace.
- One of the subcontractors (AFI Hydro) has been setting and aligning the draft tube stop log sill beams, side guides, and lintels.
- Work to begin repairs of the intake gate guides has started with scaffold erection completed in the intake gate well.
- Scroll case soffit shoring tower erection is advancing well (Figure 1).

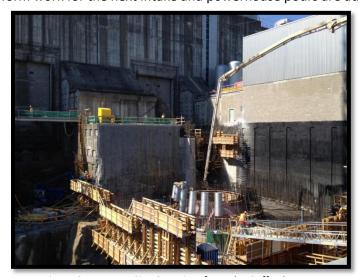
Figure 2: Harmon Site Overview from the Cofferdam

- 1,313 m³ of concrete was poured in the powerhouse and intake areas this month, bringing the total poured to date to 4,811 m³ (Figure 2).
- Rebar and form work for the next intake and powerhouse pours are advancing.

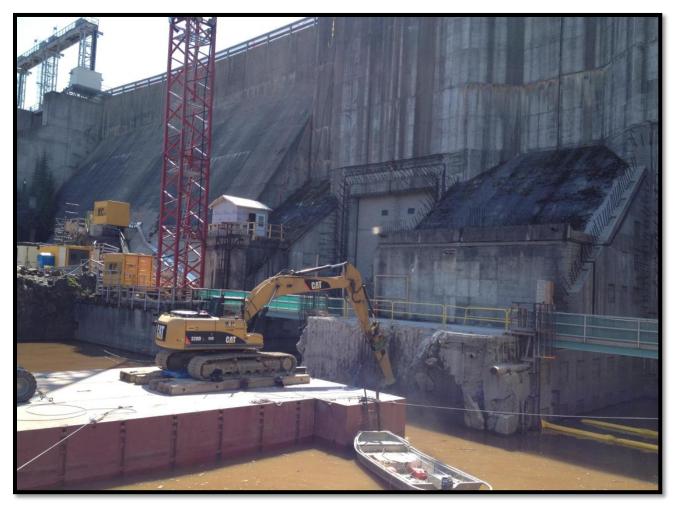
Figure 3: Work on Unit 3 pier at Kipling

- Drill and grout work on Cell #2 and the shore tie-in is nearing completion.
- Drill and grout work on the Arc Cells is nearing completion.
- Post-tension anchors were installed on Cell #2.
- The dewatering system has been successfully set up and tested.
- Drill and blast of the Kipling Unit 3 pier was completed.
- The Unit 3 intake block wall removal is nearing completion (Figure 3).

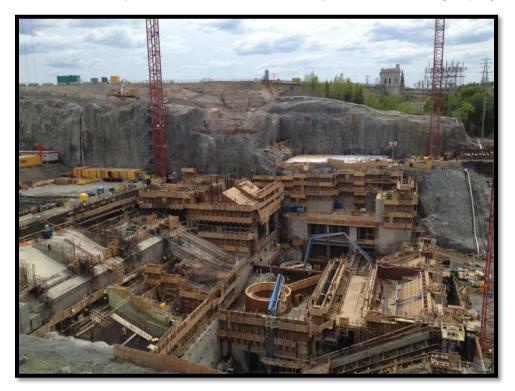
Figure 4: Smoky Falls Site Overview

- 6,091 m3 of concrete was poured this month in the service bay, powerhouse, and intake areas, bringing the total poured to date to 30,842 m3 compared with a total volume planned of 135,905 m3.
- Eighteen other concrete pours are in various stages of work (form work started and/or rebar being installed) and progressing.
- The reconstruction of the Smoky Falls Unit 2 / Unit 3 bullnose was completed, and all six extensometers required for the rebuild were installed and grouted.
- The winter shelter removal was completed on May 9th.

- Wet tailrace drilling has been completed. Blasting will resume at the end of the fish window, on July 15th.
- The mud slabs for the permanent bridge abutments were successfully poured.
- A mud slab was poured for the East Gravity Dam, and grout curtain hole drilling for the East Gravity Dam is in progress.
- Work in the switchyard (concrete form work, rebar, pours, and backfilling) is progressing.

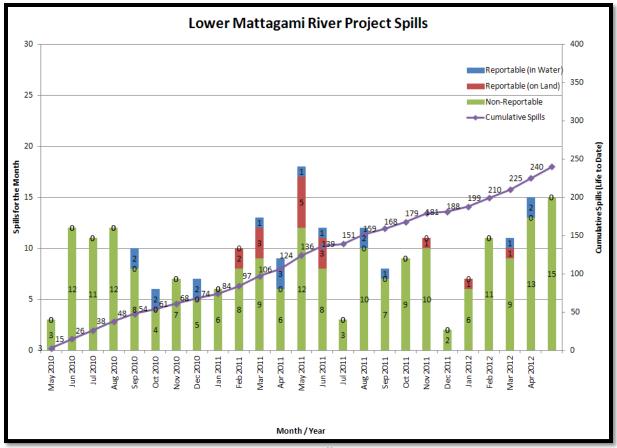
Figure 6: Lower Mattagami River Project spills

cours												
SPILLS												
No. of Spills:		15; Spill Reports 226-240 (see Figure 6 for LMRP spills breakdown).										
Classification of	Spills:	Project Classification										
		Minor – 15 Moderate – 0 M	Minor – 15 Moderate – 0 Major –0 To Water - 0									
		MOE Classification										
		Non-reportable - 15										
	Reportable to MOE

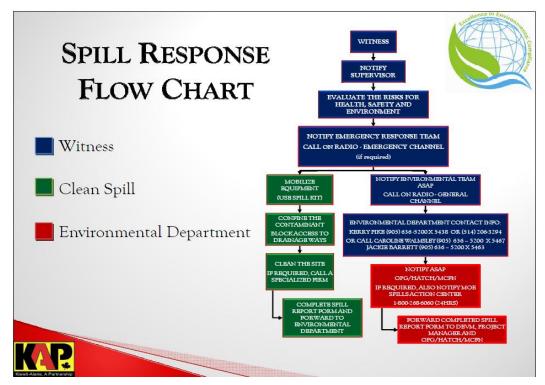
Figure 7: KAP Spills Response Flowchart

•	•	able to the MOE	 Class B – Serious 									
(See Figure 7: K	AP Spills Respon	se Flowchart)	 Class A – Very Serious 									
Sediment Pond	Exceedance of E	ffluent Objective										
No. of	Location	ocation Mitigation Measures used										
Exceedance												
days recorded												
The increase in the NTU levels is due to heavy rain that occurr the previous night. KAP added Alum to the pond as a correction measure. 5 Smoky Falls The haffle curtains were installed on May 15th and are												
					(May 4, 8-11)		The baffle curtains were installed on May 15th and are					
					working well. KAP received a thunder shower and amount of rain on the 15th and discharge turbidity							
										did not increase.		
The increase in the turbidly was a result heavy rain as												
	the night of May 20 which											
1 (May 21) Little Long stirred the creek up, increasing the turbidity. As the i turbidity was due to the weather conditions and not
