Environmental Working Group

Monthly Report

April 2014

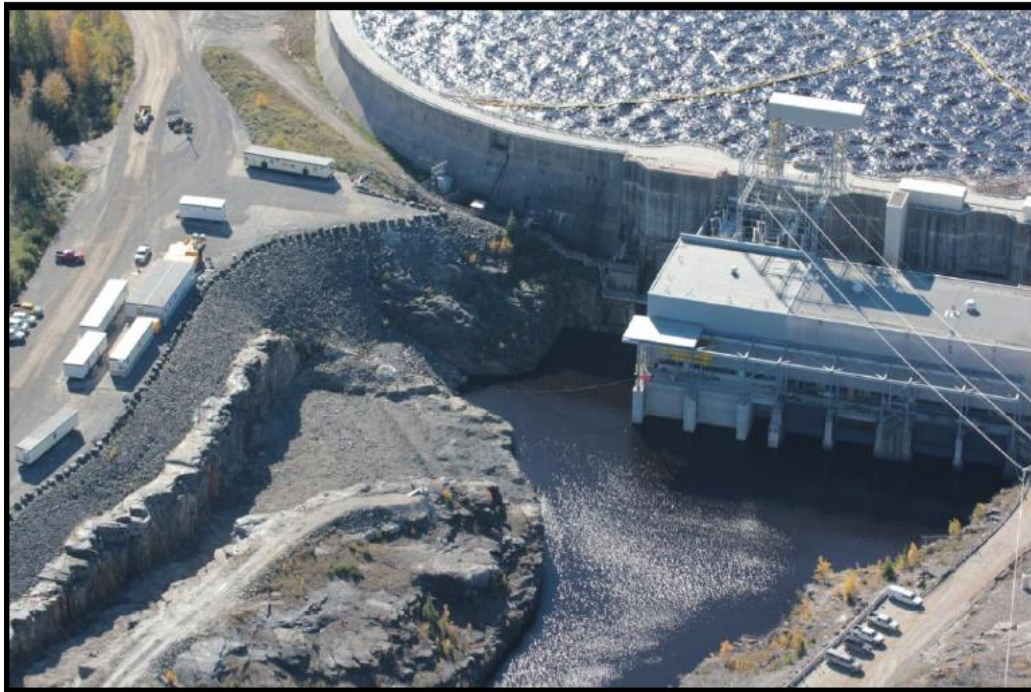
Figure 1: Little Long Unit 3

- KAP and OPG closed out 16 punch list items this month.
- KAP resubmitted its notice of substantial completion for review and acceptance by OPG.
- Little Long Unit was 3 (Figure 1) was declared in service on January 19, 2014.

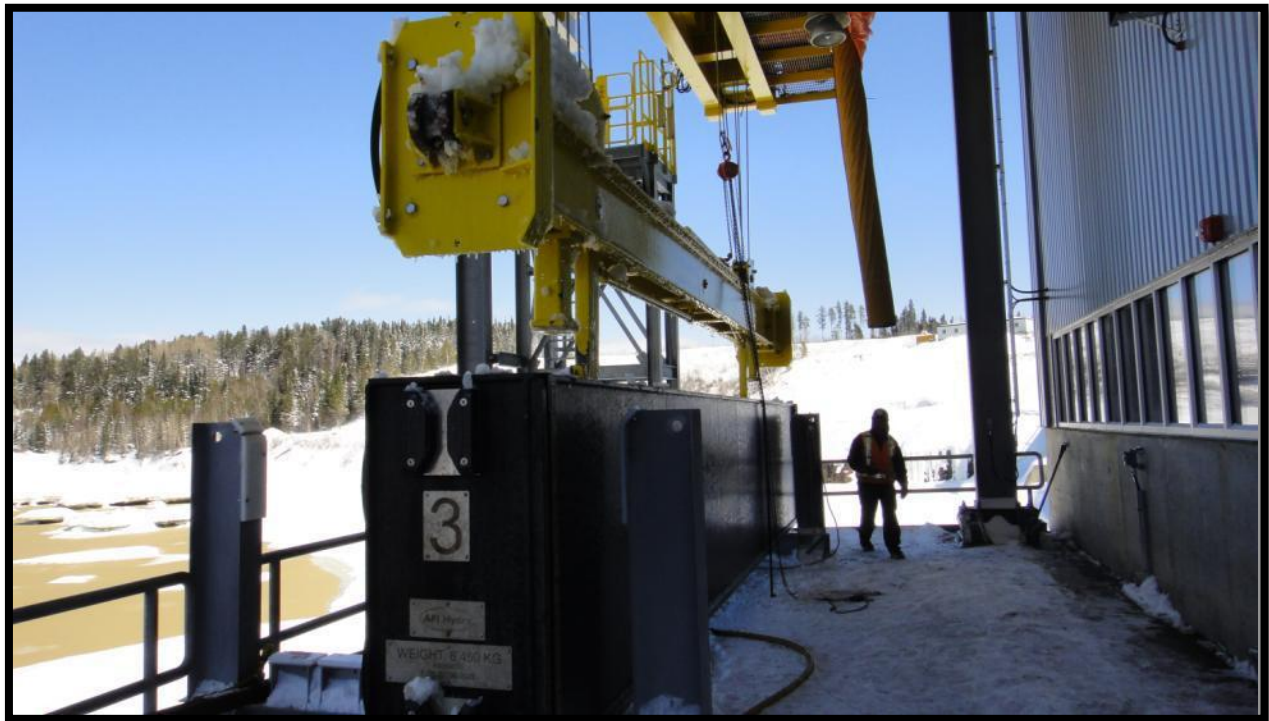
Figure 2: Harmon stop log removal

- The focus of the work this month was operational testing and commissioning (Figure 2).
- During periods when the Unit was not being tested, injection of hydrophobic polyurethane resin into concrete floor cracks occurred.
- On April 5th, KAP primed the Unit as part of testing and discovered issues with the priming procedure. An investigation was completed and the procedure was revised.
- The Unit was successfully synchronized to the grid on April 17th and online testing proceeded for the balance of the month.
- At month-end KAP was doing demonstration testing for OPG and preparing for the 10-day trial run of the Unit, leading up to in-service.
- Details on backfeed activities can be found in Section 6.2.6.
- It is forecasted that Harmon Unit 3 will be declared in service in May 2014.

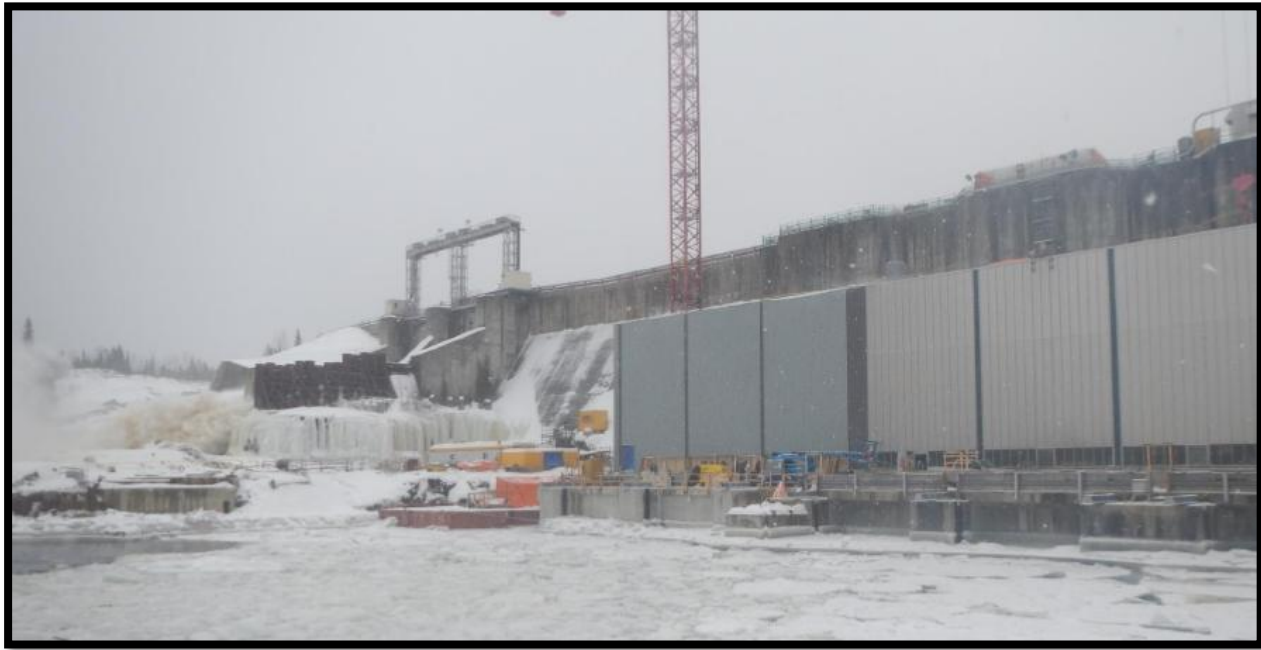
Figure 3: Kipling Overview

Kipling (Figure 3)

- KAP performed concrete repairs in the scroll case soffit using epoxy grout injection and corrected minor deficiencies using point and patch on the scroll case walls and in the intake.

- Rotor rim piling was completed and fan blades were installed on the top and bottom of the rotor rim.
- Stator winding continued on plan this month and is forecast to continue into next month.

- Installation of BOP electrical components such as instrument panels and pulling and terminating cables was performed, along with welding of the IPB.
- KAP employees erected the formwork and then grouted the intake gate guide roller paths.

- KAP ironworkers started assembling the draft tube stop log hoist structure at the tailrace deck.
- Runner blade / discharge ring clearance remediation was completed and Andritz installed the runner in the turbine pit at month-end.

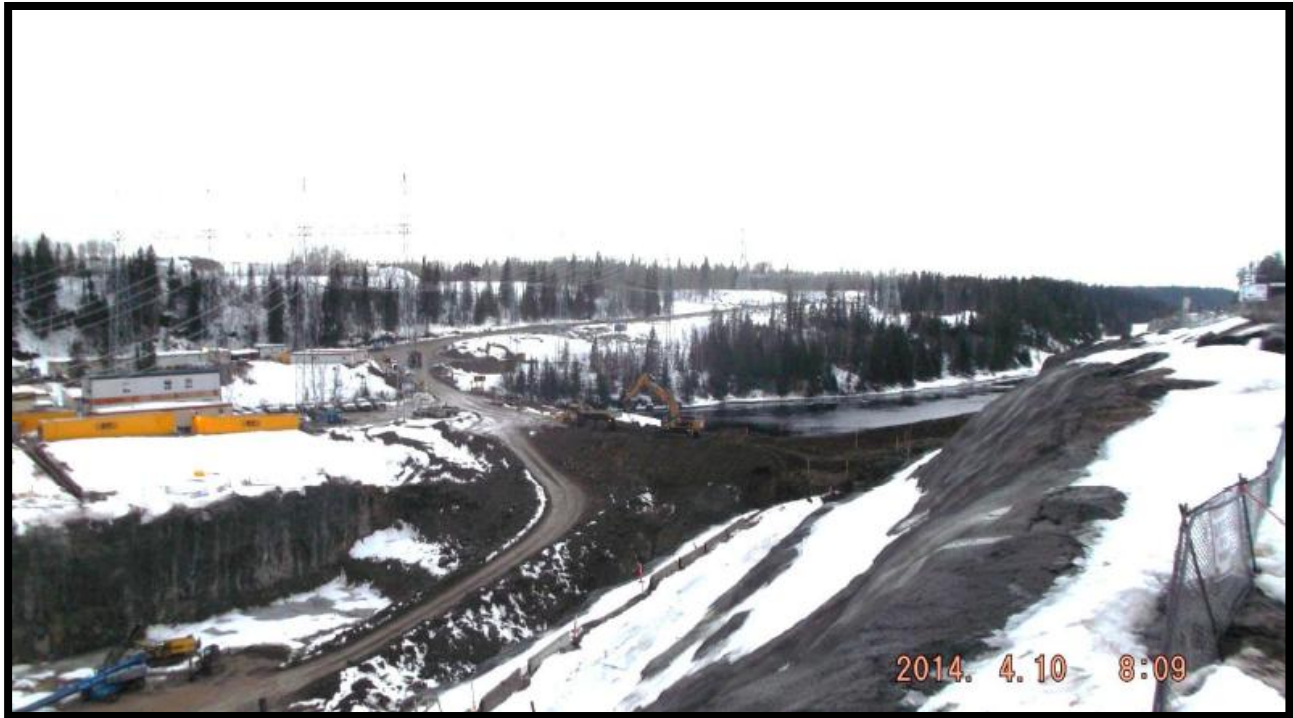
Figure 4: Smoky Falls – Rock-plug excavations

- Excavating powerhouse and tailrace pads as well as excavating top portion of rockplug (Figure 4 and 5).
- At month-end, KAP had nearly completed the preparations for watering up the forebay, as well as installation of instrumentation, cables and control panels for dam monitoring (once the forebay has been watered up). Water-up will occur in May.

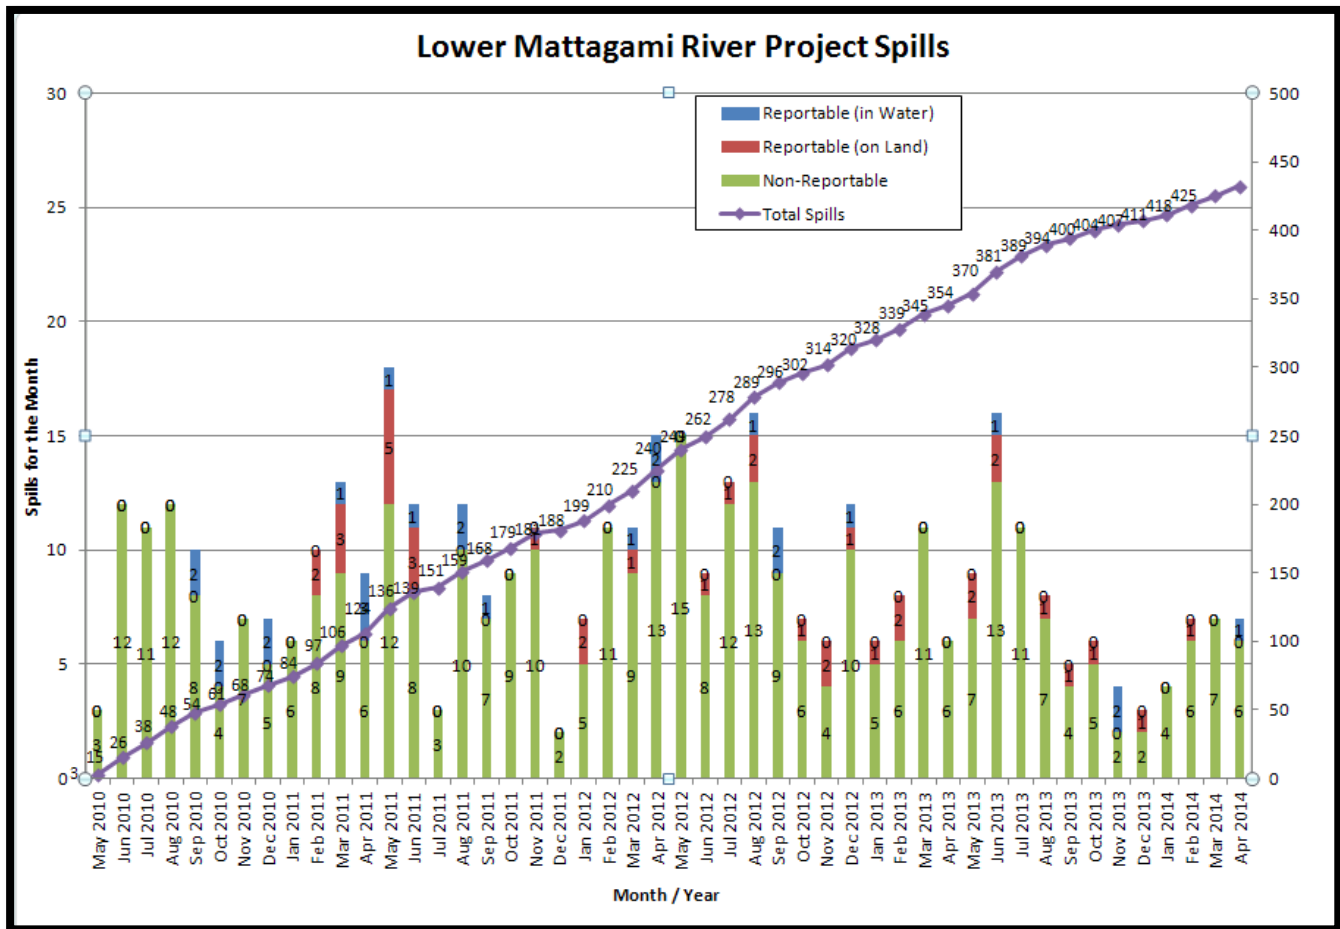
Figure 6: Lower Mattagami River Project spills

| SPILLS | | | |
|--|---|--|---|
| No. of Spills: | | 7; Spill Reports 426-432 (see Figure 6 for LMRP spills breakdown). | |
