## **Environmental Working Group**

### **Monthly Report**

**August 2013**

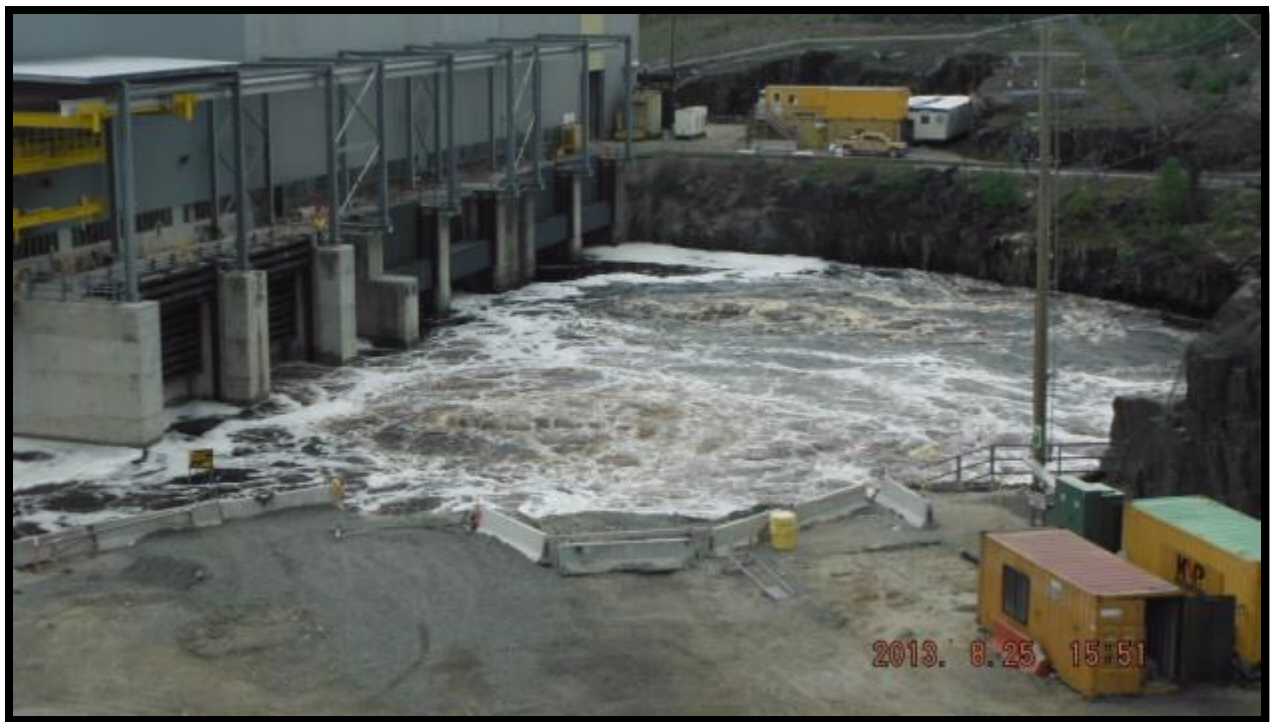
Figure 1: Little Long first Run of Unit 3 at nominal speed.jpg

- First rotation of Unit 3 was completed on August 24. Some noise was detected and minor adjustments were made. Rotation tests at nominal speed were done and the rotor was balanced (Figure 1).

- A mechanical heat run and two over speed tests were conducted on Unit 3. Following these the Unit was shut down for inspection.
- The transformer was energized from the Hydro One transmission line on August 29.

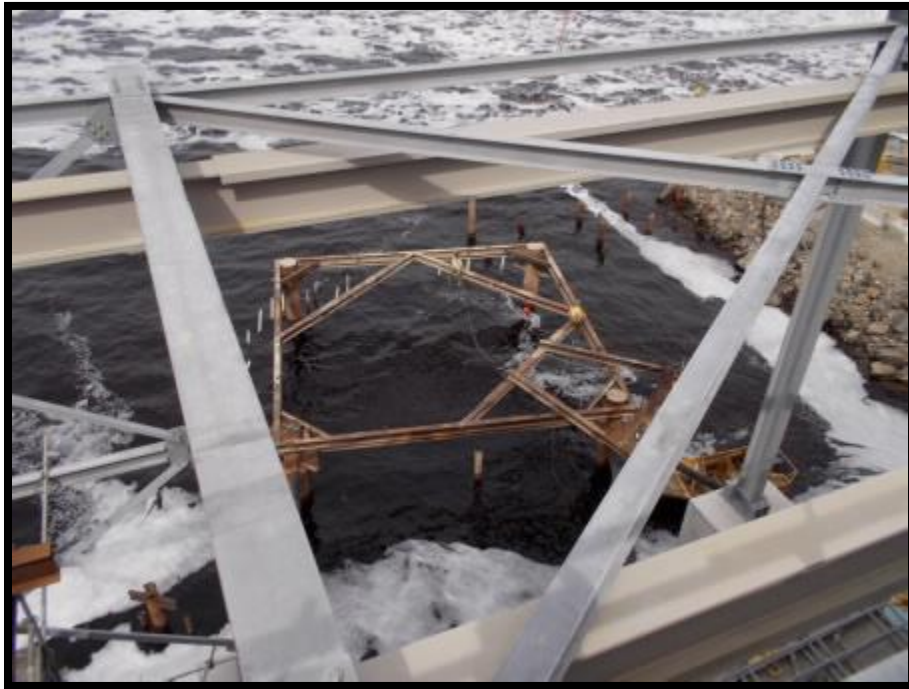
Figure 2: Harmon Cofferdam Template Removal

- Cofferdam removal is nearing completion. All sheet piles were removed from Cell 1, the Cell 1 template was disassembled and removed (Figure 2), blasting of tremie concrete in Cell 1 was completed and clamming of debris in the Cell 1 footprint is under way.
- Andritz is assembling the lower bracket and the thrust bearing.
- The generator shaft was connected to the turbine shaft.
- Rotor assembly (welding and leveling) continues in the Service Bay.
- Andritz completed erecting the generator enclosure wall steel frames and has started installing the enclosure panels.
- KAP continues to advance the Isolated Phase Bus (IPB) installation with welding and grinding IPB sections near the Generator Circuit Breaker (GCB) on the Mezzanine.
- Cable tray installation and cable pulling continues throughout the powerhouse.

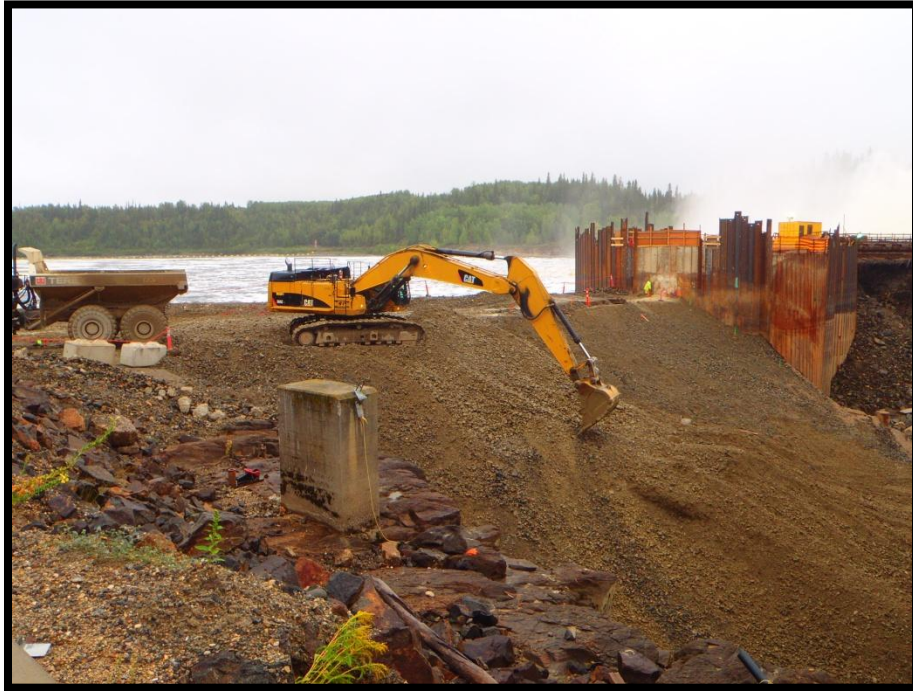
Figure 3: Kipling – Removing road from Kipling cofferdam

- 660 m<sup>3</sup> of concrete was poured this month, bringing the total poured to date to 9,298 m<sup>3</sup> of 11,885 m<sup>3</sup> total.
- KAP's earthworks team completed removing fill material from the cofferdam earth berm between the soldier pile wall and the timber lagging wall. The soldier pile wall and timber lagging wall have been removed. KAP has started to remove the crest of the earth berm in preparation for water-up, currently forecast for late September (Figure 3).

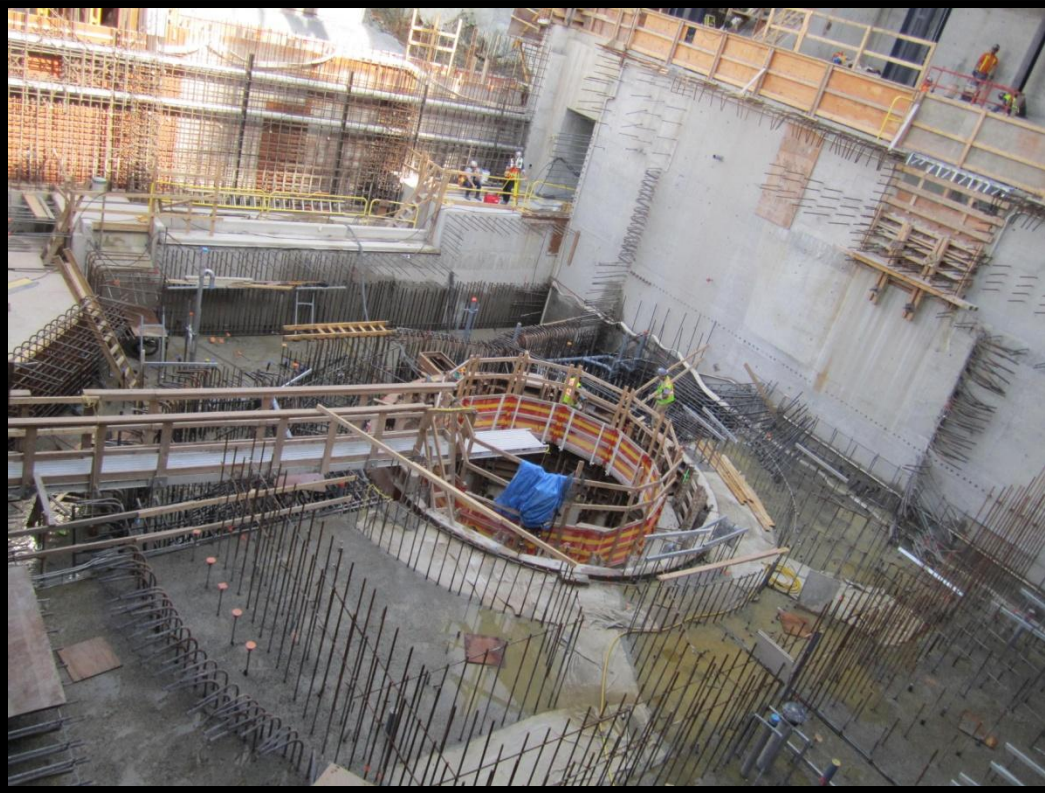
Figure 4: Smoky Falls: Progress view of Unit 3

- At Unit 2, given that Alstom was off-site for most of the month, no significant activity occurred on the assembly of the Unit 2 rotor;
  - At Unit 3, KAP completed installing rebar and formwork for the scrollcase soffit concrete pour, and poured the soffit concrete (Figure 4).

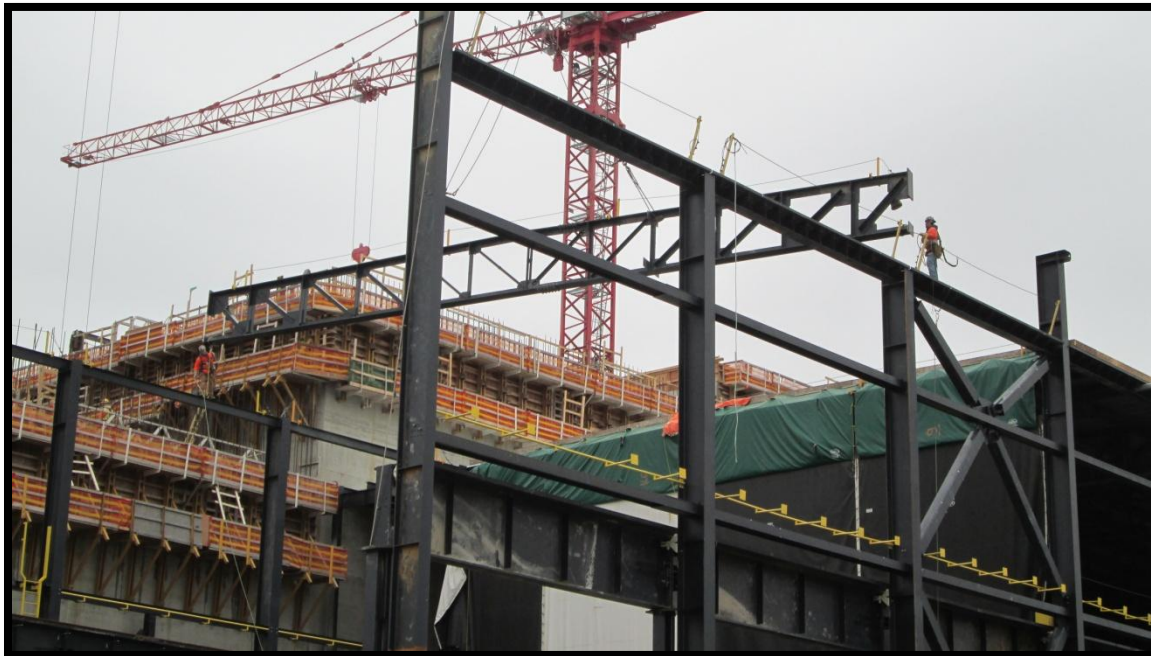
Figure 5: Smoky Falls: Unit 3 superstructure erection

- Superm  tal has installed structural steel frame over the East Service Bay and has torqued the bolts. Unit 3 superstructure erection is also under way (Figure 5).
- At Zone 5, the installation of additional rock anchors to improve the stability of the rock face continues.

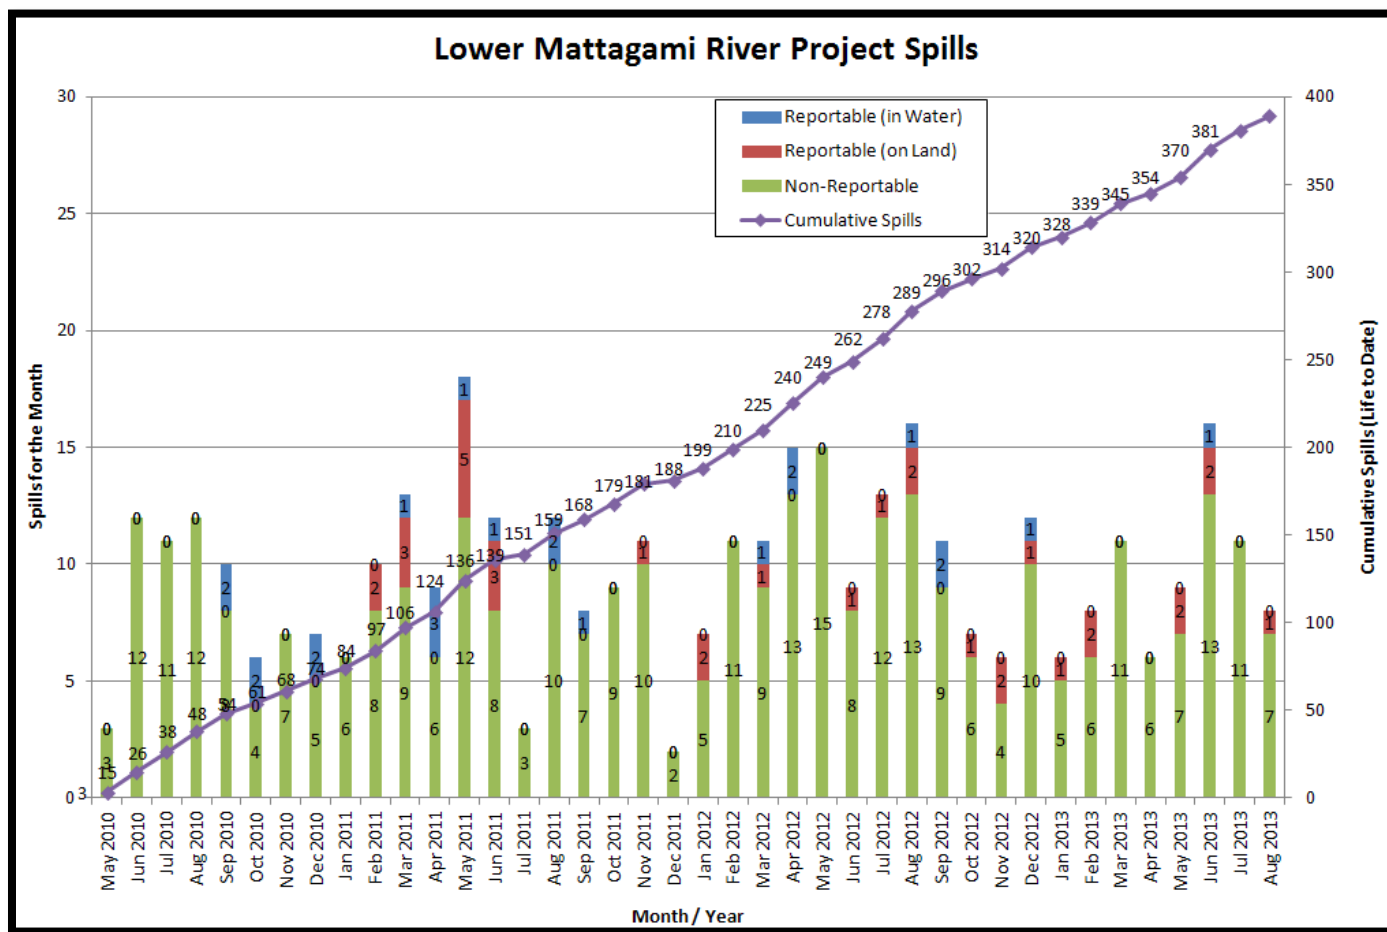
Figure 6: Lower Mattagami River Project spills

SPILLS			
No. of Spills:		8; Spill Reports 382-389 (see Figure 6 for LMRP spills breakdown).	
Classification of Spills:		<u>KAP Project Classification</u> Minor – 6   Moderate – 1   Major –1   To Water - 0 <u>MOE Classification</u> Non-reportable - 7 Reportable to MOE <div>- Class C – 1 - Class B – 0 - Class A – 0</div>	
Reportable Spills			
No.	Quantity /Product Spilled	Spill Site	Reason for being Reportable
1	5 m <sup>3</sup> / Raw Sewage	Waste Water Treatment Plant	Reportable spill on-land. A leak was noticed coming from the inlet pipe of the sewage tank. The leak was caused by a broken pipe, which caused raw sewage to leak out inside the bermed area surrounding the waste water treatment plant. The inlet pipe was repaired.
KAP Project Classification Minor: ≤ 10L Moderate: Between 10L and 100L Major: ≥100L To Water: Any amount is reportable to the MOE (See Figure 7: KAP Spills Response Flowchart)			MOE Classification (see Reportable and Non-reportable Spills definition below) Non-reportable: < 100L Reportable to MOE <div><div>• Class C - Less Serious</div><div>• Class B – Serious</div><div>• Class A – Very Serious</div></div>
