Environmental Working Group

Monthly Report

February 2013

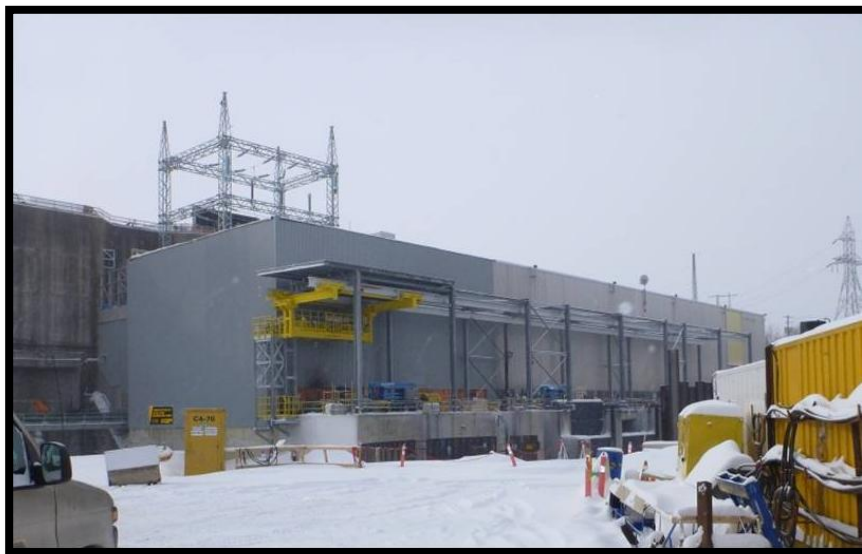
Figure 1: Little Long Power House

- CanAm continues to install architectural cladding (the transformer splash wall and the south parapet wall). They have also installed vent lines through the downstream powerhouse wall (Figure 1).

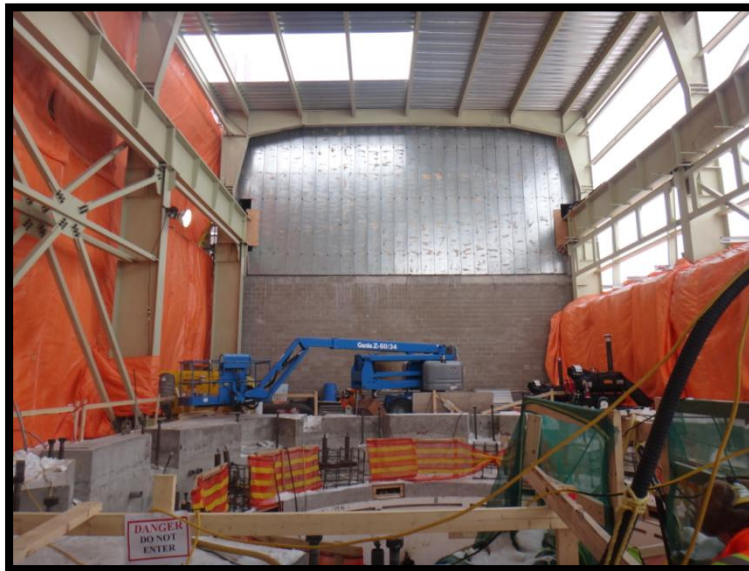
Figure 2: G3 Pit and New Powerhouse wall

- Superm  tal is bolting and torquing superstructure steel members over Unit 3. They are also finalizing Q-decking placement and welding studs onto the Q-decking. CanAm has started installing the interior cladding (Figure 2).

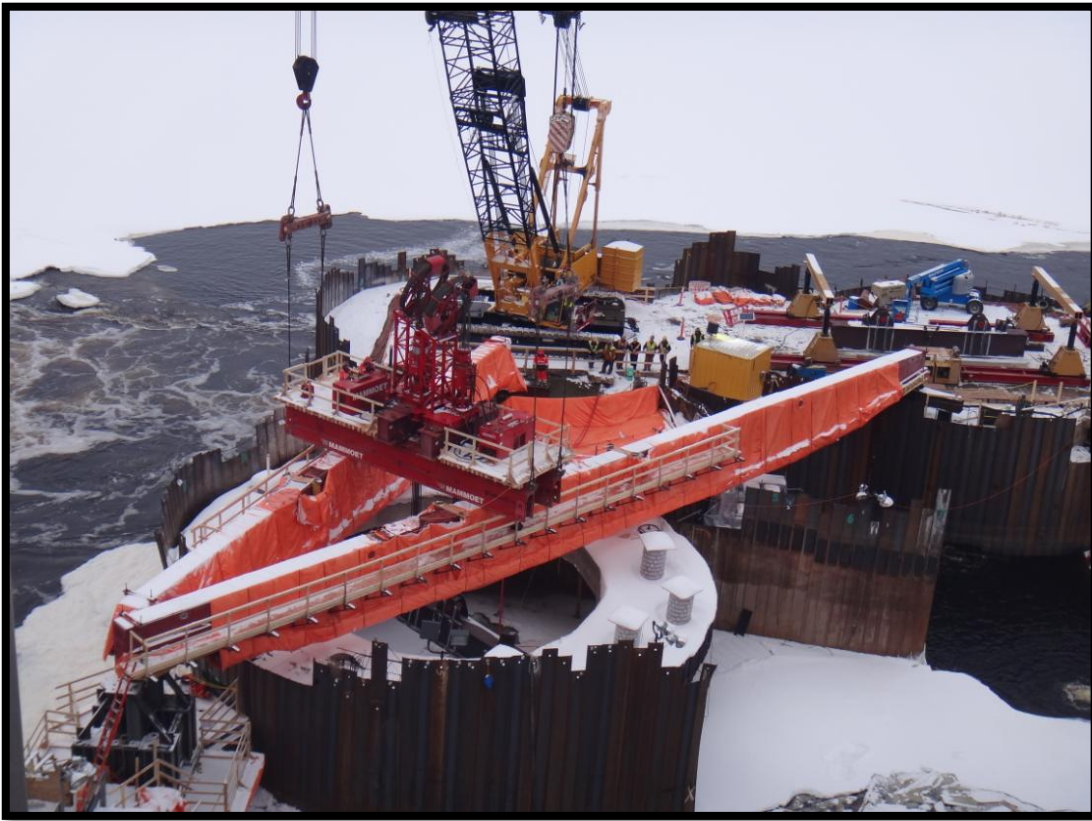
Figure 3: Troll Beams to stabilize the Cell 3 concrete ring

- The bearing structure to support the troll beams on the Unit 2 tailrace deck was installed, bolted and grouted.
- The final troll beam components were delivered to site and assembled. KAP lifted them into place and tied to their supports (Figure 3).
- In the Mezzanine area, formwork and rebar installation are proceeding for a couple of pours.
- 50 m³ of concrete was poured for the last two wall sections of the Unit 3 intake.
- PowerTel has started grounding pedestals and 230 kV equipment in the switchyard.
- AFI has started remedial work on the intake gate guides for Unit 3.

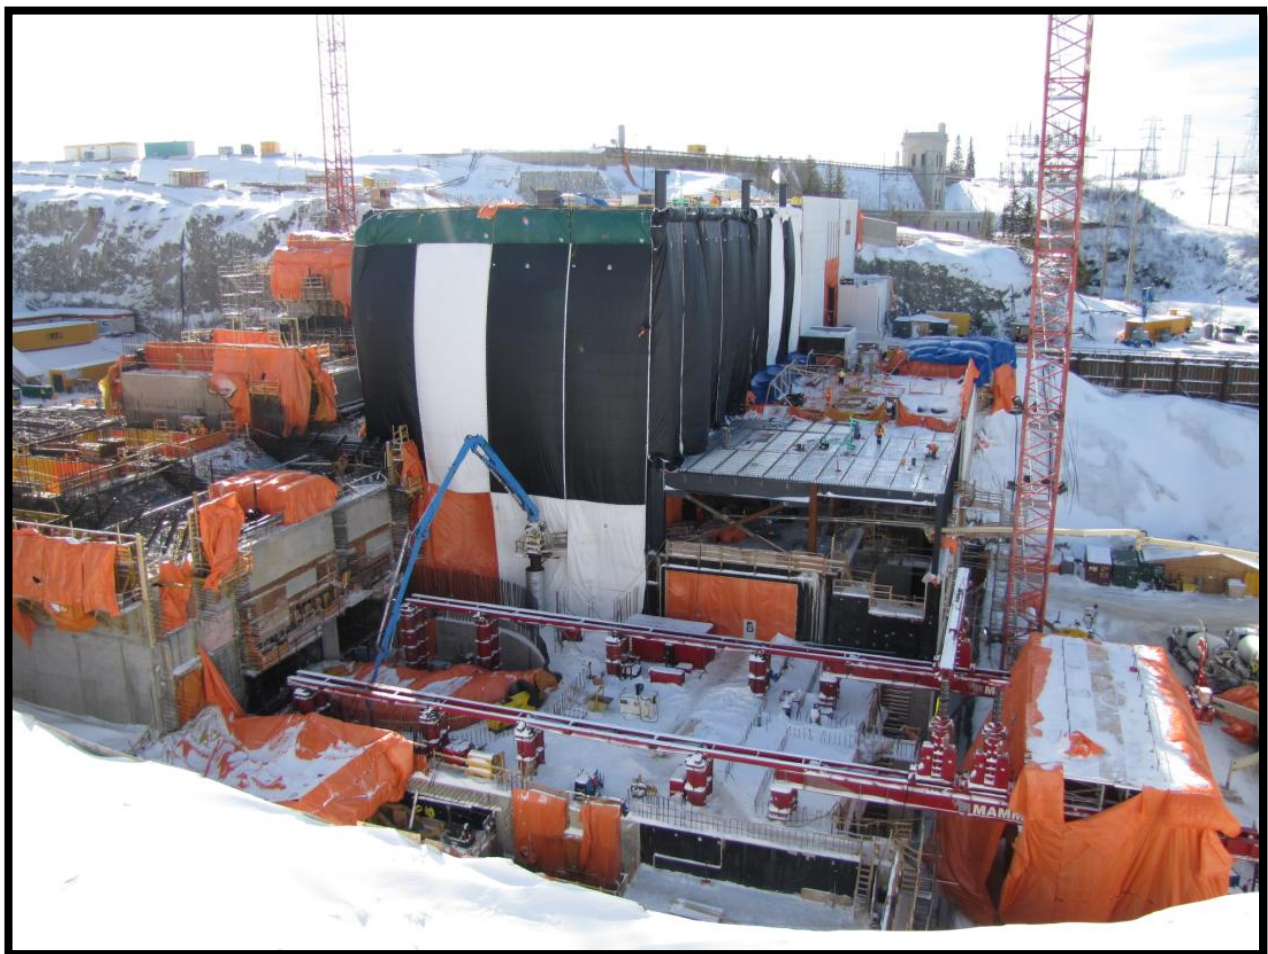
Figure 4: Smoky Falls Overview including Superstructure

- At the end of the month, thirteen (13) concrete pours are in various stages of work (formwork started and/or rebar being installed) and progressing in the intake, powerhouse, East service bay, East gravity dam, and at the permanent bridge. Eleven (11) pours were completed during the month (Figure 4).

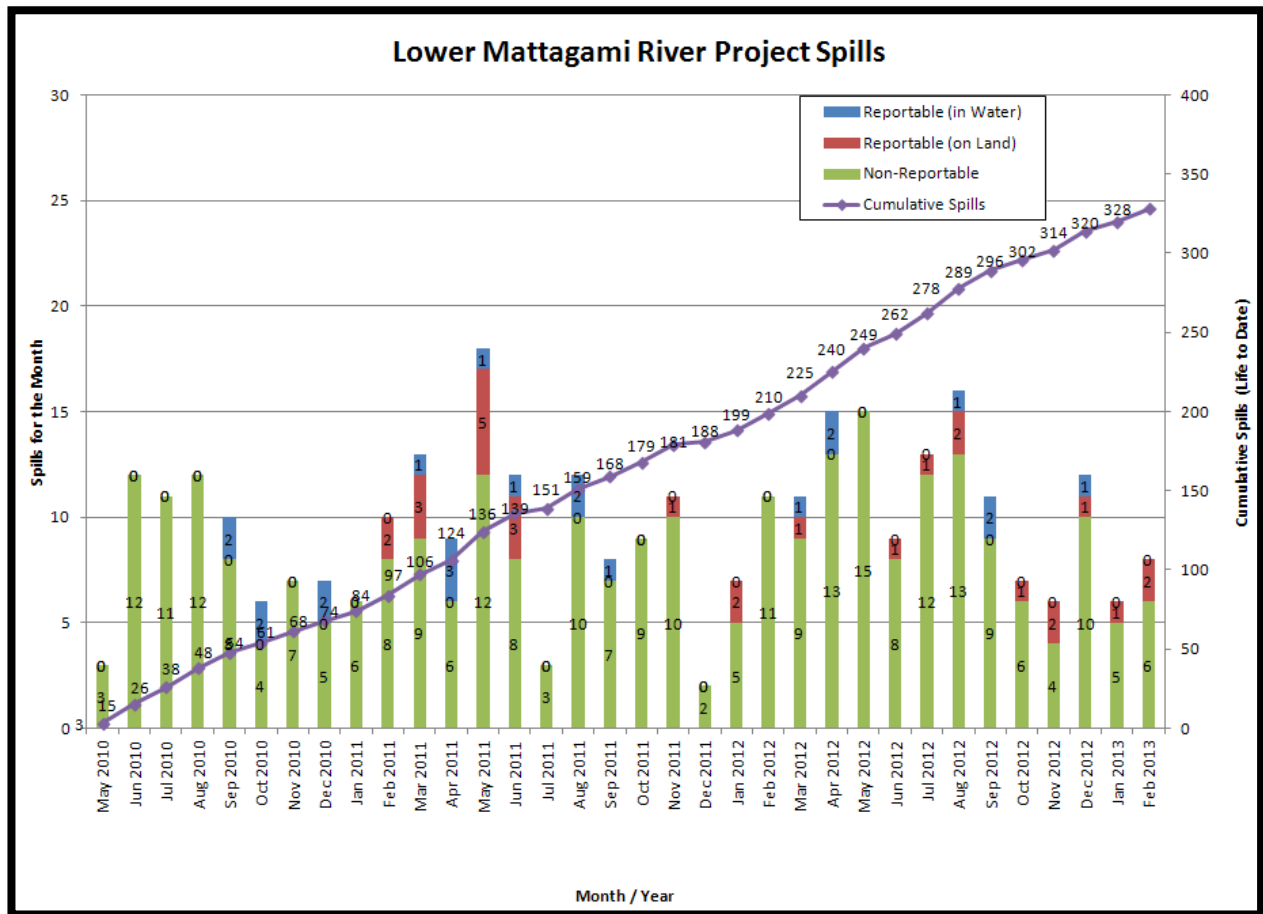
Figure 6: Lower Mattagami River Project spills

SPILLS			
No. of Spills:		6; Spill Reports 321-328(see Figure 6 for LMRP spills breakdown).	
Classification of Spills:		<u>Project Classification</u> Minor – 5 Moderate – 3 Major – 0 To Water - 0 <u>MOE Classification</u> Non-reportable - 2 Reportable to MOE <div>- Class C – 6 - Class B – 0 - Class A – 0</div>	
Reportable Spills			
No.	Quantity /Product Spilled	Spill Site	Reason for being Reportable
1	15L / Glycol	Kipling – Cell #2	Reportable (on-land due to quantity). The ground heater was thawing the soil of cell # 2 of the cofferdam when a hose containing glycol broke. The workers were reminded to conduct thorough visual inspections.
2	56L/Hydraulic Oil	Kipling – Cofferdam Cell #2	Reportable (on-land due to quantity). The ground heater was being used to thaw the ground on cell # 2, when a labor walking by observed a hose leaking. The environmental department attended Kipling daily morning / evening PTI meetings to give a refresher on spill reporting and spill procedure.
