Environmental Working Group

Monthly Report

January 2013

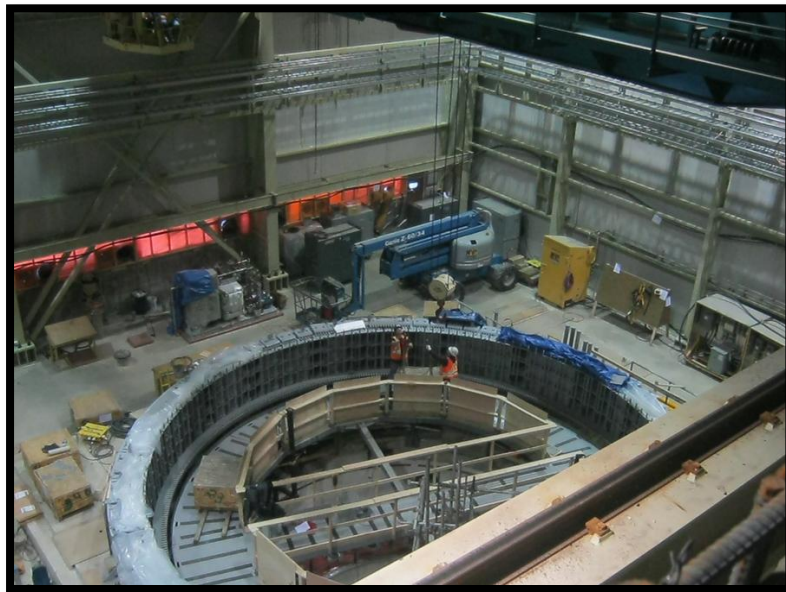
Figure 1: Little Long overview of G3 Powerhouse

- Andritz workers continued to assemble the G3 runner in the Service Bay (Figure 1).
- The stator core loop test was successfully completed in the evening of January 29, with Andritz, KAP, OPG, and Hatch representatives present.

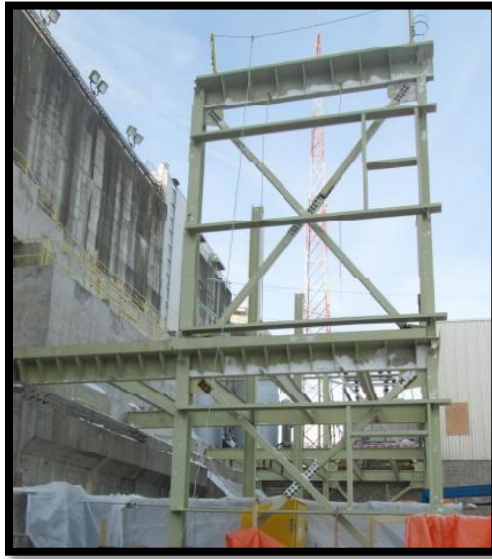
Figure 2: Harmon Superstructure Progress

- 42m³ of concrete was poured this month, bringing the total poured to date to 10,794 m³ of 12,251 m³ total, against a plan of 9,321 m³.
- KAP has started removing the shoring towers and formwork from the scroll case soffit pour.
- Supermétal has started erecting the superstructure over Unit 3 (Figure 2).
- KAP has opened the spillway as they did last winter to eliminate ice build-up during cold weather. However, during a two week cold snap, the spillway was locked to prevent further ice build-up which would have occurred had the spillway been opened.

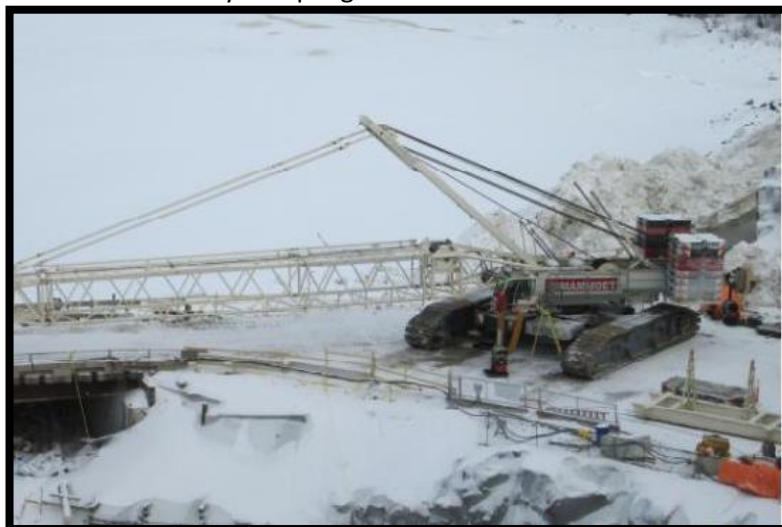
Figure 3: Mammoeth Crane Assembly

- KAP is controlling ice buildup in the lagoon using a bubbler system.
- KAP has mobilized a Mammoeth 600 Ton crane to site (and is assembling it) as it will be required to stabilize the Cell 3 concrete cap (Figure 3).

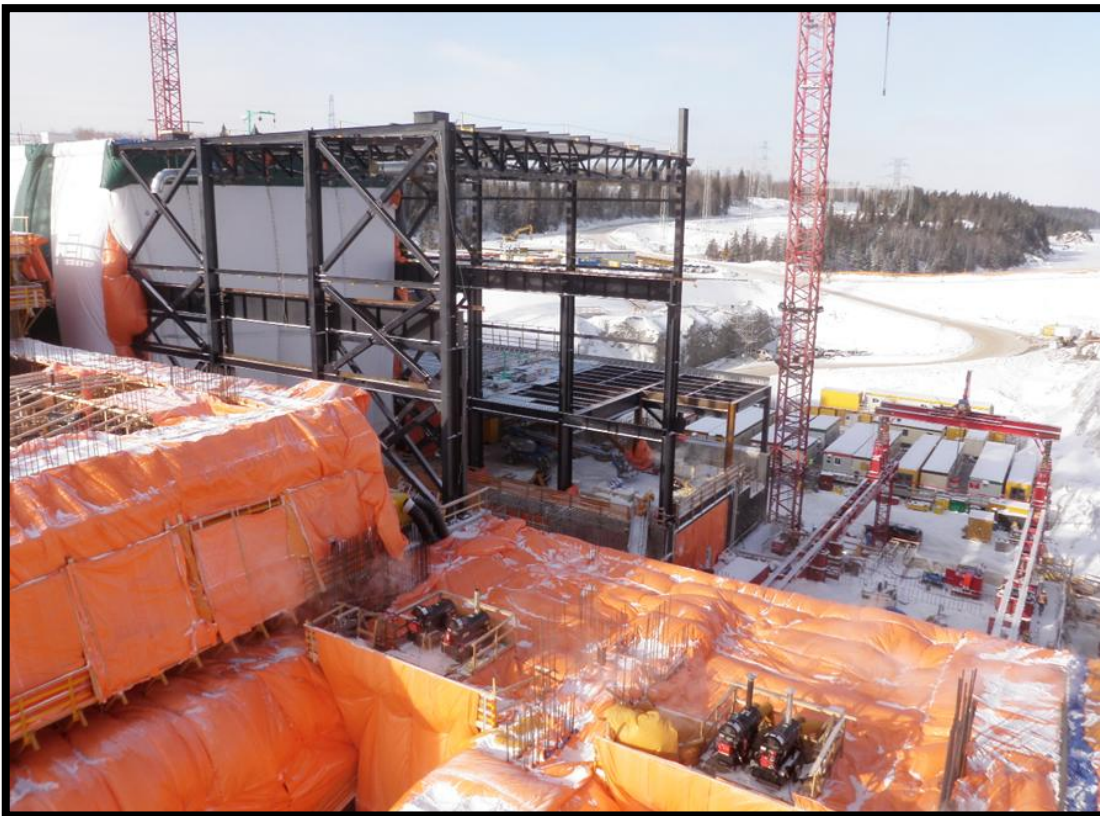
Figure 4: Smoky Falls Overview including Superstructure

- Alstom are installing anchors on the Unit 3 draft tube cone.
- Superm tal workers completed the erection of structural steel over Unit 2. Bolting and torquing of the superstructure over Unit 2 was completed and tarpaulins have been installed over Unit 2 to provide a winter enclosure (Figure 4).

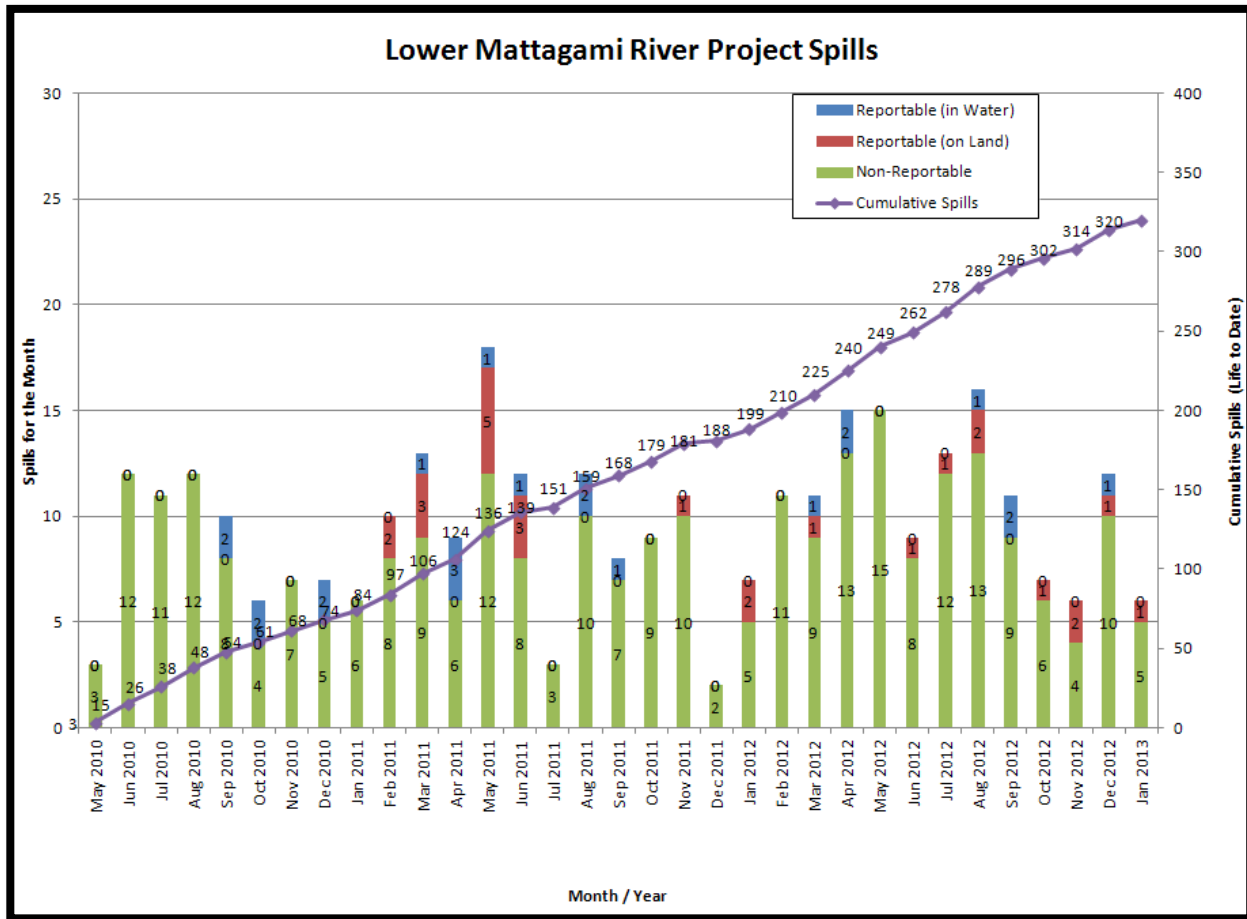
Figure 6: Lower Mattagami River Project spills

SPILLS			
No. of Spills:		6; Spill Reports 315-321(see Figure 6 for LMRP spills breakdown).	
Classification of Spills:		<u>Project Classification</u> Minor – 5 Moderate – 1 Major –0 To Water - 0 <u>MOE Classification</u> Non-reportable - 1 Reportable to MOE <div>- Class C – 5 - Class B – 0 - Class A – 0</div>	
Reportable Spills			
No.	Quantity /Product Spilled	Spill Site	Reason for being Reportable
1	10 L / Antifreeze	Smoky Falls – Maintenance Shop	A compressor was parked (not running) across from the Electrical Department Office. A worker passing by observed coolant under the machine. Reportable because it was from a non-motor vehicle.
Project Classification (KAP) Minor: ≤ 10L Moderate: Between 10L and 100L Major: ≥100L To Water: Any amount is reportable to the MOE (See Figure 7: KAP Spills Response Flowchart)			MOE Classification Non-reportable: < 100L Reportable to MOE <div>• Class C - Less Serious • Class B – Serious • Class A – Very Serious</div>
