Environmental Working Group

Monthly Report

June 2014

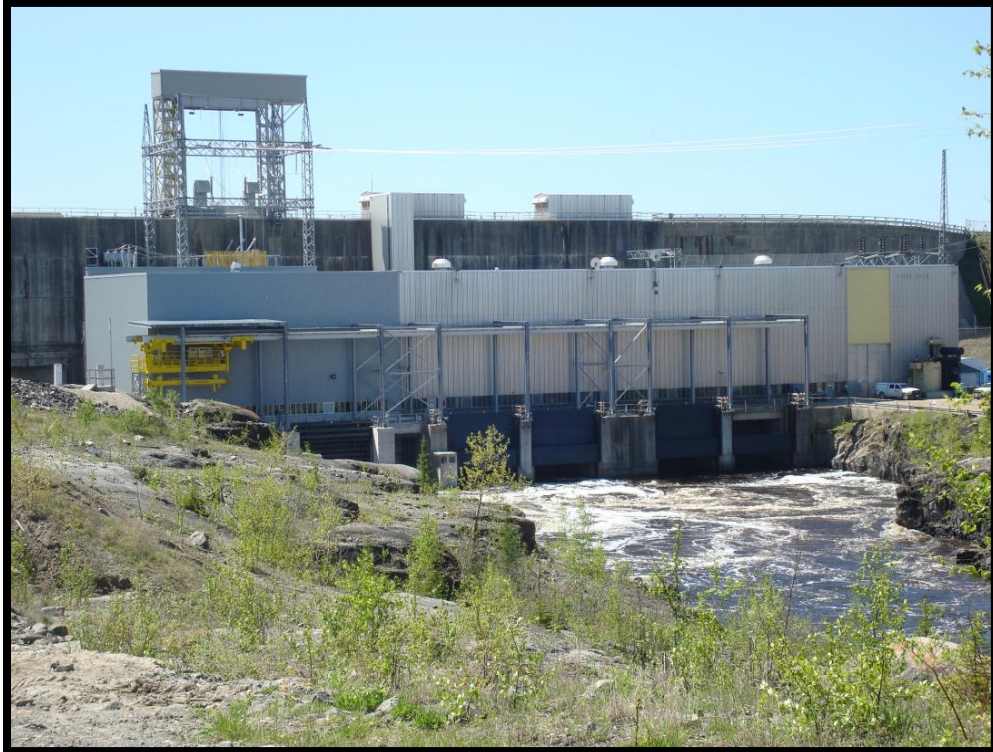
Figure 1: Little Long Unit 3

- KAP continues to work on closing out punch list items. A Unit outage is planned for early July to address punch list items that require the generator to be offline.
- Little Long Unit was 3 (Figure 1) was declared in service on January 19, 2014.

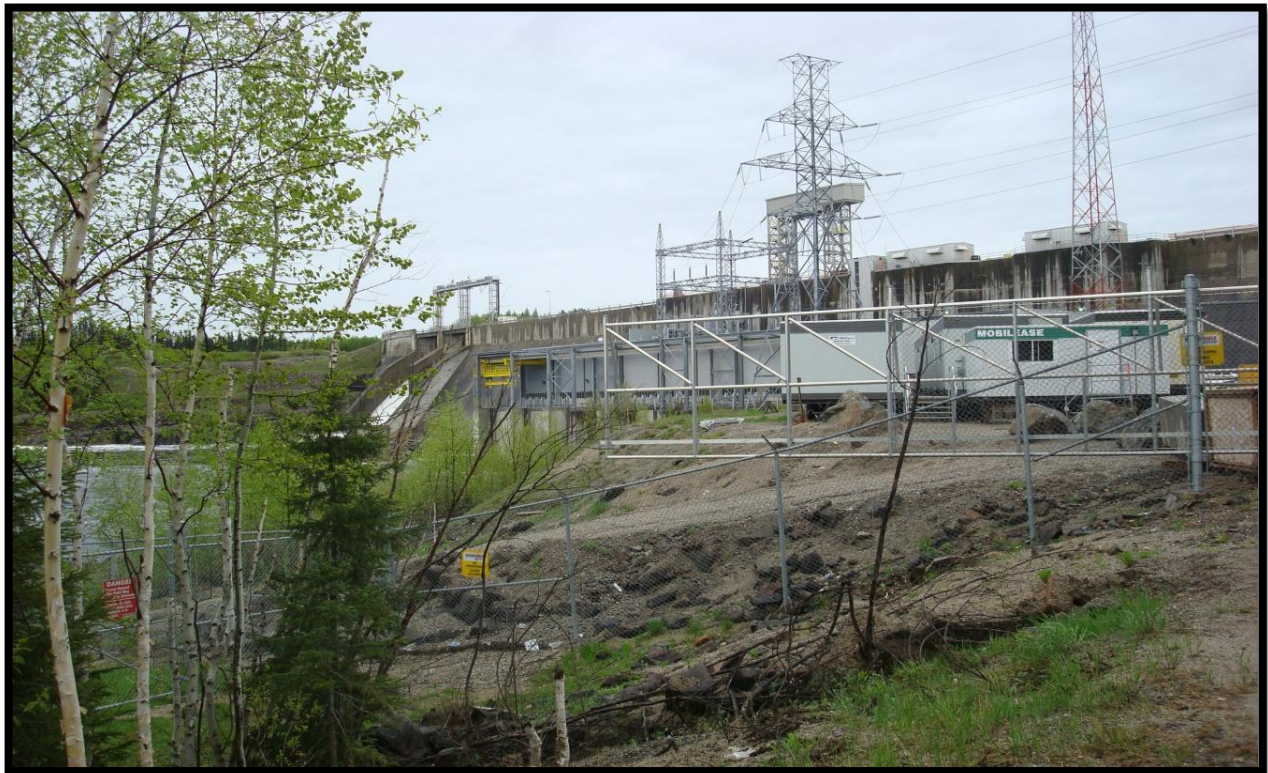
Figure 2: Harmon overview

- Injections occurred to eliminate leaks inside the powerhouse.
- The Unit tripped late in the month on lower guide bearing high temperature. An investigation revealed the trip settings were set 10 to 15 °C lower than the recommended settings in the Operations and Maintenance manual. This issue was corrected.
- Temporary power cables used for construction were de-energized and removed from the site.
- KAP worked on correcting punch list items throughout the month.
- During a scheduled Unit outage, PowerTel replaced an improperly sized cable drop in the switchyard with the correct one.
- Harmon was declared in-service on June 3rd, 2014, three months ahead of the target in-service date.

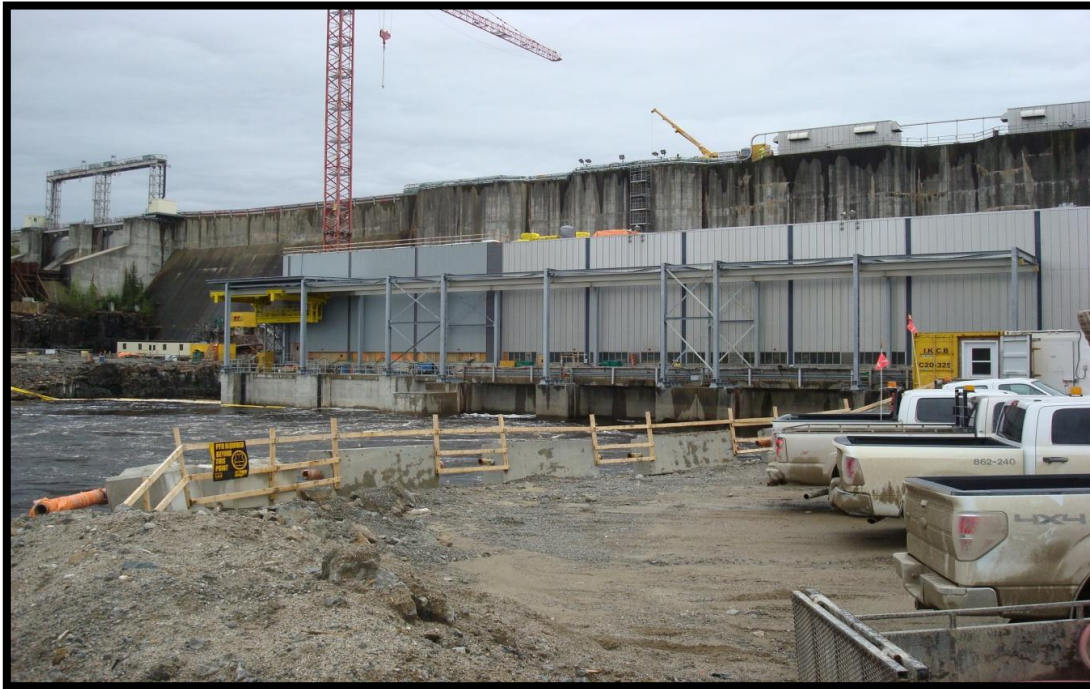
Figure 3: Kipling Overview

- KAP completed the removal of the shoring towers from the intake.
- Andritz installed the rotor spider, rotor rim, the generator enclosure wall sections, the upper bracket, generator surface air coolers, and a number of piping systems.
- The rotor rim shrink was completed.
- Installation of BOP electrical components, panels and instrumentation continued.
- KAP completed re-routing the cables on the top of the dam and erected the draft tube stop log hoist structure.
- Electrical system installation in the hoist structure has started. It is forecasted that Kipling Unit 3 will be declared in service in December 2014.

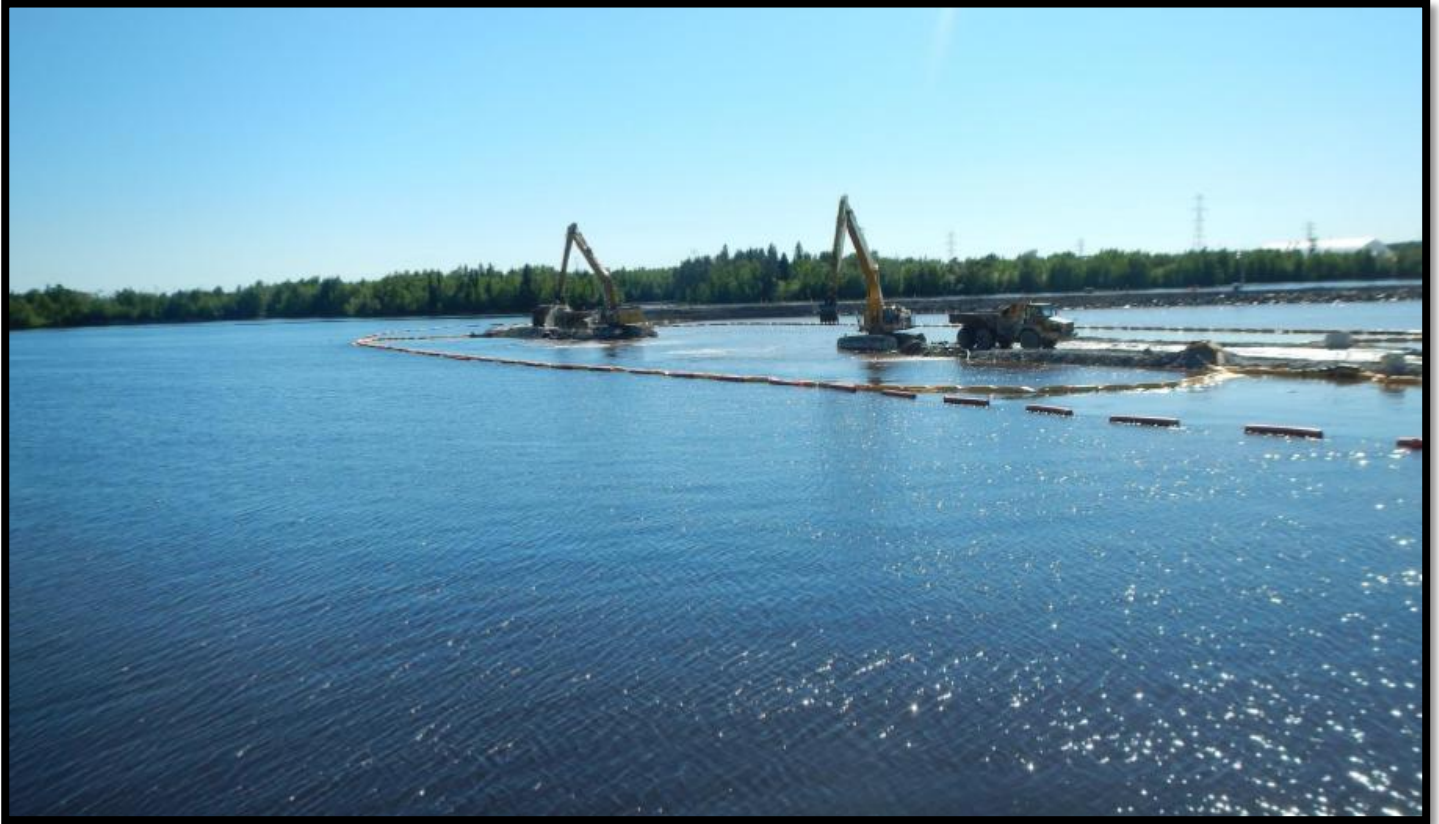
Figure 4: Smoky Falls cofferdam excavations

- Dry excavation at the upstream cofferdam was completed by mid-month. Full water-up was completed by June 16th, the silt curtains were installed around the cofferdam and wet excavation proceeded (Figure 4). At month-end, excavation is progressing well and will not prevent Unit 1 wet testing from starting on-schedule.

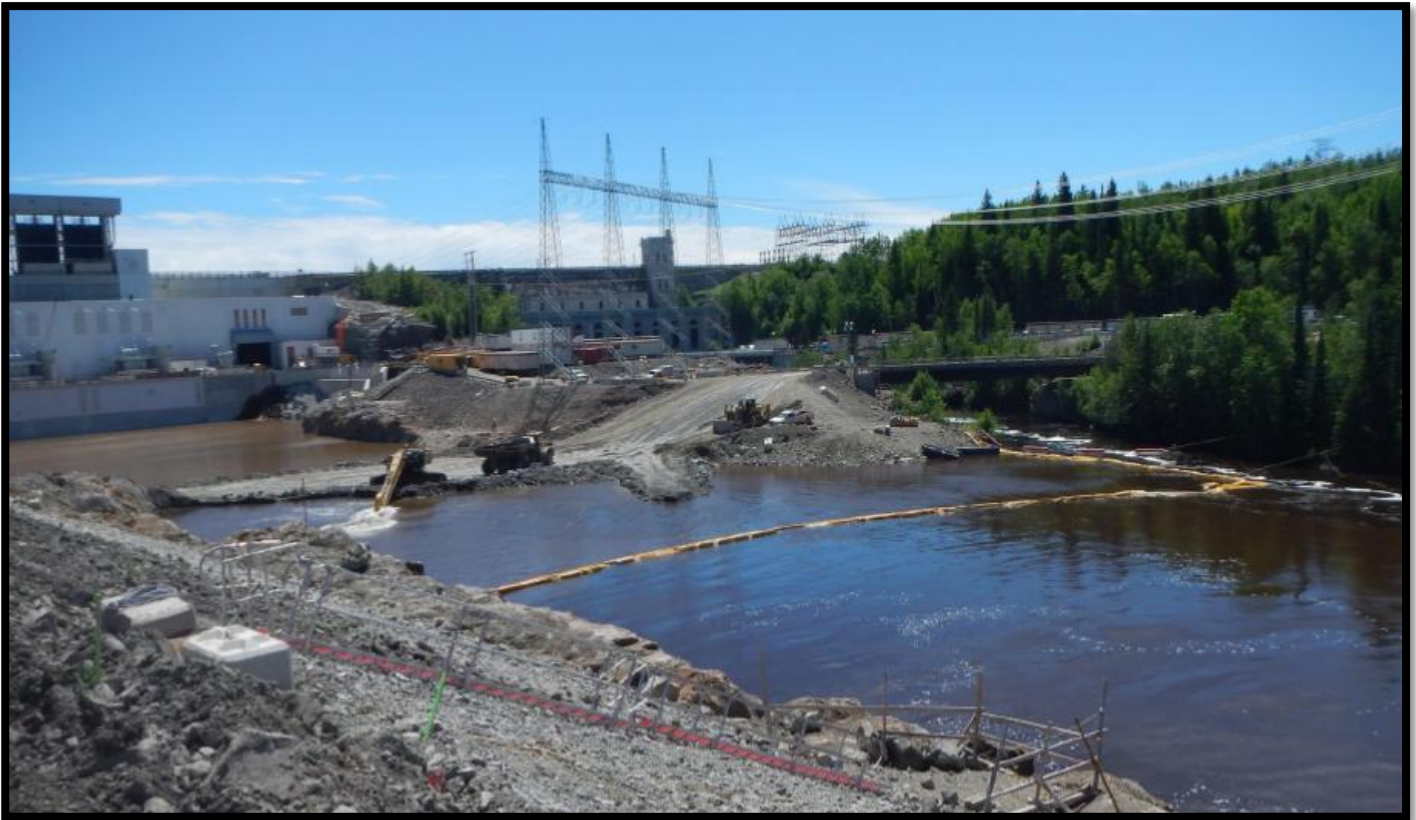
Figure 5: Smoky Falls rock plug excavations

- Tailrace water-up preparations were completed by June 6th and water-up was completed between June 7th and June 10th. The final blast on the rock plug was completed and wet excavation of the plug material is under way (Figure 5).

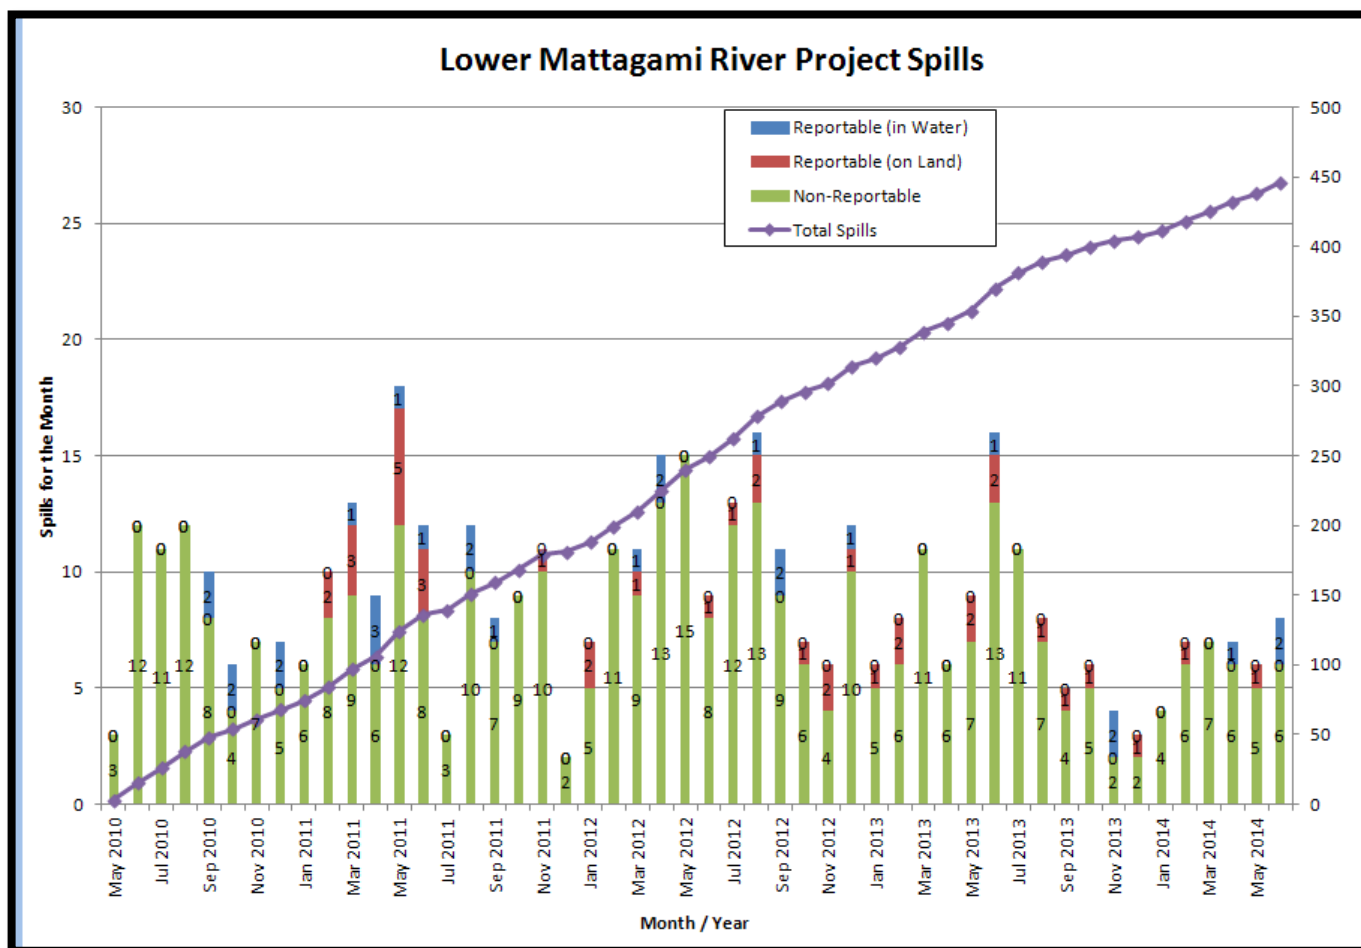
Figure 6: Lower Mattagami River Project spills

SPILLS			
No. of Spills:		8; Spill Reports 438-445 (see Figure 6 for LMRP spills breakdown).	
Classification of Spills:		<u>KAP Project Classification</u> Minor – 6 Moderate – 2 Major – 0 To Water - 0 <u>MOE Classification</u> Non-reportable - 2 Reportable to MOE <ul style="list-style-type: none">- Class C – 6- Class B – 0- Class A – 0	
Reportable Spills			
No.	Quantity /Product Spilled	Spill Site	Reason for being Reportable
1	4L/Hydraulic Oil	Smoky Falls Tailrace	Reportable (in-water). While monitoring the watering-up operation of the Smoky Falls Tailrace Channel it was noticed a slow hydraulic leak originating from the plug of the hydraulic tank of the pump. The plug of the tank aligns with one of the cross beams of the cage surrounding it, which rubbed against the plug causing it to loosen. When the pump was removed, approximately 1 liter of hydraulic oil was released to the ground (3 L in-water, 1 L on Land). A permanent oil boom was placed in the water prior to the start of in-water work at the Smoky Falls Rock Plug as a preventative measure.
