Environmental Working Group

Monthly Report

March 2013

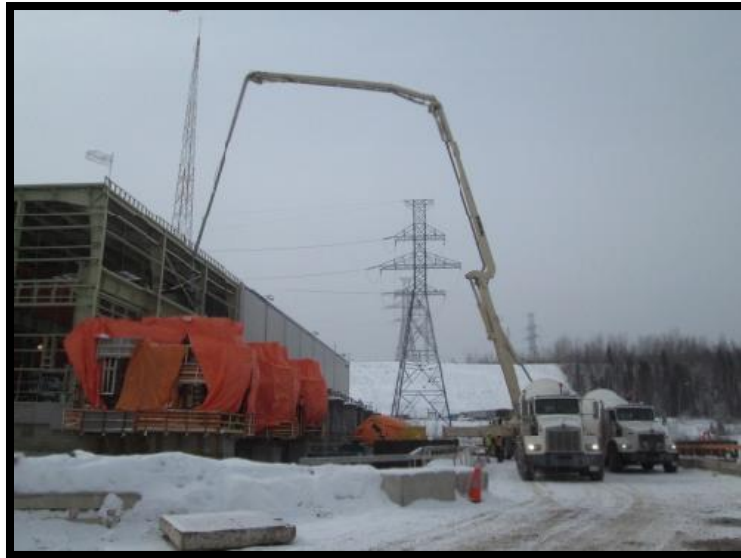
Figure 2: Harmon concrete pour.

- 142 m³ of concrete was poured this month, bringing the total poured to date to 11,128 m³ of 12,302 m³ total, against a plan of 9,832 m³ (Figure 2).
- Concrete deficiency repairs inside the scroll case continue to progress.

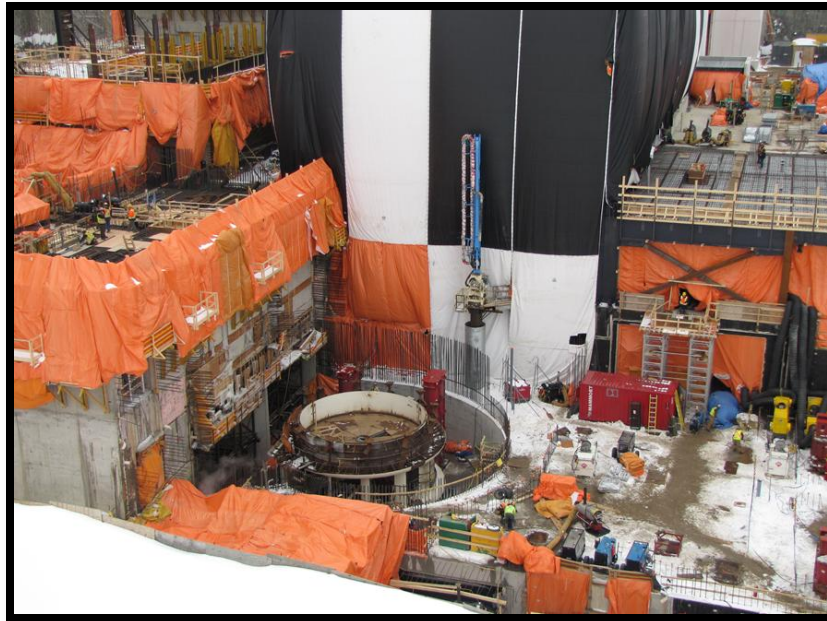
Figure 3: Smoky Falls Overview Power House Unit 3

- At Unit 2, KAP continues to work on rebar and formwork installation for the concrete pour under the stay ring; and
 - At Unit 3, the stay ring assembly was installed in Unit 3, centred, and leveled. The upper stay ring anchors were welded to the stay ring, and the J-hooks were welded on the upper pit liner. KAP has started formwork and rebar installation for the concrete pour under the stay ring (Figure 3).

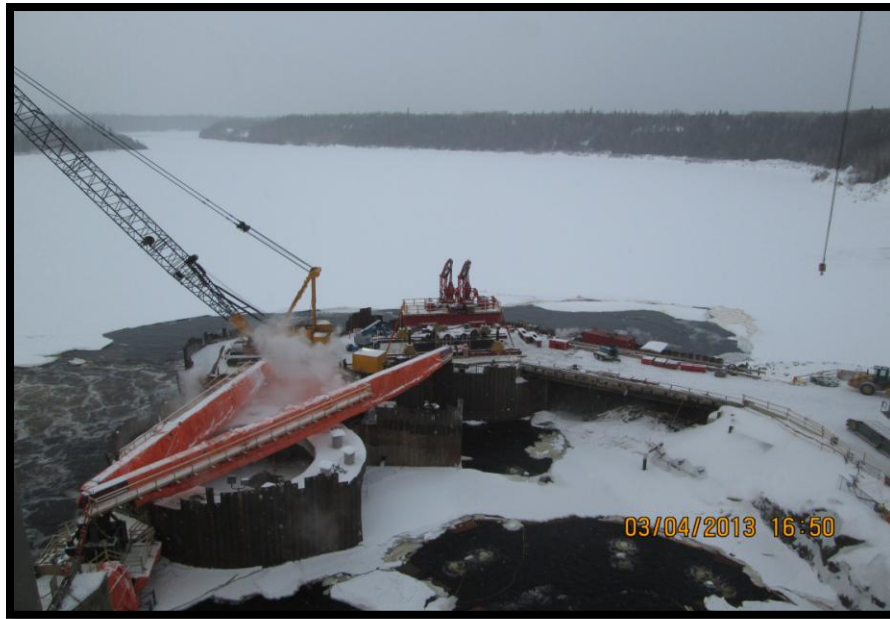
Figure 4: Kipling Jack Beam Assembly

- The spillway was set to discharge at $100 \text{ m}^3/\text{s}$ to allow KAP to build the earth berm.
- The jacking beam assemblies were successfully installed beneath the Cell #3 concrete ring and the ring was declared stabilized on March 14th, on schedule (Figure 4).
- KAP completed installing Stage 1 of the earthfill cofferdam (Figure 5).
- KAP completed building the cement-bentonite slurry cut-off wall of the rockfill cofferdam.
- Installation of dewatering pumps and pipes is ongoing.
