## **Environmental Working Group**

### **Monthly Report**

**May 2014**

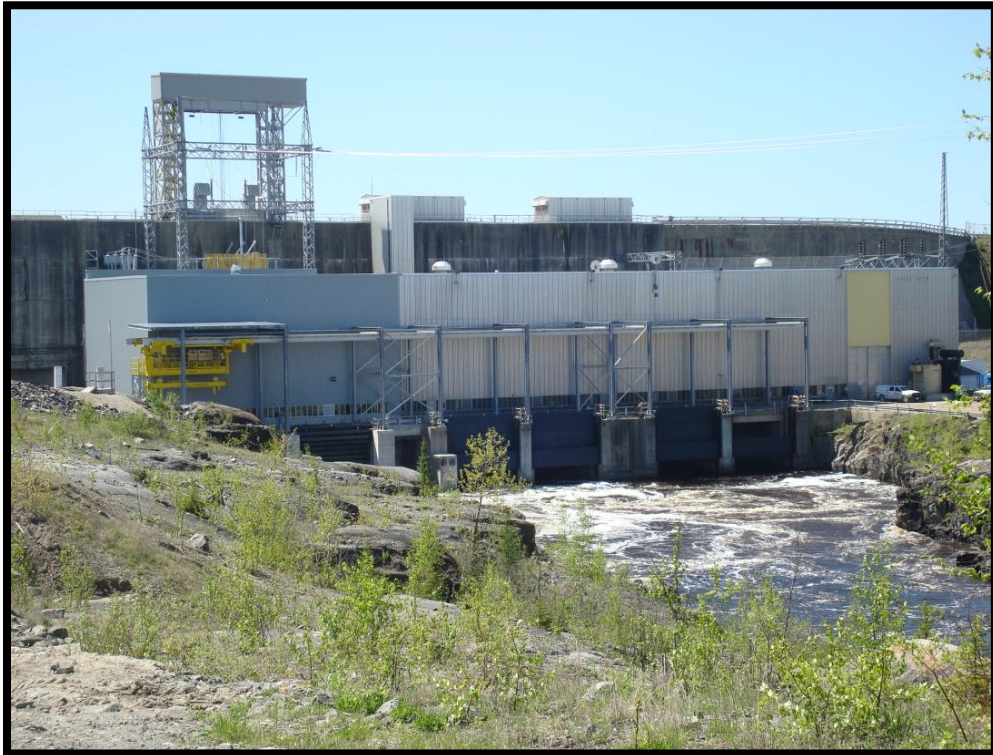
Figure 1: Little Long Unit 3

- KAP closed out 9 punch list items this month. OPG confirmed one as complete and is reviewing the others.
- Confirmation of substantial completion was provided to KAP by OPG on May 28th.
- Little Long Unit was 3 (Figure 1) was declared in service on January 19, 2014.

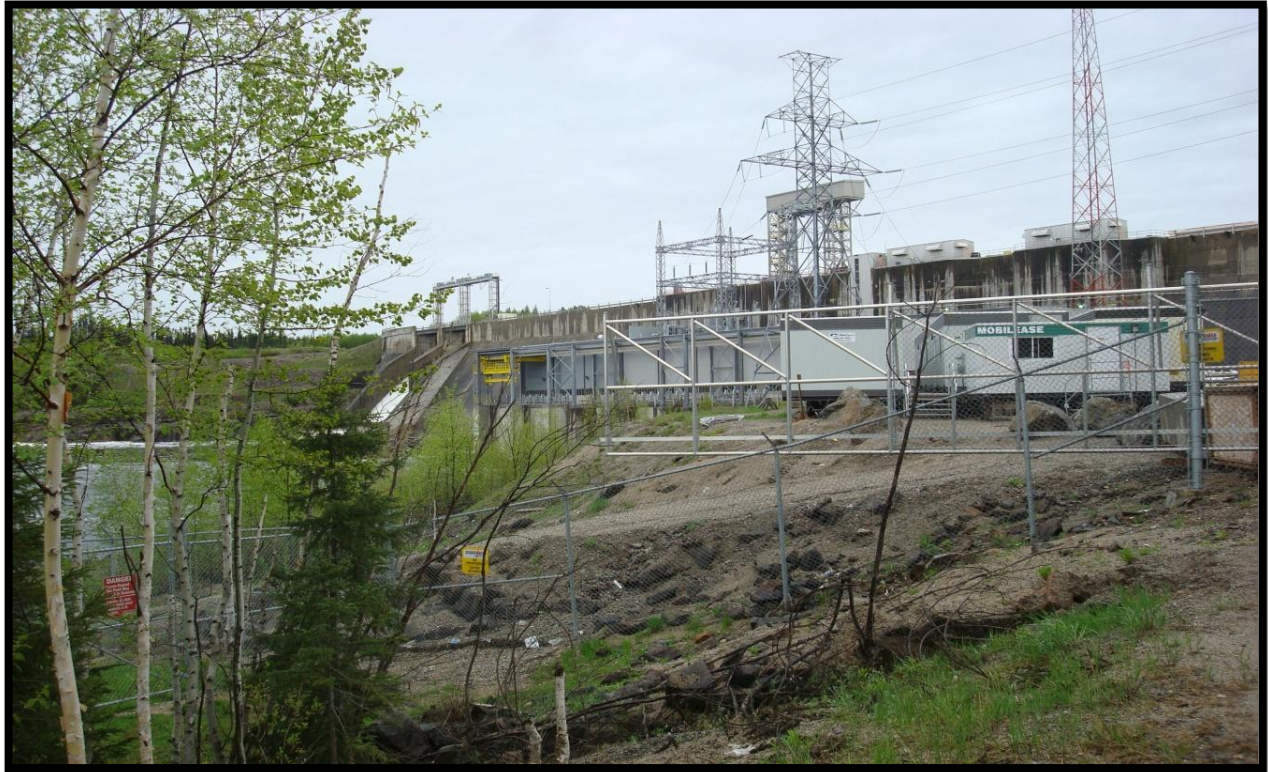
Figure 2: Harmon overview

- Issues were noticed with the intake gate hoist gears during commissioning. An investigation was completed and a design deficiency was identified as the root cause. RSW is preparing an updated design to correct the issue.
- KAP used the gears intended for Kipling to replace the damaged gears at Harmon and ordered new gears for Kipling.
- Miscellaneous metals installation, painting, cleaning and other non-critical activities continued throughout the month.
- Harmon was declared in-service on June 3rd, 2014, three months ahead of the target in-service date.

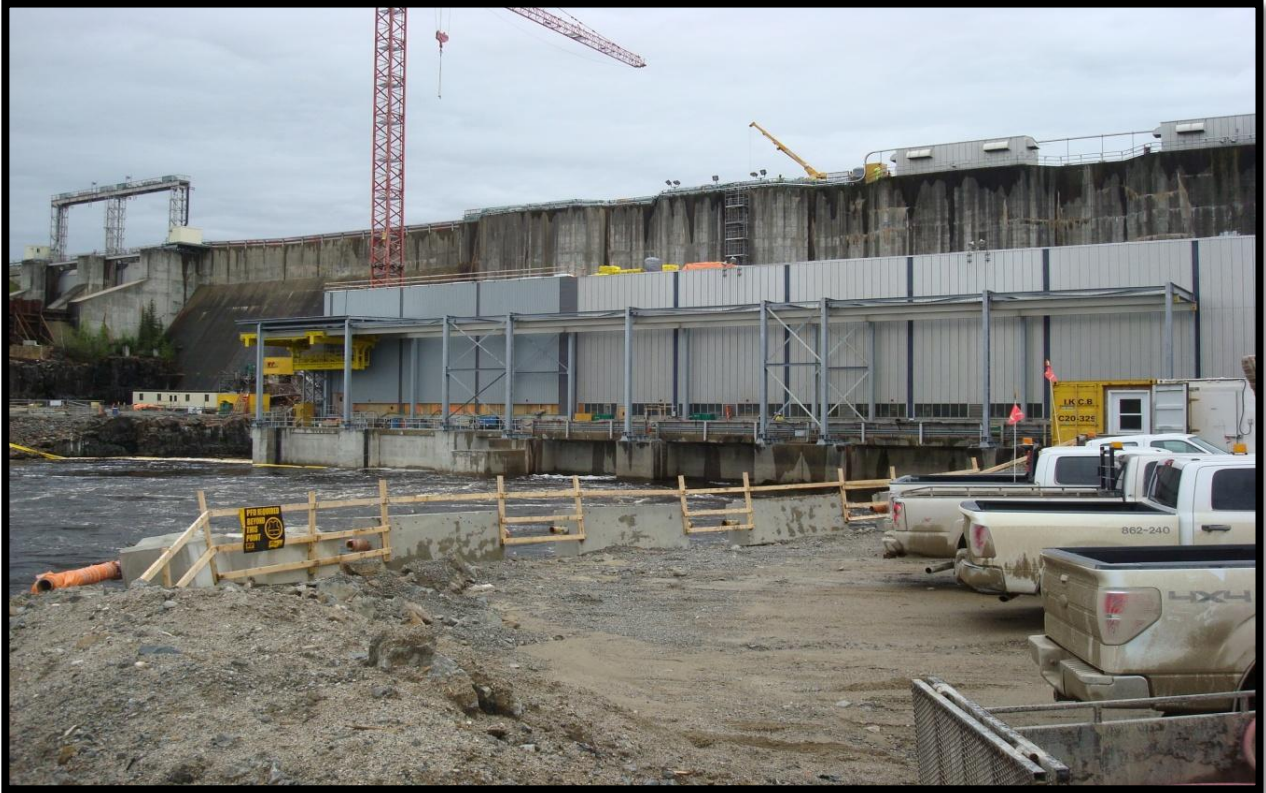
Figure 3: Kipling Overview

- KAP started dismantling shoring towers in the intake.
- Andritz installed the turbine shaft, servomotors, the lower guide bearing, the lower bracket, the generator shaft, the turbine thrust bearing, and generator enclosure base plates.
- Stator winding and the hi-pot test were completed. No issues were identified.
- Installation of BOP electrical components, panels and instrumentation continued.
- KAP has started preparations to re-route cables on the top of the dam to allow the erection of the draft tube stop log hoist structure.
- It is forecasted that Kipling Unit 3 will be declared in service in December 2014.

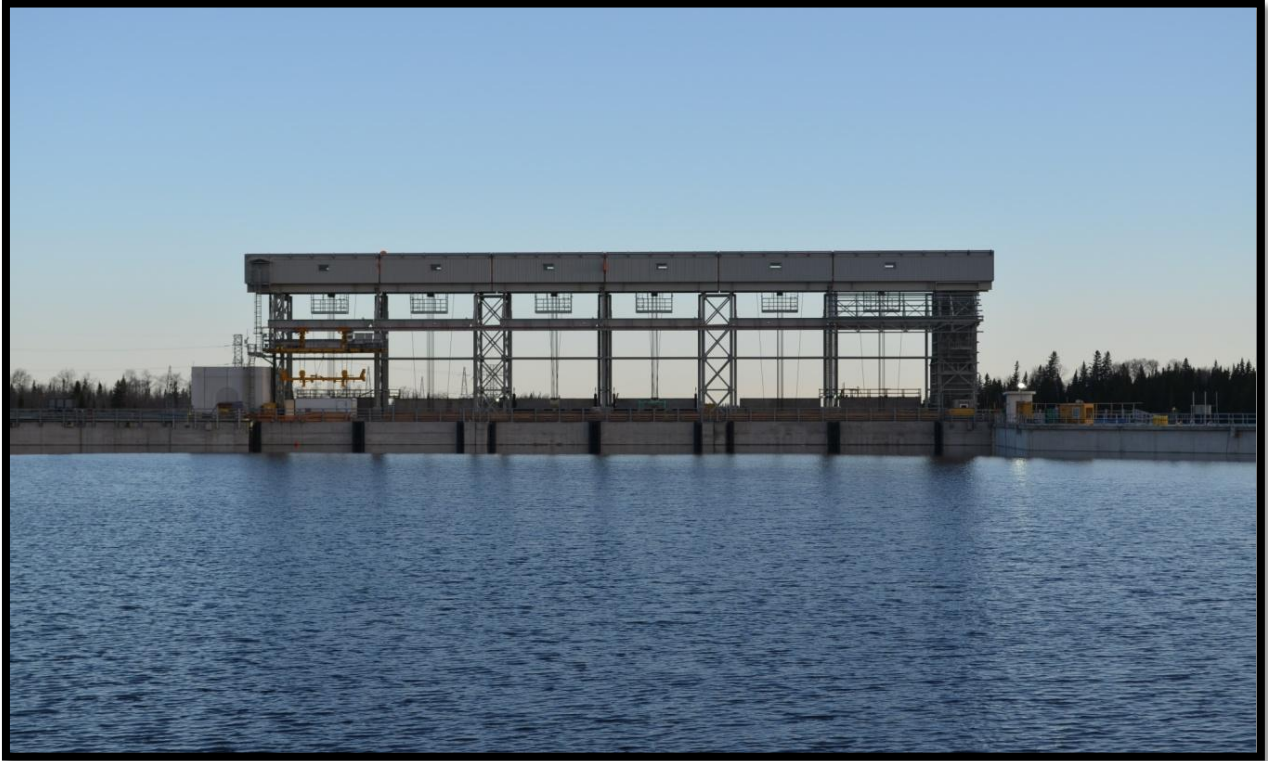
Figure 4: Smoky Falls intake water-up

- Water-up (Phase 1) was completed between May 4<sup>th</sup> and May 7<sup>th</sup> (Figure 4). Minor issues were identified. KAP dewatered the forebay in order to correct them.

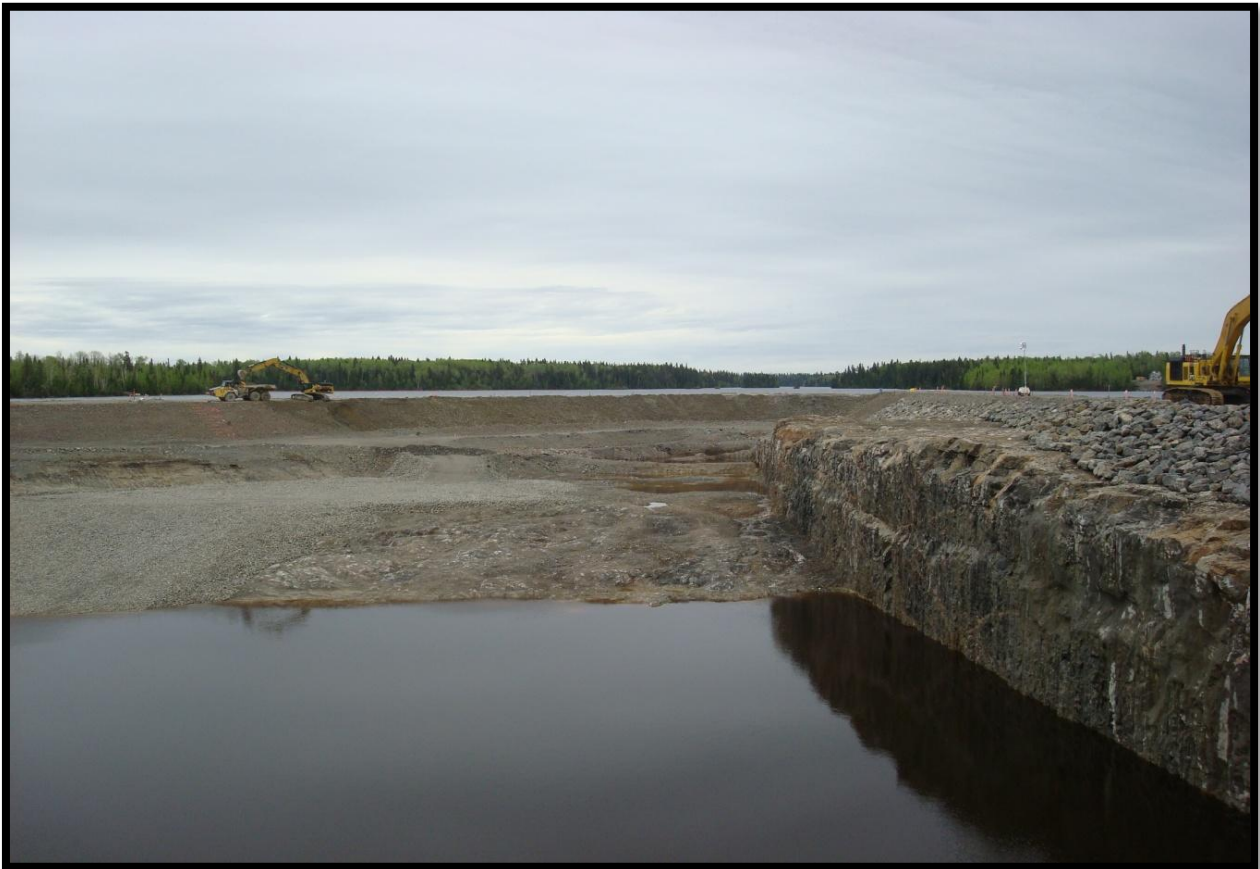
Figure 5: Smoky Falls cofferdam excavations

- Excavation and clean-up continued in the tailrace channel (Figure 5). Tailrace channel depressions were backfilled, and rock bolts were grouted.
- Final preparations for tailrace water-up started near month-end.

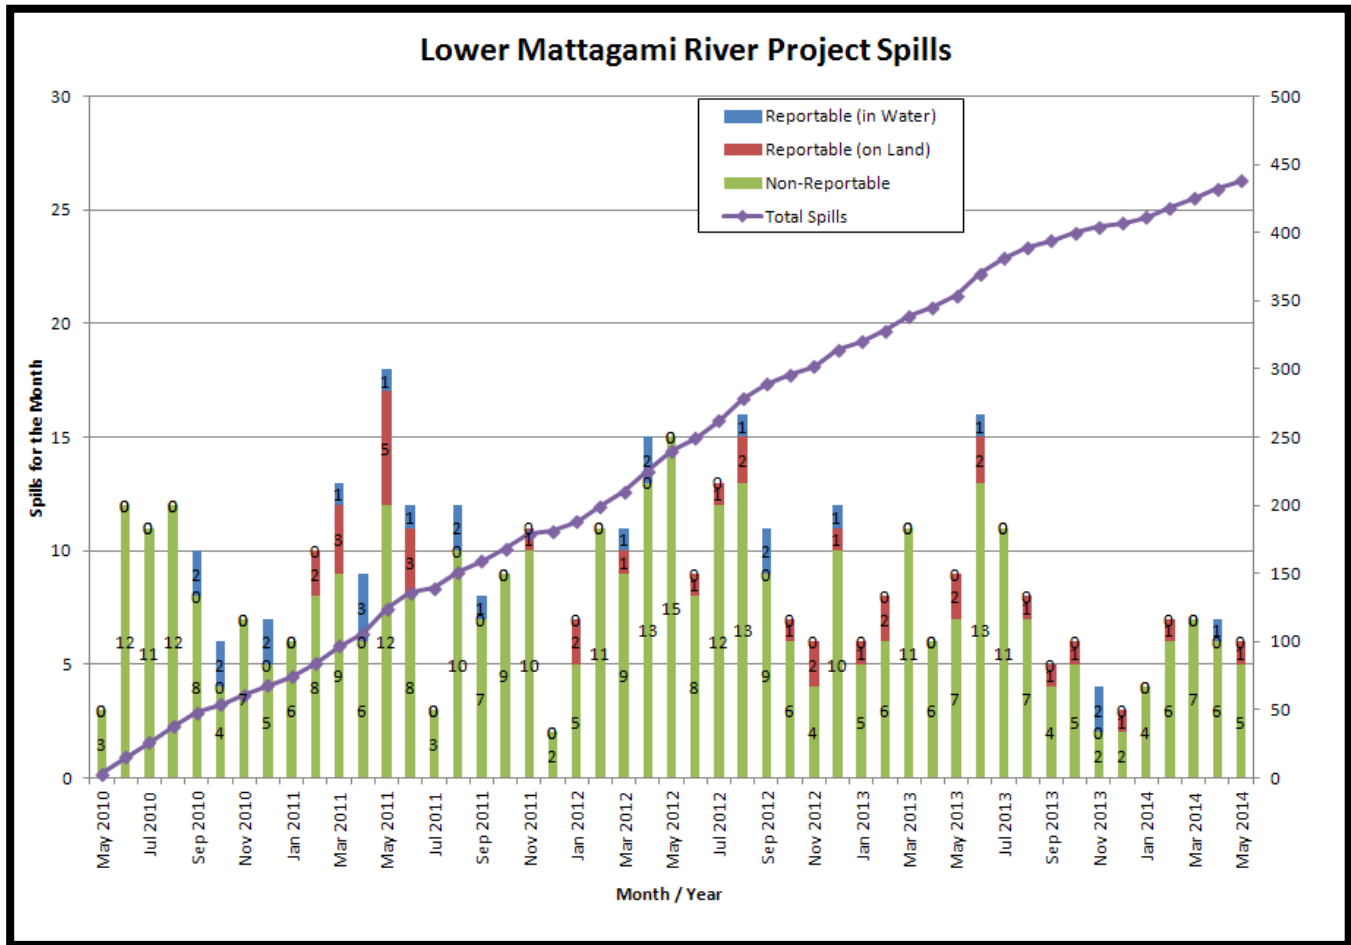
Figure 6: Lower Mattagami River Project spills

SPILLS			
No. of Spills:		5; Spill Reports 433-437 (see Figure 6 for LMRP spills breakdown).	
Classification of Spills:		<u>KAP Project Classification</u> Minor – 4 Moderate – 0 Major –1 To Water - 0 <u>MOE Classification</u> Non-reportable - 4 Reportable to MOE <div>- Class C – 1 - Class B – 0 - Class A – 0</div>	
Reportable Spills			
No.	Quantity /Product Spilled	Spill Site	Reason for being Reportable
1	120L/Oily Water	Fuel Farm	On-land Spill. While going to the fuel farm to collect the quarterly sample, water was noticed to be slowly leaking under the pipe, rather than through it. It was noted that the concrete around the pipe was cracked, and caused water to leak out. An epoxy water seal was placed on the crack to repair it and seal the leak.
KAP Project Classification Minor: ≤ 10L Moderate: Between 10L and 100L Major: ≥100L To Water: Any amount is reportable to the MOE (See Figure 7: KAP Spills Response Flowchart)			MOE Classification (see Reportable and Non-reportable Spills definition below) Non-reportable: < 100L Reportable to MOE <div><div>• Class C - Less Serious</div><div>• Class B – Serious</div><div>• Class A – Very Serious</div></div>

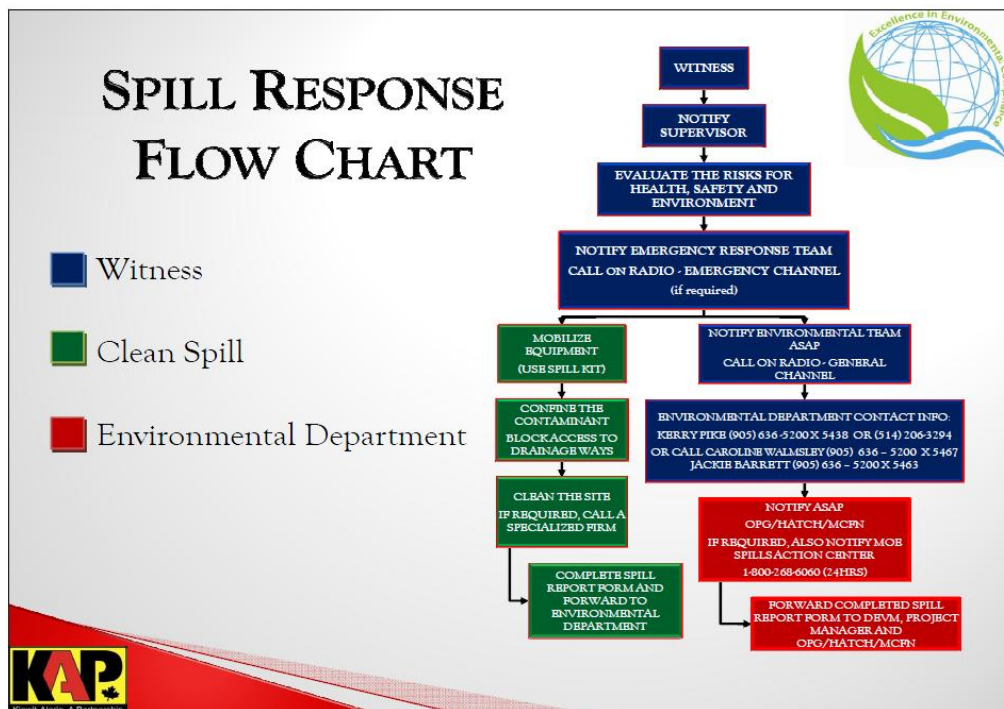
Figure 7: KAP Spills Response Flowchart

When **any spill** occurs on site, KAPs spill response process is to be followed (Figure 7). This includes notification of the Supervisor and KAPs Environmental Department, and an assessment of the severity of the spill. Regardless of the quantity, clean-up measures are implemented for **every spill** using spill kits that are available throughout the site (materials used for clean-up and any contaminated soil are removed from the site). A spill report is then prepared for **each spill that occurs** which outlines the location, type, severity and quantity of the spill, in addition to details on how the spill occurred, how it was cleaned up and measures implemented on how the spill could be avoided for the future. This report is sent out to several OPG and Hatch representatives as well as all EWG members.
