Environmental Working Group

Monthly Report

October 2012

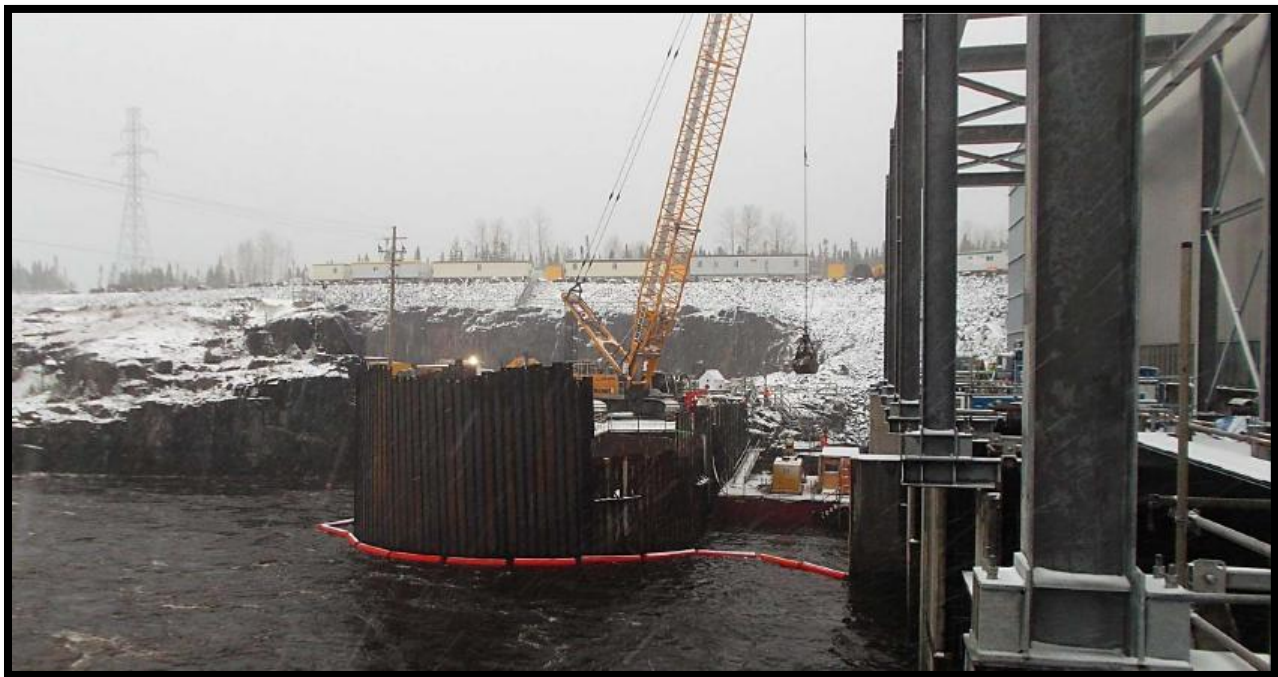
Figure 1: Little Long Cofferdam Removal

- Removal of the cofferdam continues, with arc cell 2-3 and cell 3 fully removed. Removal of the sand from cell 2 and arc cell 1-2 is under way and advancing quickly (Figure 1).

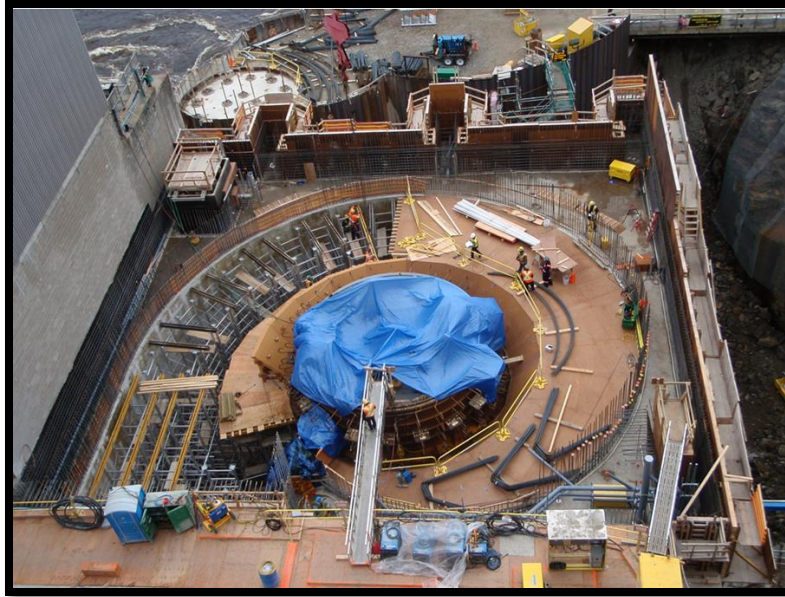
Figure 2: Harmon overview, scroll case soffit work

- 257 m³ of concrete was poured this month, bringing the total poured to date to 9,053 m³ of 12,251 m³ total, against a plan of 8,334 m³.
- Removal of the penstock shoring towers from Unit 3 is now complete.
- Formwork, embedded piping, shoring tower, and rebar installation for the scroll case soffit continues (Figure 2).
- Welding re-work was completed on the pit liner and baffle vane by Andritz.
- Repairs of concrete deficiencies in the scroll case have started.

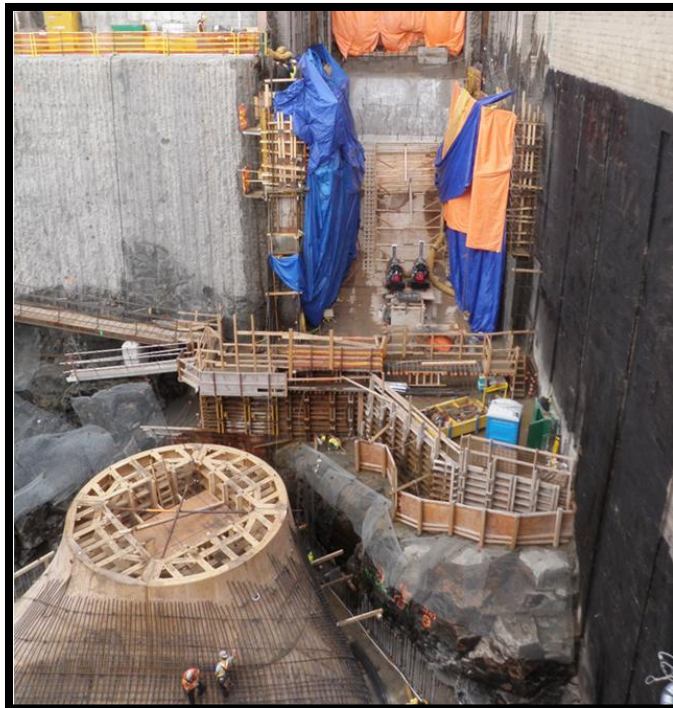
Figure 3: Kipling overview, intake and draft tube work.

- 1,419 m³ of structural concrete was poured this month, bringing the total poured to date to 3,185 m³ of 11,647 m³ total, against a baseline plan of 7,443 m³.
- Concrete work in the switchyard (equipment footings and columns) is progressing. PowerTel (electrical sub-contractor) has dismantled the existing disconnect switch and will install the new switch once the concrete support column has been poured and cured.
- Backfilling around the completed lock block retaining wall, transformer, and oil/water separator foundations is ongoing.
- Several large powerhouse concrete pours were completed this month, as well as a couple of intake pours (Figure 3).

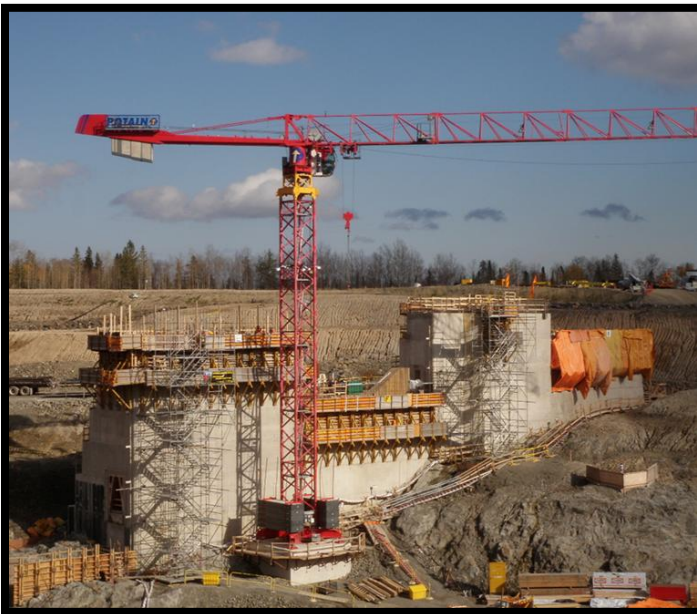
Figure 4: Smoky Falls East Gravity Dam.

- At the end of the month, fifteen (15) concrete pours are in various stages of work (formwork started and/or rebar being installed) and progressing in the intake, powerhouse, East gravity dam (Figure 4), and at the permanent bridge. Thirty eight (38) pours were completed during the month.

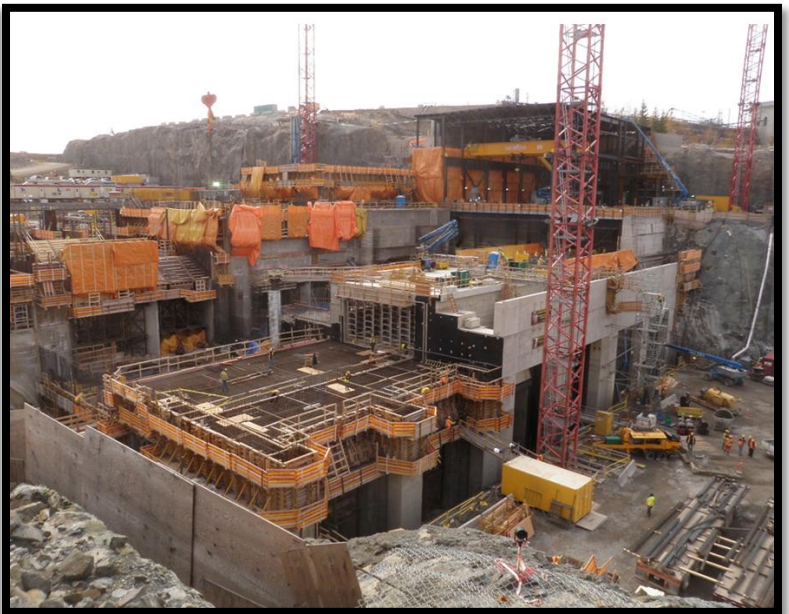
Figure 5: Smoky Falls overview.

- 7,575 m³ of concrete was poured this month in the service bay, powerhouse, and intake areas, bringing the total poured to date to 74,000 m³ of 155,084 m³ total, against a plan of 77,992 m³.

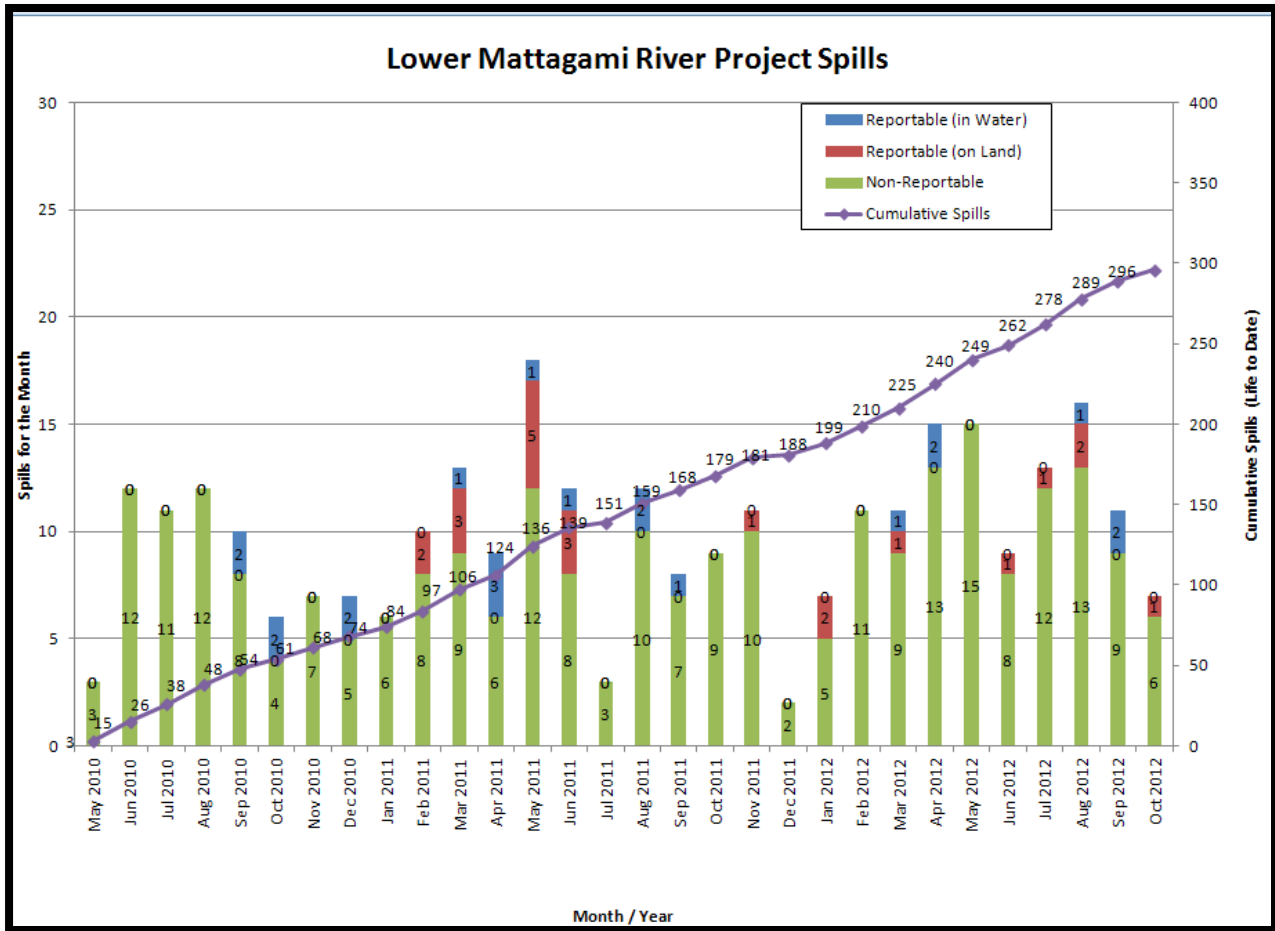
Figure 6: Lower Mattagami River Project spills

SPILLS			
No. of Spills:		11; Spill Reports 279-289 (see Figure 6 for LMRP spills breakdown).	
Classification of Spills:		<u>Project Classification</u> Minor – 4 Moderate – 2 Major –1 To Water - 0 <u>MOE Classification</u> Non-reportable - 6 Reportable to MOE <ul style="list-style-type: none">- Class C – 1- Class B – 0- Class A – 0	
<u>Reportable Spills</u>			
No.	Quantity /Product Spilled	Spill Site	Reason for being Reportable
1	Hydraulic Oil/120 L	Smoky Falls – Wet Tailrace	Reportable (due to quantity). The pump truck was parked on the pad in front of the Smoky Falls New Powerhouse, pumping concrete for pour when a main hydraulic line blew causing oil to leak/spray onto the ground. The superintendents and foreman discussed the spill with their crews and remind the crews the importance of conducting the visual inspections of the equipment.
Project Classification (KAP) Minor: ≤ 10L Moderate: Between 10L and 100L Major: ≥100L To Water: Any amount is reportable to the MOE (See Figure 7: KAP Spills Response Flowchart)			MOE Classification Non-reportable: < 100L Reportable to MOE <ul style="list-style-type: none">• Class C - Less Serious• Class B – Serious• Class A – Very Serious
