Environmental Working Group

Monthly Report

September 2012

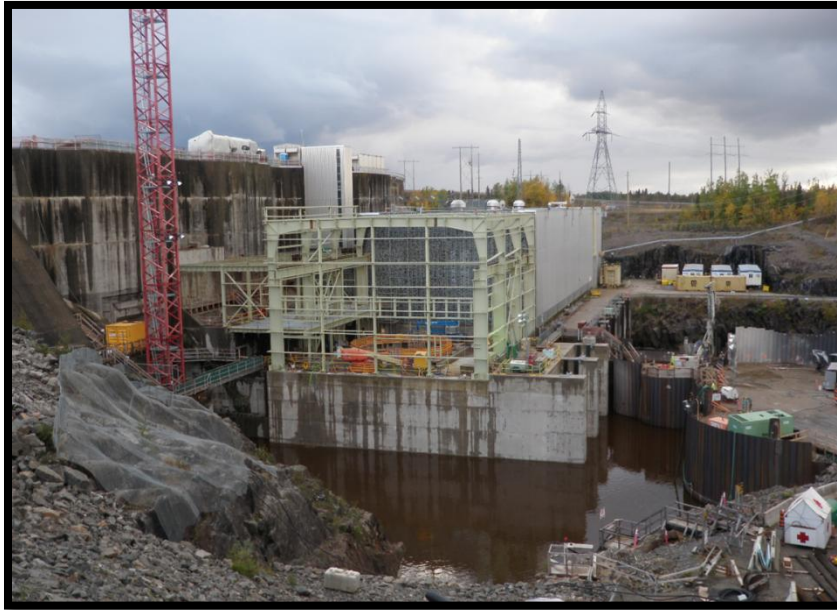
Figure 1: Little Long Superstructure and watered-up lagoon

- The superstructure erection was completed on September 26th.
- Roof deck installation has started over the superstructure (Figure 1).
- Watering-up of the lagoon area was successfully completed after an inspection of the draft tube sectional gates (Figure 1).

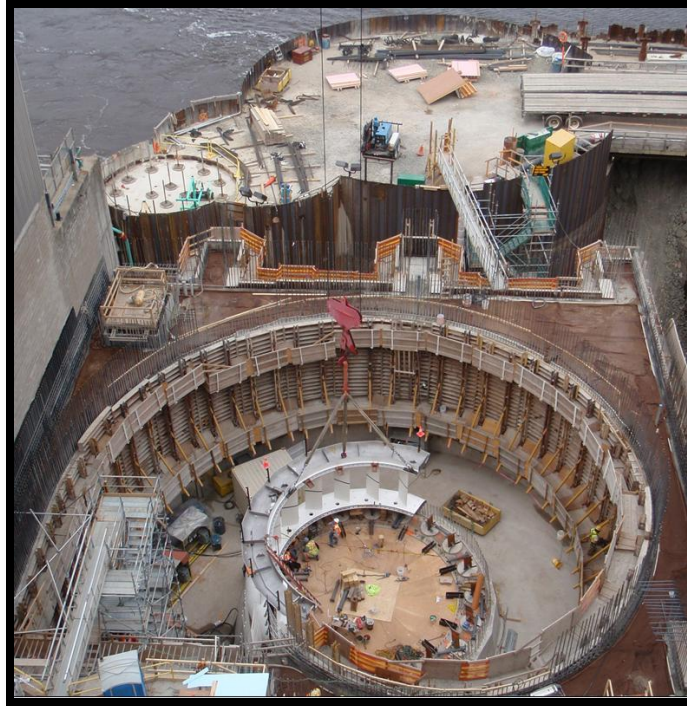
Figure 2: Harmon Stay ring assembly

- 743 m³ of concrete was poured this month, bringing the total poured to date to 8,796 m³ of 12,251 m³ total, against a plan of 7,417 m³.
- All four stay ring sections have been assembled in place and welding of the top and bottom anchors to the stay ring is complete (Figure 2).
- Welding of the pit liner sections is under way.
- Concrete repairs are progressing as the deficiencies are identified.
- Fiber optic cable installation between Harmon and Smoky Falls is complete.
- Removal of the penstock shoring towers from Unit 3 continues.

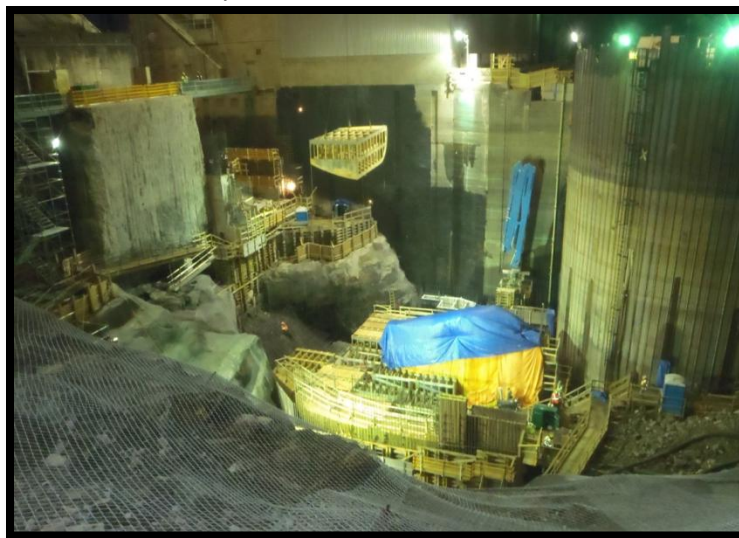
Figure 4: Kipling draft tube formwork module.

- 722 m³ of structural concrete was poured this month, bringing the total poured to date to 1,766 m³ of 11,647 m³ total, against a baseline plan of 7,330 m³.
- The concrete supply line from the top of the existing tailrace deck to the placing boom pad was installed.
- Work for Unit 3 support equipment continues to progress at the switchyard.
- Draft tube shoring formwork modules have been installed on the draft tube base slab as part of ongoing powerhouse concrete work (Figure 4).
- The sump shaft steel form was also installed in the powerhouse area.
- Work has started on the 230 kV transmission line and the 15 kV bus bar between the existing powerhouse and the switchyard.

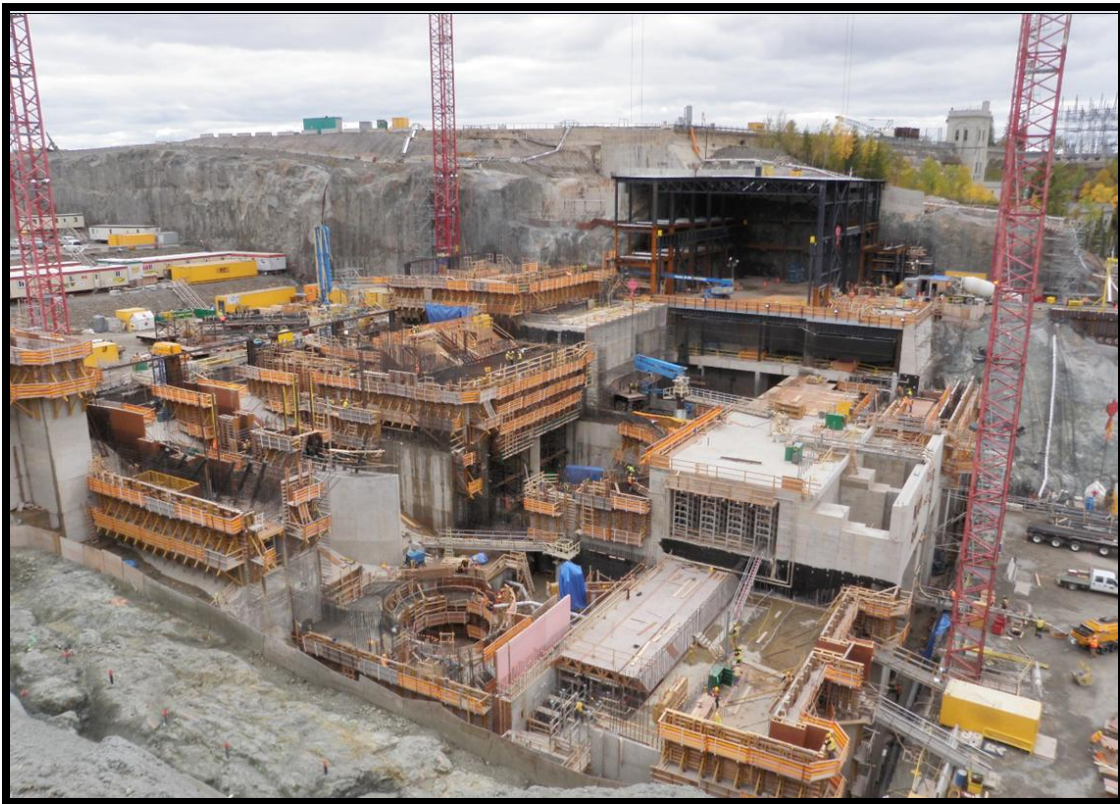
Figure 4: Smoky Falls Site Overview

- At the end of the month, twenty five (25) concrete pours are in various stages of work (formwork started and/or rebar being installed) and progressing in the intake, powerhouse, East gravity dam, and at the permanent bridge (Figure 4).

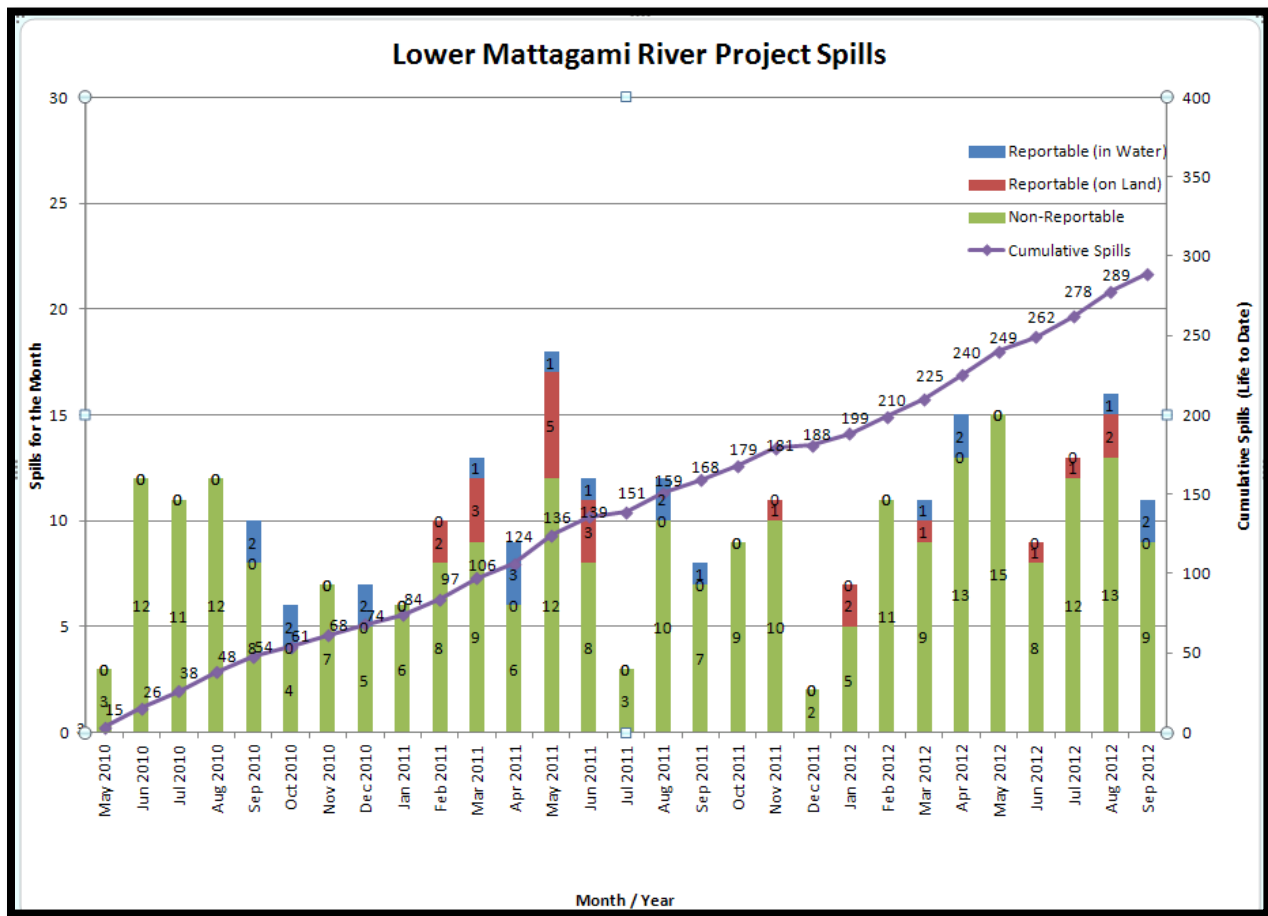
Figure 6: Lower Mattagami River Project spills

SPILLS			
No. of Spills:		11; Spill Reports 279-289 (see Figure 6 for LMRP spills breakdown).	
Classification of Spills:		<u>Project Classification</u> Minor – 5 Moderate – 4 Major –0 To Water - 2 <u>MOE Classification</u> Non-reportable - 9 Reportable to MOE <ul style="list-style-type: none">- Class C – 2- Class B – 0- Class A – 0	
<u>Reportable Spills</u>			
No.	Quantity /Product Spilled	Spill Site	Reason for being Reportable
1	Hydraulic Oil/9.5 L	Smoky Falls – Wet Tailrace	While the operator was loading a 773 Rock Truck at the wet tailrace, the driver of the truck informed the operator of oil spraying from the boom. The operator immediately stopped the machine and inspected the boom. A small crack was observed on a hydraulic line. A small amount of oil spray (<1 L) hit the water.
2	Hydraulic Oil/37 L	Smoky Falls – Wet Tailrace	The excavator was working within the wet tailrace when the operator heard a pop and then noticed oil spraying from the top of the boom on the excavator. The operators swung the boom to shore and placed the bucket on the ground before shutting the machine down. An oil boom curtain has been installed in front of the existing turbidity curtain as an additional measure as well as a second larger spill drum was also placed at the tailrace.
